ELEVEN FOLLIES IN COUNTY OFFALY

CONDITION SURVEY & MEASURED DRAWINGS

October 2013

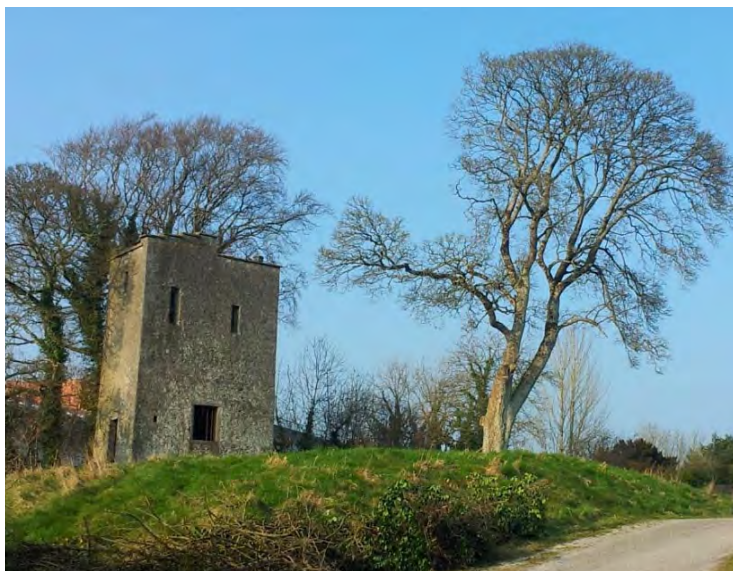
1. View of south east elevation from town park
2. North east elevation of folly.
3. Unusual detail at corner.
4. View of parapet with stone copings, chimney pots and remains of a handrail.
5. Scar of the former staircase to the south west elevation.

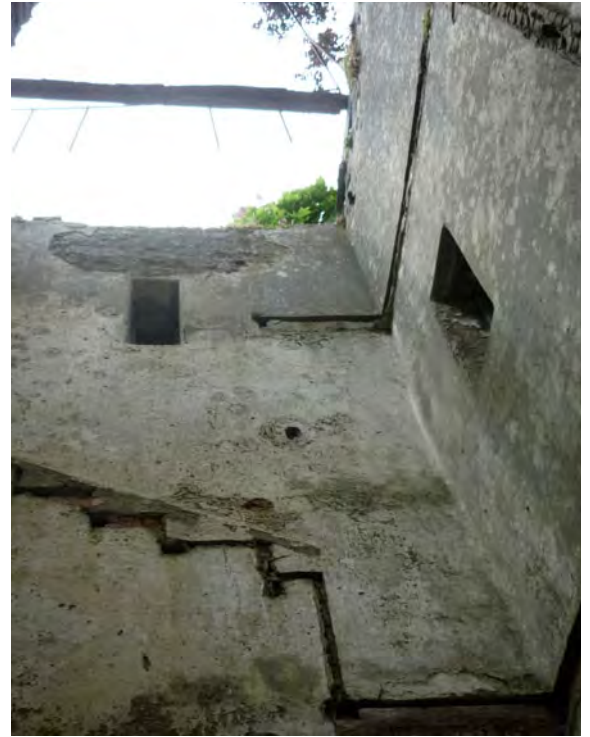
The structure is completely derelict with the roof and roof terrace now entirely gone and only some rotten floor joists remaining from the original first floor. Similarly the timber staircase has been removed in its entirety leaving only an imprint in the plaster as to its former presence. Most of the internal cross wall, which like the floor vault was constructed of brick, has fallen and all of the original door and windows and chimney pieces are now missing. The original entrance door and window to the undercroft have been in-filled with concrete blocks. Despite this advanced state of dereliction the structure is relatively sound and appears to be at rest. This is partly due to the excellent limestone copings that will have protected the wall heads. However, these have only been viewed from the ground using binoculars and should be inspected at close quarters to ensure that they are not loose and at risk of falling. A similar inspection should be made of all the window surround and structural heads, the railings and chimney pots, together with the fragmented cross wall, brick vaulted

1. Internal view of remains of first floor.
2. scar of staircase in north west corner.
3. Former opening for fireplace.
4. Remains of former cross wall.
5. Vaulted basement.

1. Carry out a high level inspection, using a cherry picker, of all wall heads and interior of the structure with an experienced stone mason in attendance.
2. Take down or consolidate any loose masonry, plaster or rotten timbers.
3. Clear out all debris from ground floor and undercroft.
4. Unblock door and window in southwest elevation and make good reveals.
5. Install metal grilles in three openings in ground floor and undercroft.
6. Consider installing internal metal staircase, guard rails and decking to first floor and roof levels to restore rooftop viewing gallery.
7. Thin back some of the mature surrounding trees to improve views to and from the structure.

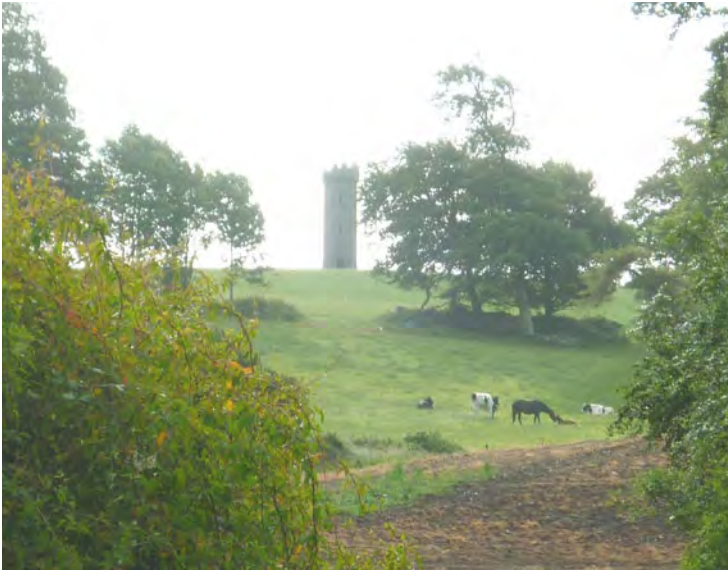
1. View of tower from Busherstown house.
2. West facing elevation of the tower.
3. North facing elevation of the tower.
4. South east elevation of the tower.
5. Detail view of the parapet of the tower with missing battlements.

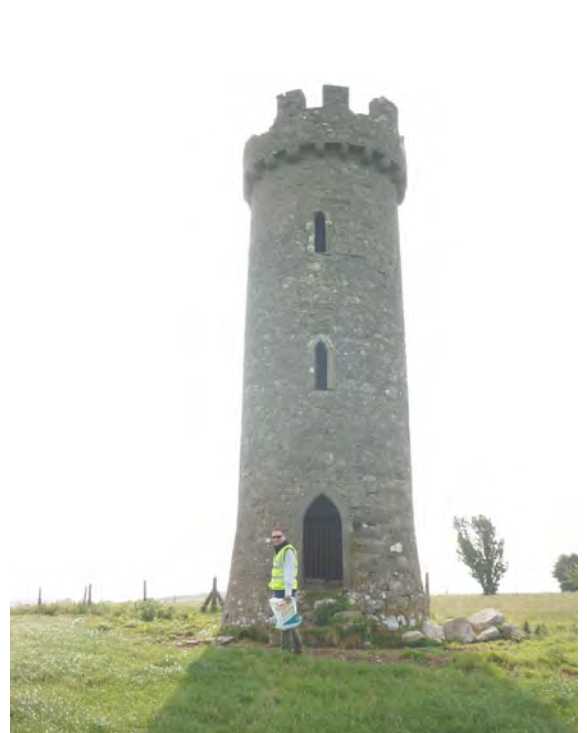
The condition of the tower is generally good with the exception of two of the battlements on the north side of the parapet, which have fallen or been pushed over. There are a number of small holes and a few limited areas of masonry that are severely weathered, which would benefit from pinning and pointing. Much of the upper levels have been cement pointed, which is unsightly but for the moment not causing any significant damage. The makeshift metal gate is unsightly and the light chain and lock used to close it are far from secure. Leading up to the entrance door was a flight of stone steps that have been dislodged, probably by cattle. The greatest structural damage is to the internal cast iron staircase, many of the treads of which have been broken, most likely as a result of vandalism, or removed deliberately as in Belview, Kilclare. This is not only a great loss of an important early cast iron, highly decorative staircase, but denies access to what would have been one of the finest vantage points in Offaly.

1. Carry out a high level inspection, using a cherry picker, of all wall heads with an experienced stonemason in attendance.
2. Take down or consolidate any loose masonry to wall heads and flaunch in sand and lime to weather.
3. Clear out all debris from the interior of the tower – set aside the iron fragments of the staircase.
4. Spray any plant growth on the structure with approved biocide.
5. Pin and point holes and minor areas of weathered masonry.
6. Repair the original stone steps leading up to entrance door.
7. Install a secure metal gate to the entrance door.
8. Consider restoring cast iron staircase and guardrails to restore rooftop viewing point.
9. If funds were ever available the cement pointing should be removed and the masonry repointed using sand and lime.
(The latter two items are highly desirable but relative expensive to undertake.)

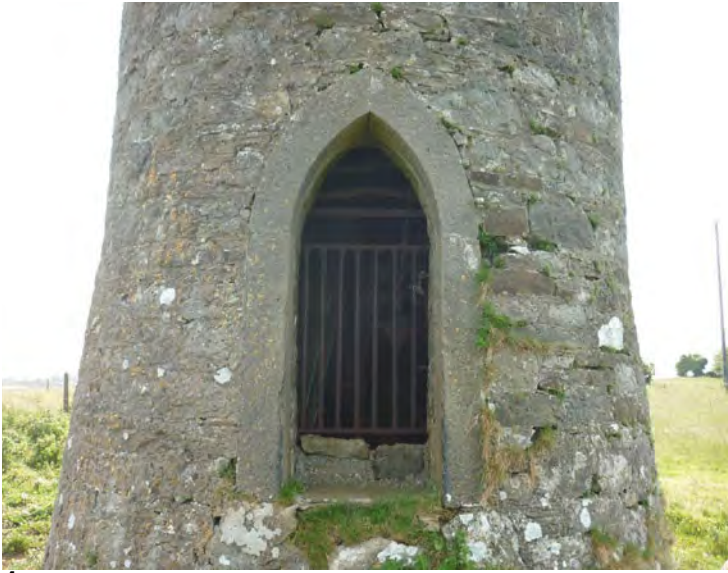
1. The makeshift unsightly metal gate to the entrance.
2. General view of the internal cast iron staircase showing damage.
3. Detail of dressed limestone enrichments forming door jamb.
4. Detail of the cast iron stair treads.
5. Detail of area of loose masonry.

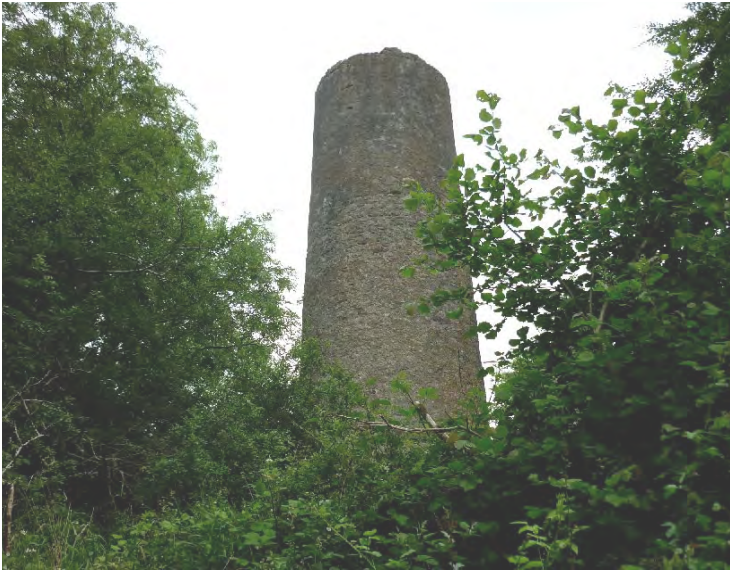
1. View of the south elevation of the tower above the treeline.
2. Detail of the ground floor of the tower filled with debris.
3. View of the upper levels inside the tower with missing stone stair treads.
4. Detail of the remaining stone stair at lower level.
5. Detail of small window to the upper level.

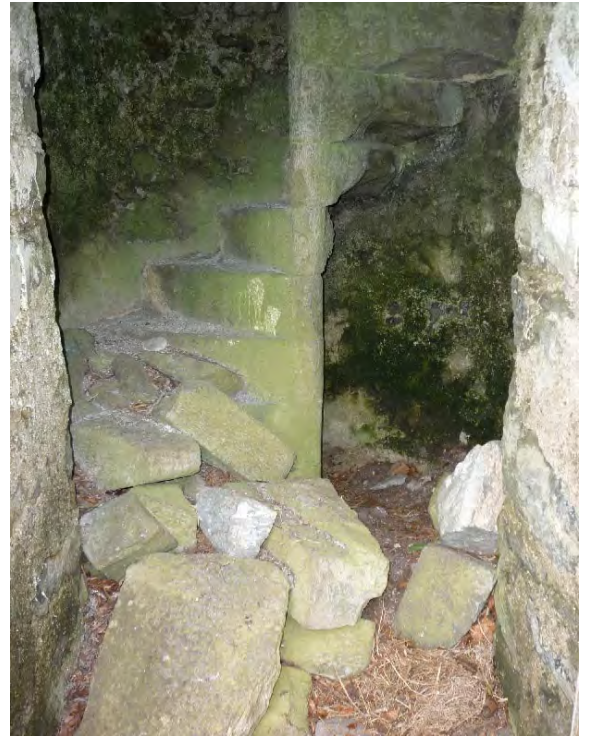
With the exception of the internal staircase and the wall heads, the structure survives in a sound condition with very little damage apparent. Sadly several treads have been sheared off and tumbled down the staircase. It appears that this was done to restrict access to the top of the structure, which may have been considered a health and safety risk.

1. Carry out a high level inspection, using a combination of the internal staircase and a ladder, of the wall heads with an experienced stonemason in attendance.
2. Take down or consolidate any loose masonry to wall heads and flaunch in sand and lime to weather.
3. Clear out all debris from the interior of the tower – set aside the stone fragments of the staircase for possible reuse.
4. Spray any plant growth on the structure with approved biocide.
5. Install a secure metal gate to the entrance door
6. Consider restoring stone staircase and guardrails to restore rooftop viewing point.

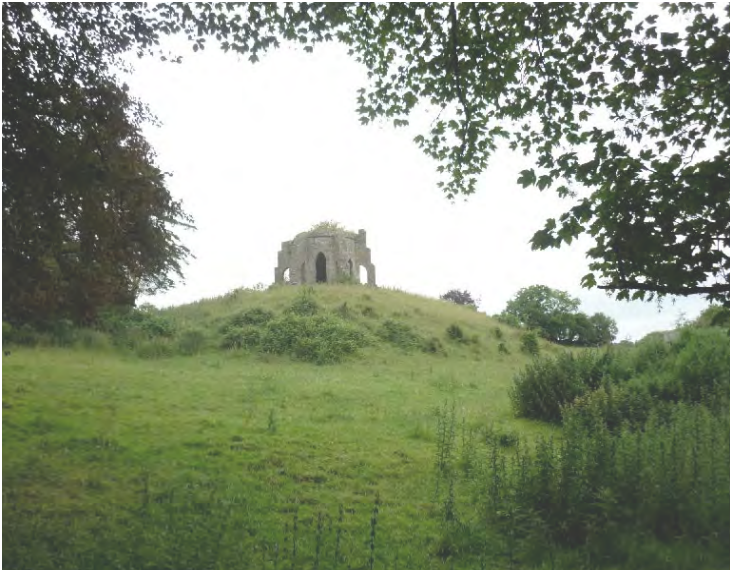
1. General view of gazebo on artificial mound from Ballycumber House.
2. Detail of one of the flying buttresses.
3. View of the entrance door which faces eastwards towards the river.
4. General view of the entrance.
5. Detail of the rubble stone walls with cut stone dressings.

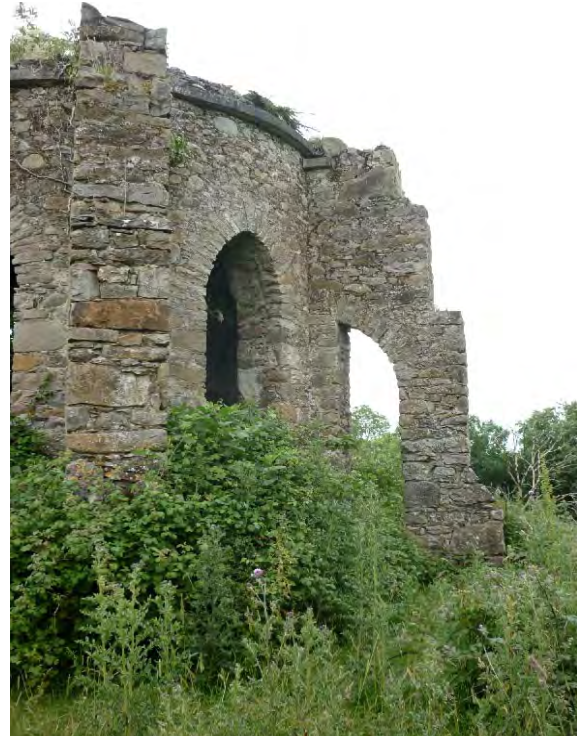
The condition could best be described as fair as the wall heads and crowns of the buttresses are loose and friable and the structure has been invaded with a great many self-seeded plants and saplings. Despite this, the arches to the openings and undersides of the buttresses are generally intact and in a reasonable state of repair. The form of the roof is not obvious from the ground but might become obvious when the rafter sockets are cleaned out and inspected at close quarters. If the plant grown from within, around and on top, is not removed promptly and the wall heads consolidated the structures will not survive for very long.

1. Remove all plant growth from within and around the structure.
2. Drill and poison all embedded roots.
3. Take down all loose masonry to wall heads and set aside for reuse – remove any embedded roots.
4. Rebuild wall head, and buttress tops and flaunch with sand and lime to weather.
5. Consolidate loose and missing areas of rubble masonry.
6. Rake out and point any open joints and allow for inserting slate wedges in voussoirs of the arches where needed.

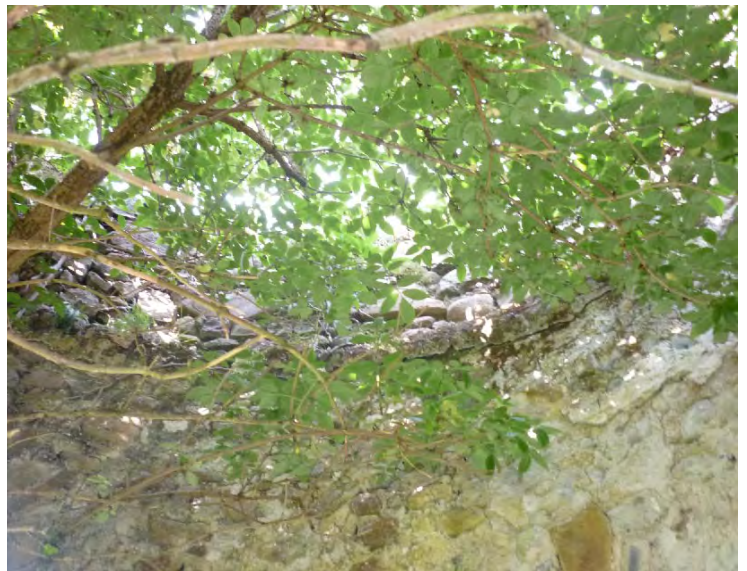
1. View of the former fireplace and window.
2. Detail of a window reveal.
3. View out through the entrance door.
4. Internal view showing mature tree growth.
5. Detail of internal plinth level.

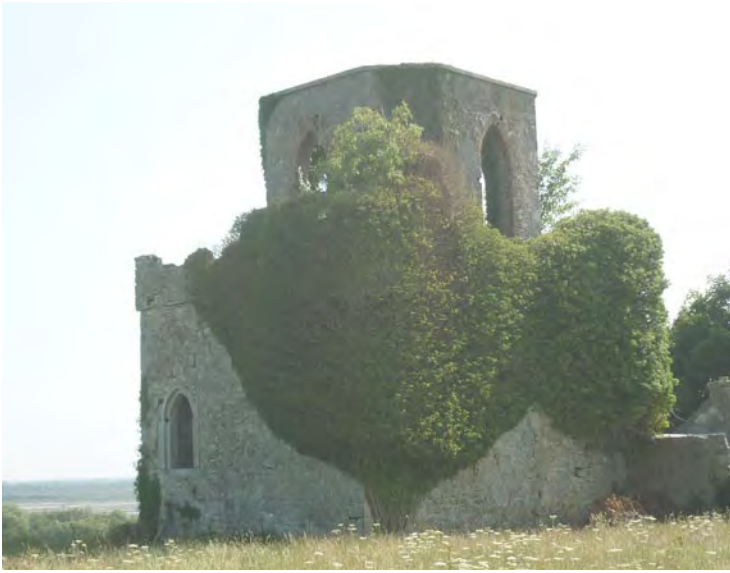
1. View from north showing gazebo on former tower house.
2. South facing elevation, from terrace showing heavy covering with ivy.
3. West facing elevation.
4. The lower opening to the building facing fields.
5. Detail of the vaulting on the tower house.

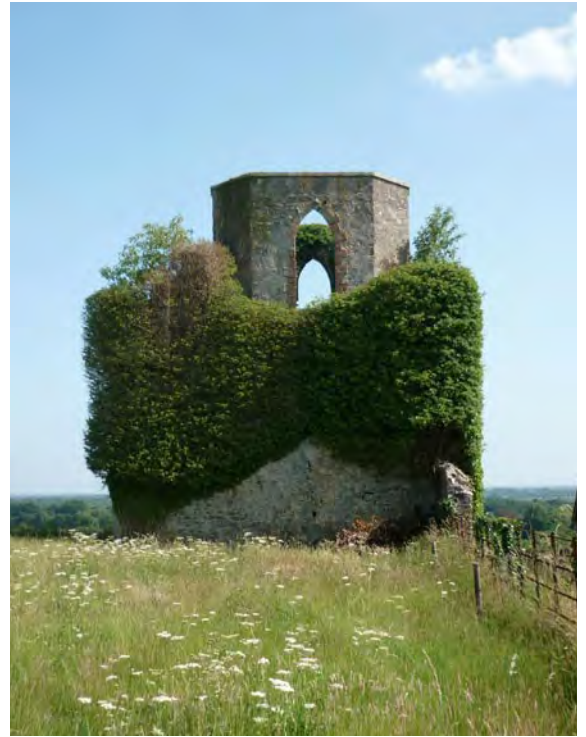
The massive walls and vaulted roof of the tower house are relatively intact, with the exception of the irregular opening on the south side, where the current stability is provided by natural arching in the rubble stonework. A dense covering of ivy has become established over most of the tower house and saplings and woody plants and shrubs have become established on the roof. All woody plants are potentially damaging to masonry structures and it is essential that these be removed without delay. Once ivy has become rooted into the masonry its effects are highly damaging if left unchecked. Even substantial defensive structures such as Toberdaly will start to crumble as the ivy roots expand, depleting the core mortar and loosening stonework. "Soft topping" – which is the use of turf, moss and ferny plants to protect a wall head, or flat roof, are only effective if easily accessibly so that saplings and woody plants can be removed when they self-seed. The masonry of the gazebo is relatively intact, but requires some consolidation and re-pointing, together with a lime and sand capping to the wall heads.

1. Remove all ivy from walls of tower house and drill and poison all embedded roots.
2. Remove all woody plants and saplings from walkway around gazebo.
3. Take down all loose masonry to wall heads and battlements and set aside for reuse – remove any embedded roots.
4. Rebuild missing and loose sections of the battlements and flaunch with sand and lime to weather.
5. Rebuild wall heads of gazebo and flaunch with sand and lime to weather.
6. Consolidate all loose and missing areas of rubble masonry.
7. Insert arch or lintol to stabilize unsupported opening on south side.
8. Repair staircase and guardings to create safe access to roof and gazebo.
9. Rake out and re-point any open joints.

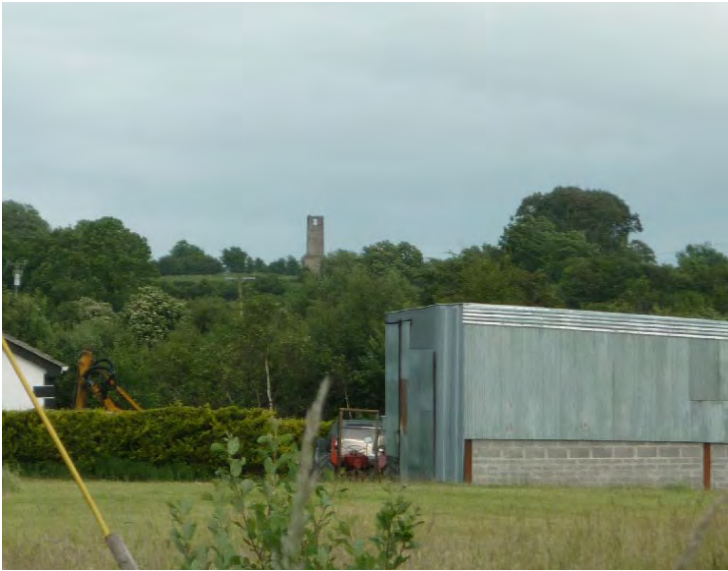
1. General view from the main road to Moate.
2. View of the north east elevation showing central opening.
3. View of the east side of the tower through central opening.
4. Above the doorway the plaque is Richard Holmes 1811.
5. Detail of six square-headed window openings.

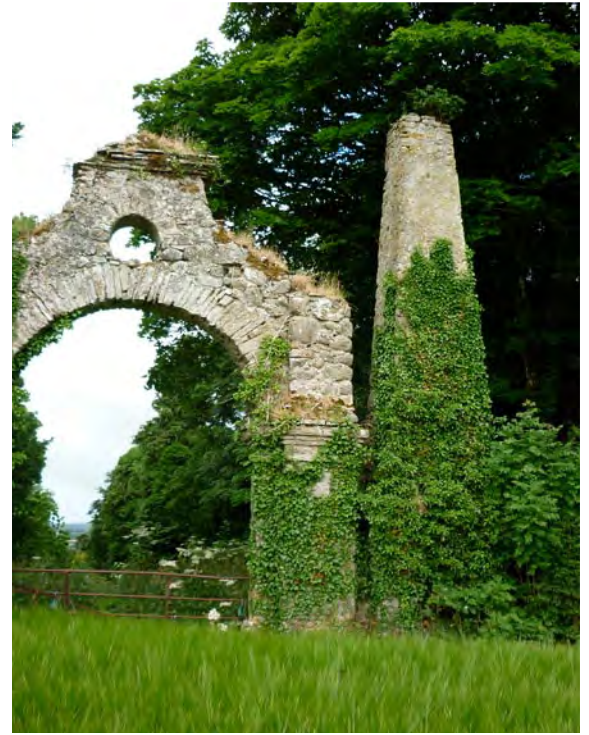
While the archway is largely intact it is currently in a very friable condition, with a thick covering of ivy from which adventitious roots have become deeply embedded in the masonry well above ground level. (This phenomenon can occur when the main growing stem is cut at ground level but the growth not removed higher up the plant causing new roots to tap horizontally into the masonry.) The pyramidons capping the obelisk shafts have eroded, as has the crown of the arch and there are numerous areas of both rubble masonry and in the dressed stone courses, where the bed mortar has eroded significantly. While the voussoirs of the stone arch appear to be at rest, some of the joints are eroded and if action is not taken promptly will become unstable and will collapse.

1. View of a Baroque crown with an elliptical opening from the east.
2. Detail showing the ivy growth.
3. View of the north west facing rubble stone obelisks.
4. Detail showing the base of the niche.
5. Detail of the base of the rubble stone plinth which has eroded significantly.

1. Spray ivy with approved herbicide and cut any primary roots. (Carry out this task only when masonry consolidation works are planned to begin.)
2. When ivy has died back carefully remove all ivy down to embedded roots.
3. Drill and poison all embedded roots.
4. Take down all loose masonry to wall heads and pyramidons and set aside for reuse – remove any embedded roots.
5. Rebuild wall head, pyramidons, top of arch and flaunch with sand and lime.
6. Consolidate loose and missing areas of rubble masonry.
7. Rake out and point any open joints and allow for inserting slate wedges in voussoirs of the arch.
8. Spray any plant growth in immediate vicinity to create sterile zone immediately around the base of the structure.

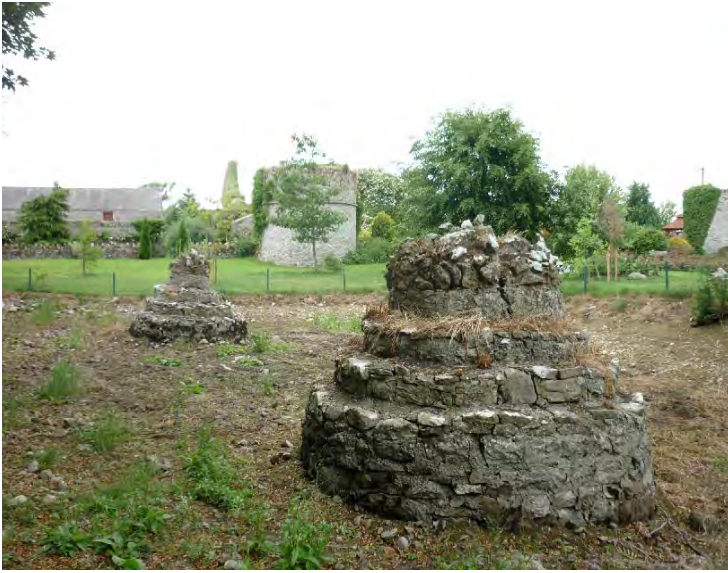
Both structures are in a very poor state of repair, with much disturbed and loose masonry. The structural deterioration has been accelerated by cement rich pointing and repairs that have been carried out previously, most of which have failed. There are some holes in the face of the pointing which reveal that much of the mortar in the core has been washed out over time. There are some vertical cracks in the upper sections of both structures that suggests the footings or bearing strata has been disturbed in some way, which is not surprising as the foundations of the structures are under water for much of the year.

1. Remove all sand and cement pointing, consolidate any loose masonry, re-point and flaunch in sand and lime to weather.
2. Fill interior of structure with sand and lime grout.
3. Spray any plant growth on the structure with approved biocide.

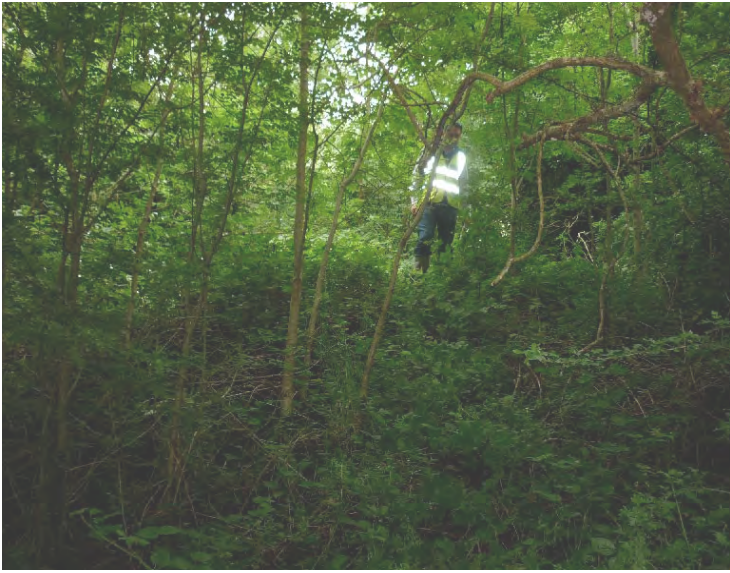
1. General view of setting it is a dense thicket of trees and is heavily overgrown with briars, nettles and saplings
2. View of one of the mature ash trees which surround the structure.
3. View from bottom of mound.
4. Detail of the fallen rubble stonework construction.
5. Apex of the mound with loose stonework.

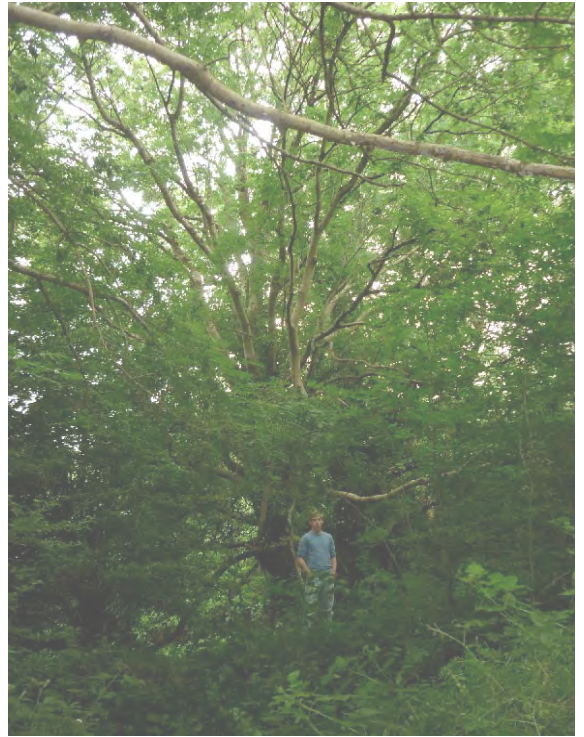
The condition is hard to judge as the original form remains unclear. Clearing all vegetation off the mound will no doubt reveal considerably more information and may reveal the original form and constructional method. There are areas of small sized rubble stone and large isolated stones lying in the undergrowth near the base of the structure, which suggests it has been vandalised at some point in its past.

1. Remove all plant growth from on top of mound and from around the base of the structure out to the ring of ash trees.
2. Sort and grade any loose masonry that comes to light during the clearing and set aside for possible reuse.
3. Spray the structure with an approved biocide.

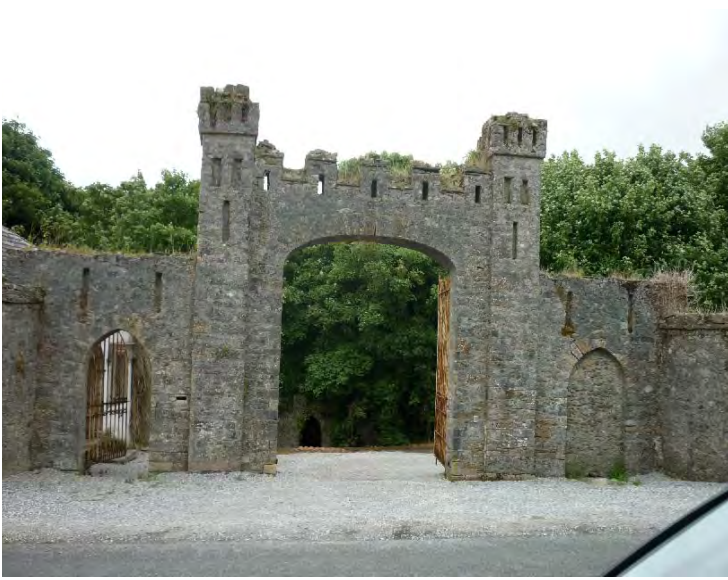
The structure is generally in a reasonable state of repair with only minor repair and re-pointing necessary, together with the removal of some minor plant growth. In the voussoirs of the wide central arch and the blind arch to one side, the joints are opening and should be repaired to avoid more serious damage occurring. The gates are rusty and need of preparing and painting.

1. View of the front elevation of the gateway.
2. Detail view through main entrance archway with iron gate visible.
3. View of the side archway.
4. Detail of battlements.
5. View of the gateway and flanking walls.

1. Consolidate any loose masonry, re-point and flush in sand and lime to weather.
2. Wedge open joints of voussoirs of central arch and arch to blind doorway with slate and re-point.
3. De-rust and paint gates.
4. Spray any plant growth on the structure with approved biocide.
