OFFALY COUNTY COUNCIL
DECLARATION UNDER SECTION 57 OF THE
PLANNING & DEVELOPMENT ACTS 2000, as amended.

Number: **DEC/25/006**

Applicant Name	John Aherne	Status	Owner
Name of Building	The Forge	Former Name	Smithy
Townland	CURRAGH (GEASHILL BY	OS Map Type	
Address 2	Geashill	Map Sheet	
Address 3		National Grid co-ordi	
Date of Request	06-Mar-25 29-May-25	Date of Inspection	Thursday 27 March 2025
Previous Declaration	N/A	Date of Declaration	Thursday 27 March 2025
Protection Status	<input checked="" type="checkbox"/>	Record of Monuments and Places	N/A
Record of Protected Structures	35-13	Archaeological Potential	N/A
Architectural Conservation Area	N/A	Preservation Order or Temp PO	N/A

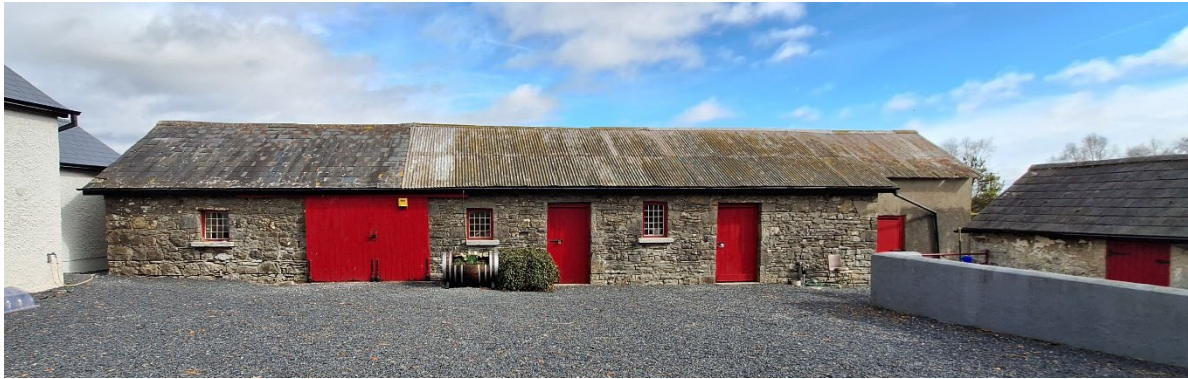
Northern range, front showing slate roof (lhs) and mixed roof coverings (rhs) with gutters and downpipe

2. Slate roof repairs: Minor repairs shall only be carried out to the roof in accordance with details submitted with the planning application unless the written consent of the planning authority has first been obtained. Slates shall be carefully removed and stored during building works. Existing slates shall be used to the front of the building with Blue Bangor or similar closely matching slate used to the rear. Ridge tiles shall be retained and similar replacement terracotta ridge tiles sourced where required. Existing cast iron gutters (where in use) and downpipes are to be repaired and retained. If new sections are required they shall match the existing. Refer to the Department Advice Series: Roofs <https://www.buildingsofireland.ie/resources/>

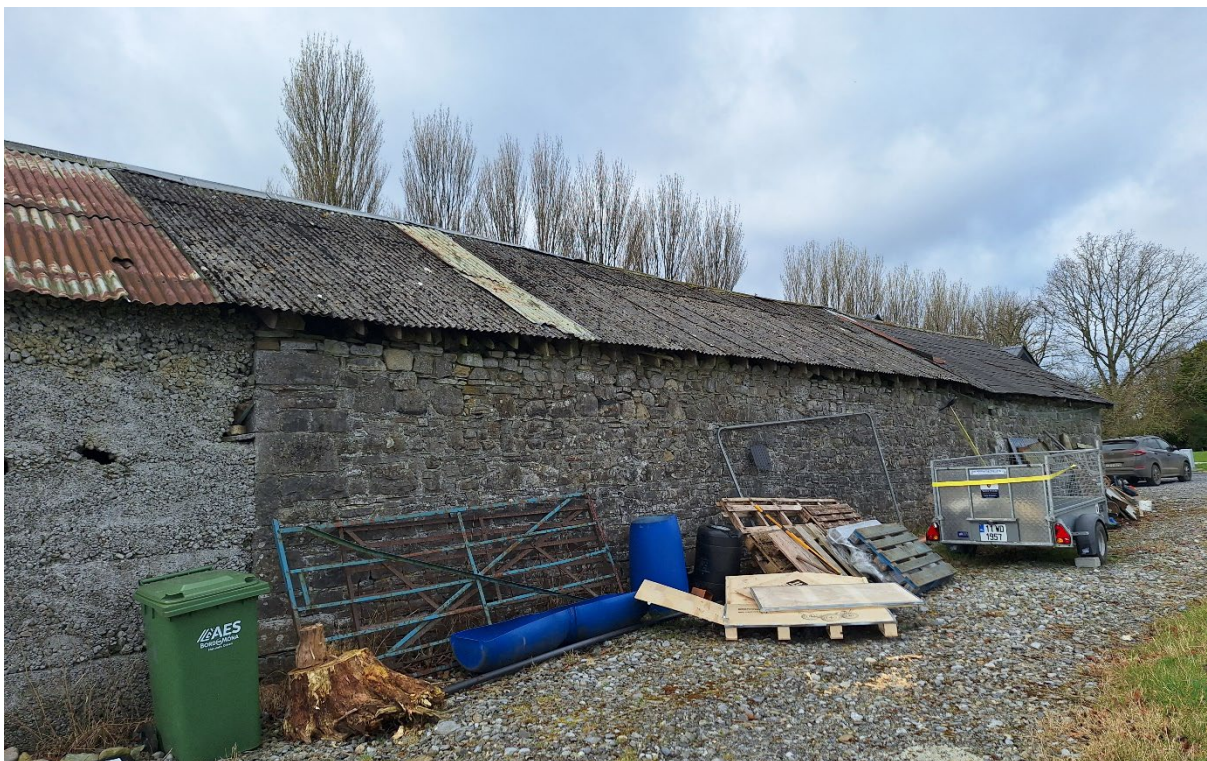
Northern range rear – mixed roof coverings (lhs) and slate roof (rhs), no gutters and exposed roof timbers. Ensure roof coverings are assessed for asbestos and appropriate measures are taken, by competent contractors. See exposed roof timbers below (rear and front detail)

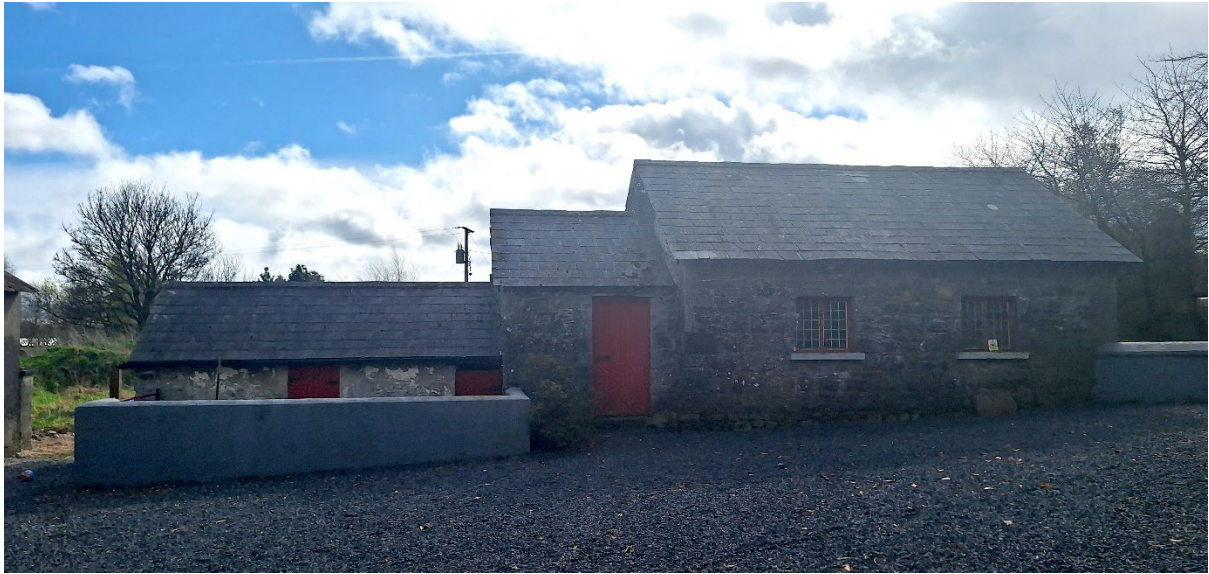
Stepped East range front elevation. Removed chimney to be rebuilt at LHS of highest range – the forge.

1. Stone repair/reinstatement of rendered chimney based on historic photo: Existing or locally sourced stone shall be used unless the written consent of the planning authority is first obtained. Pointing is to be carried out with a compatible lime based mortar to match existing. Ensure that joining is subservient to stonework and that new work blends in with existing stone walls, joints to be flush pointed and tamped back before fully set. Refer to Department Conservation Guidelines Booklet No. 4: Mortars, Pointing & Renders and Advice Series: Ruins.

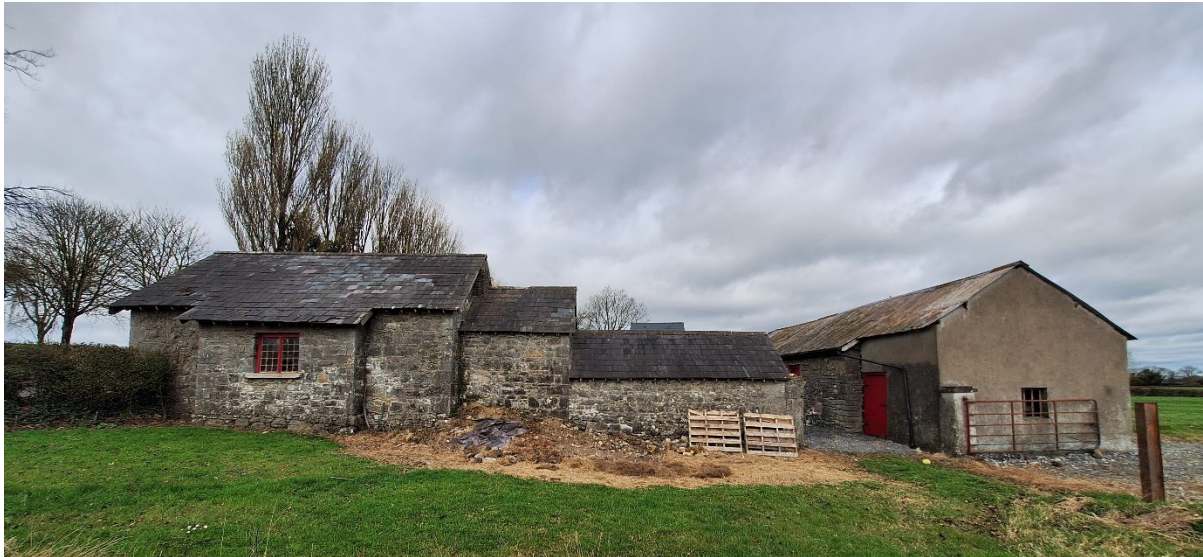
Stepped East range rear view, note storm damage and slate repair required

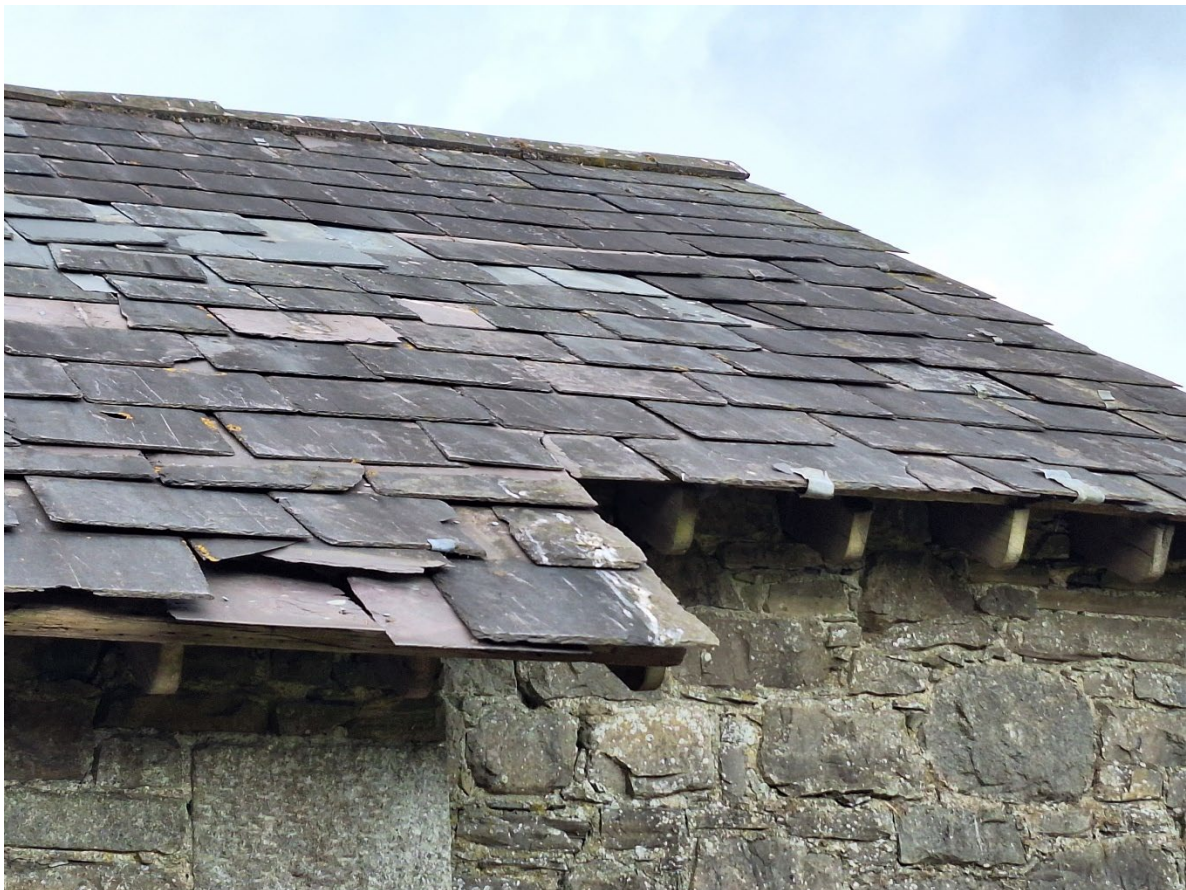
Slipped slates

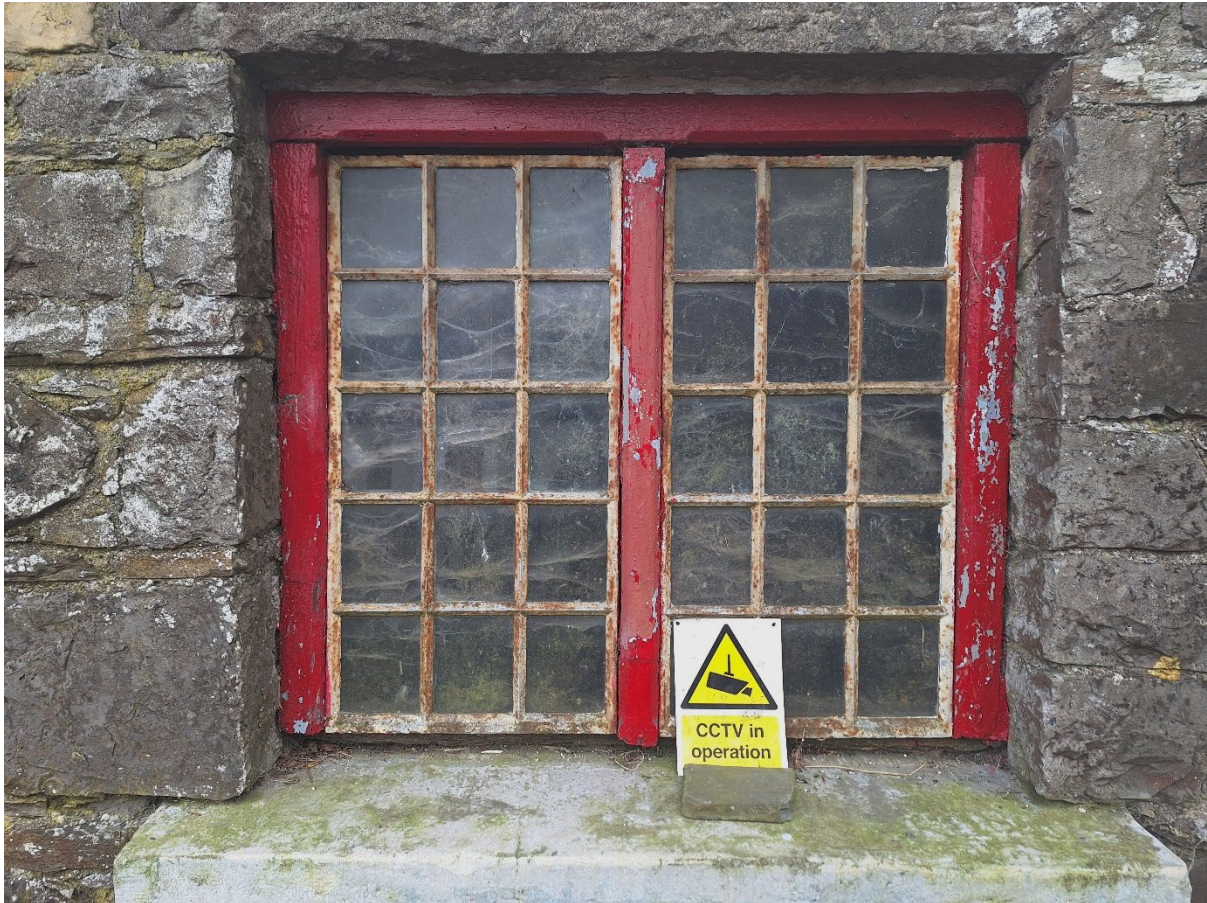
Forge windows: timber frame in need of repair – base

3. All metal windows and glazing shall be retained, cleaned down and repaired. Timber frames shall be repaired. Any replacement timber sections shall pay particular regard to existing frames, noting characteristic mouldings. All repairable items, shutters etc shall be carefully removed and restored. All timber shall be independently certified by the Forest Stewardship Council or an equivalent scheme. The development shall be in accordance with Department Advice Series 'Windows A Guide to the repair of Historic Windows' and all works shall be carried out in accordance with Department Conservation Guidelines.
Note a mix of roof coverings to both ranges of outbuildings. Ensure roof coverings are assessed for asbestos and appropriate surveys and measures are taken, by competent contractors.

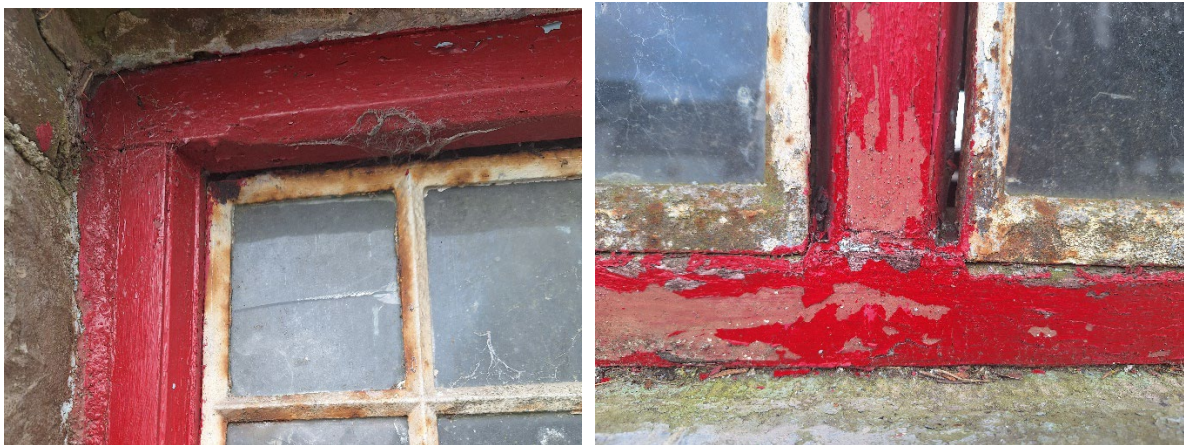
Forge windows: note chamfered detail to original timbers
