Daingean Courthouse

Daingean, Co. Offaly

Conservation Masterplan

December 2024

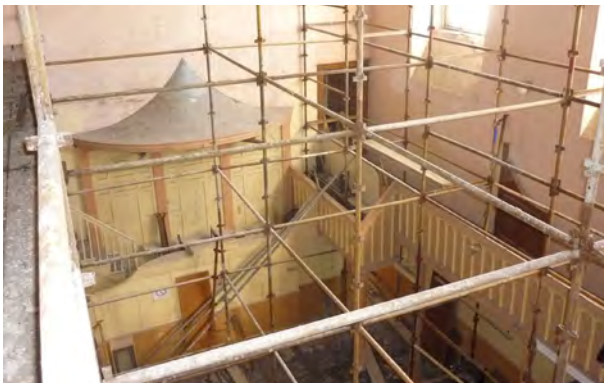
Figure 18 - View of courtroom repairs.

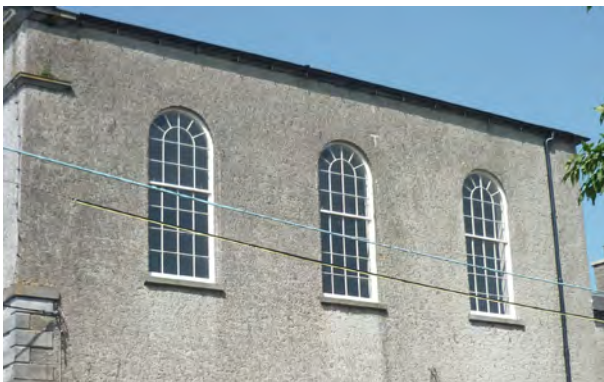
Figure 17 - View of window repairs.

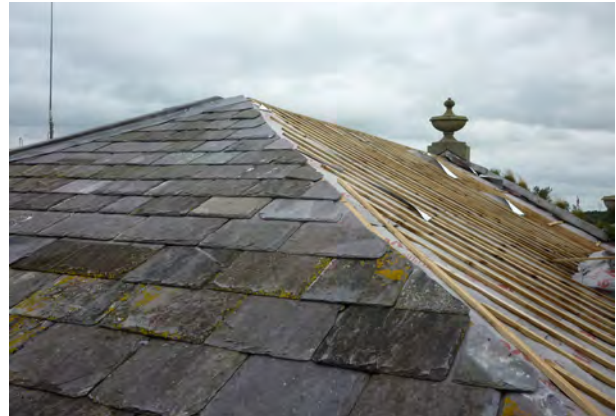
Figure 16 - View of slate roof repairs.

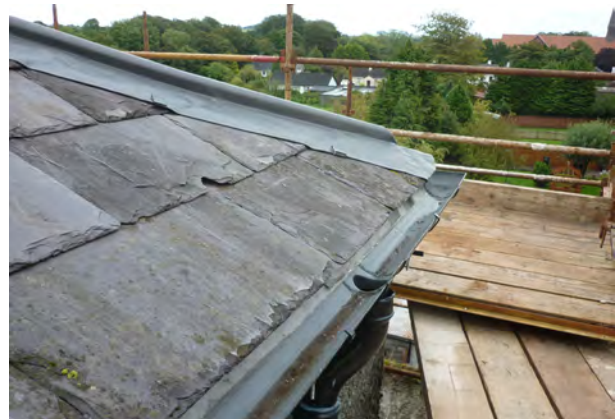
Figure 19 - View of rainwater goods repair.

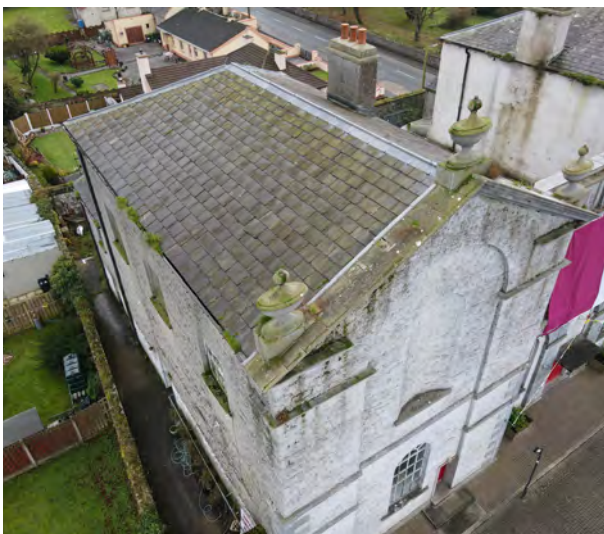
The north range roof is pitched with the ridge line running from east to west with a hipped end section on the east and a masonry parapet wall upstand on the west. As noted above, extensive repair works were carried out to this roof previously including a natural slate covering, lead ridge / hip rolls and structural roof timber repairs. Other than a slipped slate on the northern pitch, which needs to be refixed, the roof appears to be in good condition.

Figure 22 - View of the north range roof.

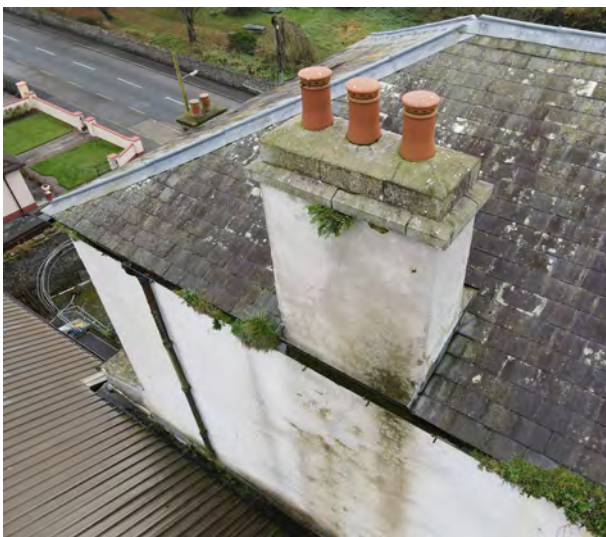
There are four chimney stacks, one on the southern side of the north range roof, one on the gable end of the pitched roof adjacent to the north range roof, one on the northern side of the south range roof, and one on the gable end of the pitched roof adjacent to the south range roof. Extensive repair works were carried out previously to all these chimney stacks including masonry works to chimney tops, new lime mortar flashing to chimney tops, new clay chimney pots and the addition of vented chimney pot cowls. Other than some vegetation growth, which needs to be treated and removed, they all appear to be in good condition.

Figure 26 - View of a chimney stack with granite capping.

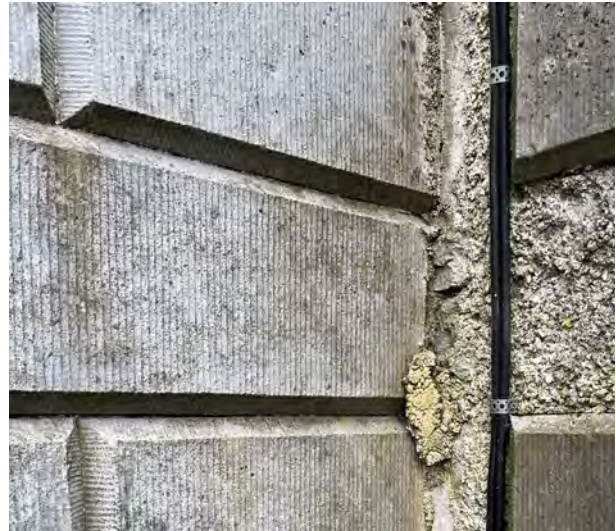
The stonework is of good quality despite the fact thick, unsightly cement-based pebbledash

Figure 25 - View of the rusticated limestone ashlar masonry at ground floor level.

render has been generously applied thickly to all elevations as a protective coat. Unfortunately, this can disfigure and hasten the decay of historic masonry, as the underlying stone or brick is softer than the render. A common problem with hard cement coatings is that over time sections of render may detach from the skin of the building which will often result in some of the soft brick underneath being carried with it. Unsightly patches of damaged brickwork result, which can clearly be seen in some parts of the building. Portland cement became particularly popular after the Second World War, quickly replacing the softer lime renders that were used originally. During the 1960s-1990s, the common practice was to re-point and render old masonry buildings with strong, cement-rich mortars and coverings. This is unsightly, unnecessary and can have a very damaging effect on the structures to which they are applied. Problems are caused by trapped moisture in the wall that enters through the many minor cracks that will always occur when hard materials are used in old masonry structures.

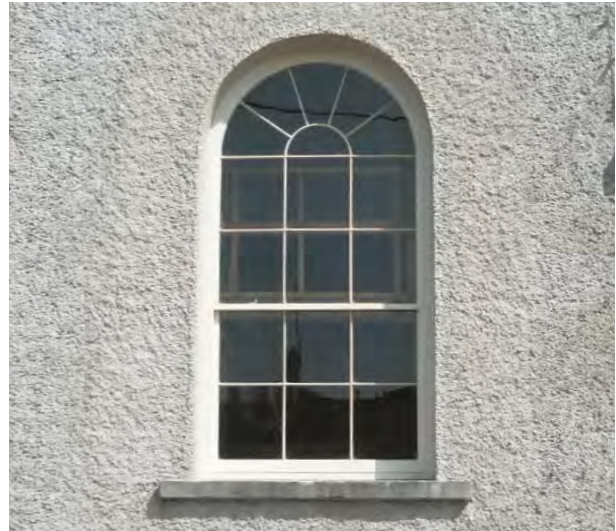
On the southern elevation of the courtroom there are three timber sliding sash windows, which were repaired / replaced as part of the previously completed works.

Figure 27 - Present day view of a courtroom window.

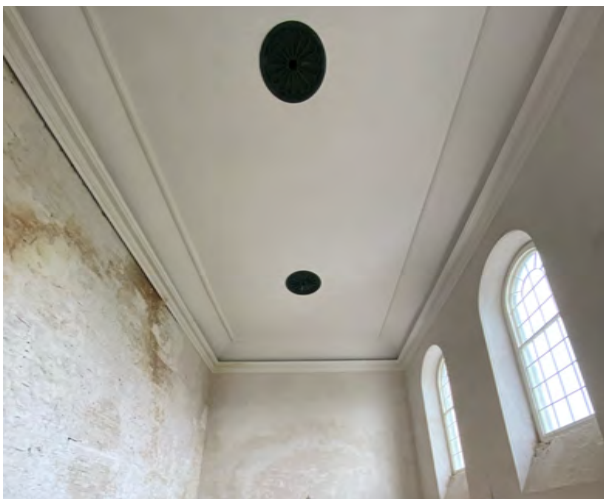
Above both courtrooms are original late Georgian plaster ceilings. These are not highly ornamented consisting of a heavy moulded plaster cornice with a coffered edge and a reeded moulding defining the ceiling bed. There are two circular openings at either end of the ceiling each with a delicate timber grille. The ceiling above the courtroom was subject to significant repairs during the previously completed works as it had been subject to significant water ingress.

Figure 30 - View of a courtroom ceiling.

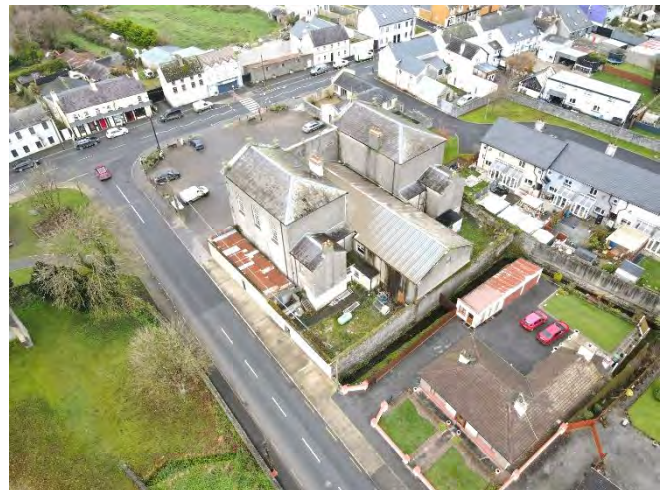
*Aerial view from drone survey, north to top right of page
Note metal sheet roofs to central auditorium and southern
single storey extension.*

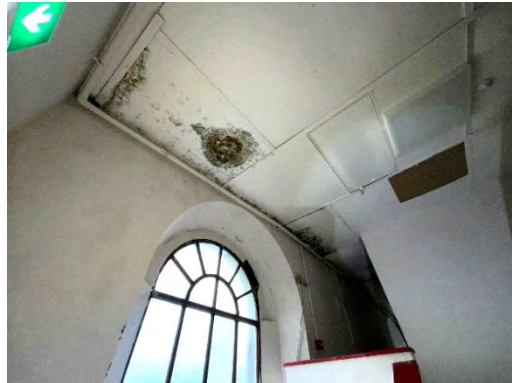
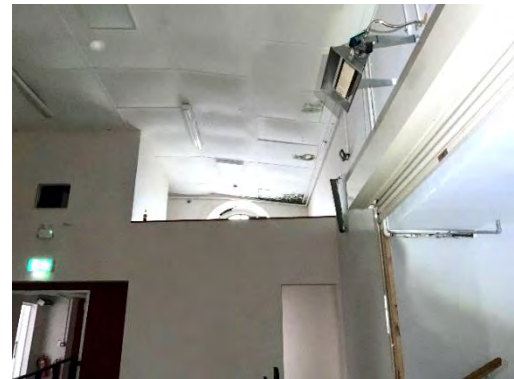
*Entrance area first floor and back of Auditorium space
Note staining to the ceiling behind the front elevation.*

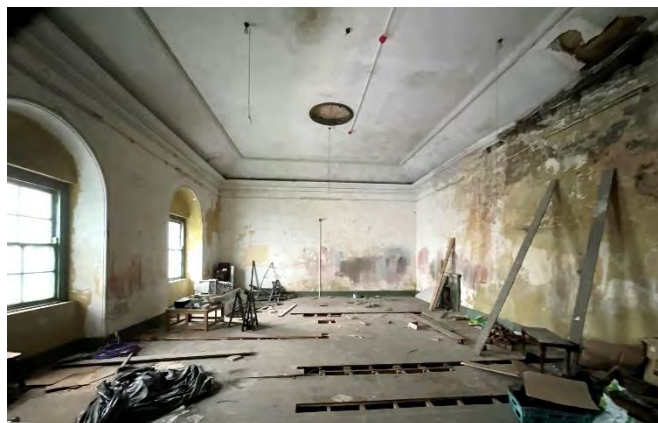
First floor north wing – this is a later working of this north wing with early to mid twentieth century steel floor joists spanning left to right and timber joisted floor.

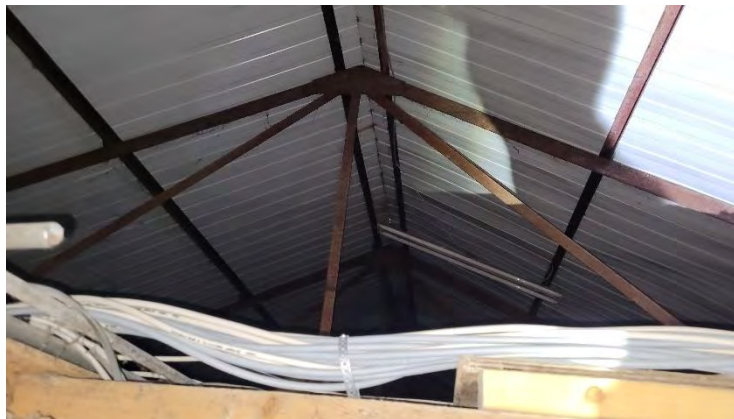
The Auditorium roof is formed of lightweight steel roof trusses from the twentieth century. These trusses appear in-substantial, poorly welded and are now showing surface rust throughout. The robustness of these trusses and the overall bracing of the roof is not of a standard suitable for a public building.

Lightweight auditorium trusses, with more recent metal sheet roofing.

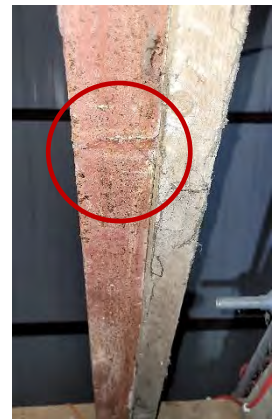
Bottom tension cord of truss has full weld across section.

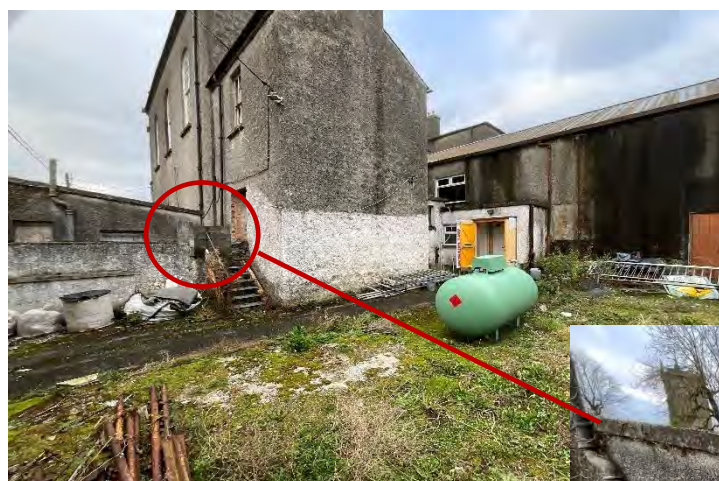
The single-story fire station, more recently the cycle club is formed of blockwork with a lightweight metal clad roof. The general condition of this building is poor and in need of a major overhaul and the roof finishes are at end of life. The location and form of construction has formed a difficult to maintain gap against the south elevation of the historic structure.

View onto end elevation and roof of former fire station. Note gap to historic structure and insubstantial 100mm block parapet to escape stair.

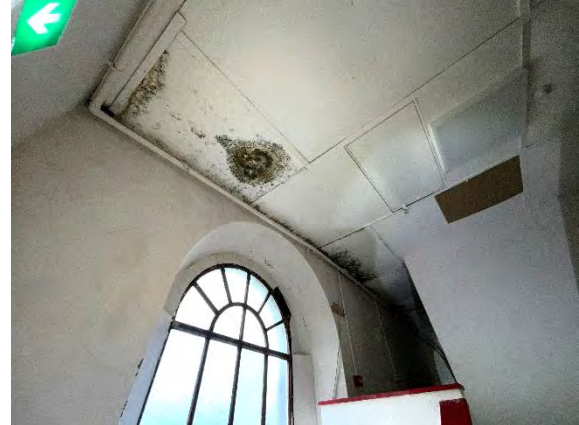
The area behind the centre of the façade is also suffering water ingress again associated with the front elevation parapet detail. The proposals include for re-roofing this section, and this should include proper weathering of the parapet copings and rear of the front wall.

*Front central window
Notice staining to ceiling.*

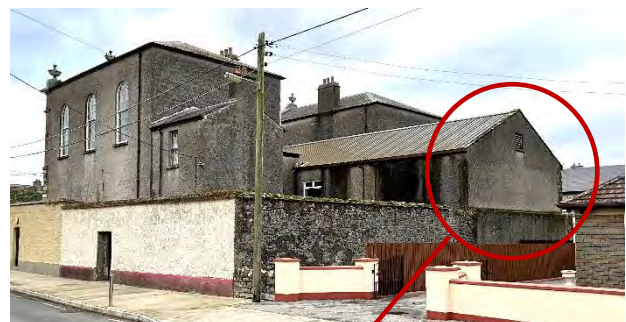
The new rear wall will likely involve the dismantling of the rear boundary wall to ensure a good footing is achieved to this wall beside the tributary stream to the east of the site.

This wall replacement may require the dismantling of boundary wall down to ground level.

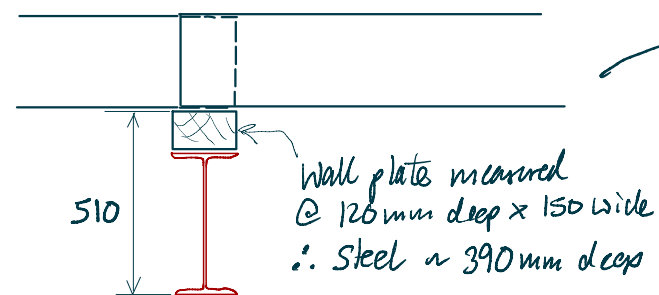
Steel beams appear joist shaped
rather than parallel flanged
therefore >1910 but <1980
