# Independent Tree Surveys Ltd

## Tree Survey Report Cloghan Active Travel Scheme Hill Street Cloghan Co. Offaly

November 2023

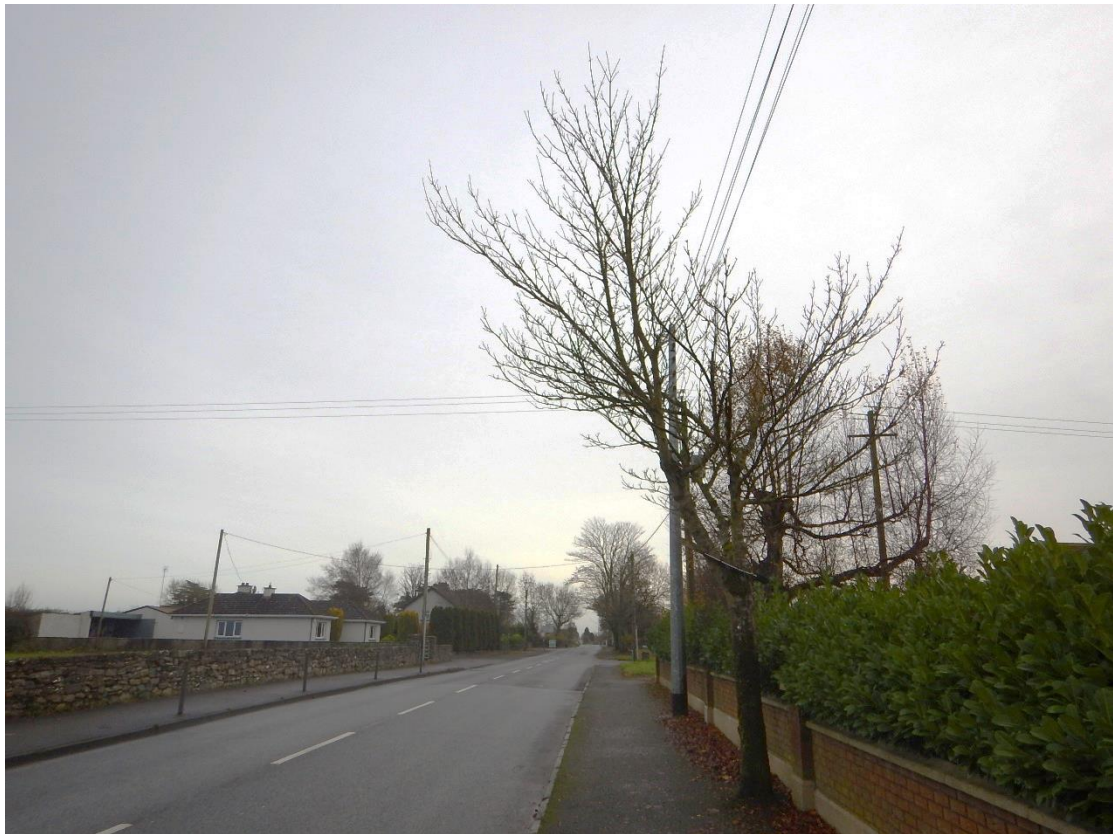
1. Young Maple tree T752 at the western end of the survey area

Type	No.	Species	Age	Ht m	Dbh mm	St	Cr	N	S	E	W	ERC	Phys Cond	Structural Condition/Comments	Preliminary Recommendations	RPA m	Cat
T	752	Acer platanoides (Norway Maple)	SM	8	270	1	2.5	3	3.5	2	3	10	Fair	Fair. Small tree that was planted into tarmac footpath, very close to the masonry wall and directly below overhead ESB wires. Tree is of poor shape & form, having been crudely cut back during ESB line clearance works, which will have to be repeated as it grows back. Low amenity value and limited potential to grow into maturity.	Prune tree clear of ESB wires. Consider removal as part of good long-term management.	3.24	C2
T	753	Fraxinus excelsior (Ash)	EM	10.5	400	1	2.5	5	5	6	5	10	Poor	Fair. Medium sized tree growing very close to low retaining stone wall, seemingly causing significant damage to the masonry. Poor shape & form as a result of being 'topped' and disfigured by ESB line clearance works. Branches restricting street light. Epicormic shoots on branching throughout crown indicative of infection by Ash dieback disease (ADB). Tree growth is causing significant damage and distortion of footpath surfacing.	Monitor tree condition to track progress of ADB disease; fell tree if condition deteriorates significantly. Prune branching clear of ESB wires. Consider removal as part of good medium-term management.	4.8	C2

The proposed footpath improvement scheme will require that the existing footpath be levelled and widened to create a better and accessible surface. Realistically the works to complete the project will require the removal of the four trees tagged 752, 753, 754 and 755. Trees T752, 753 and 755 are of relatively poor quality and value and so their removal could be readily mitigated by new replacement planting in the adjacent public park.

The 4 trees tagged T752, 753, T754 and T755 will be section-felled and the stumps will be removed.

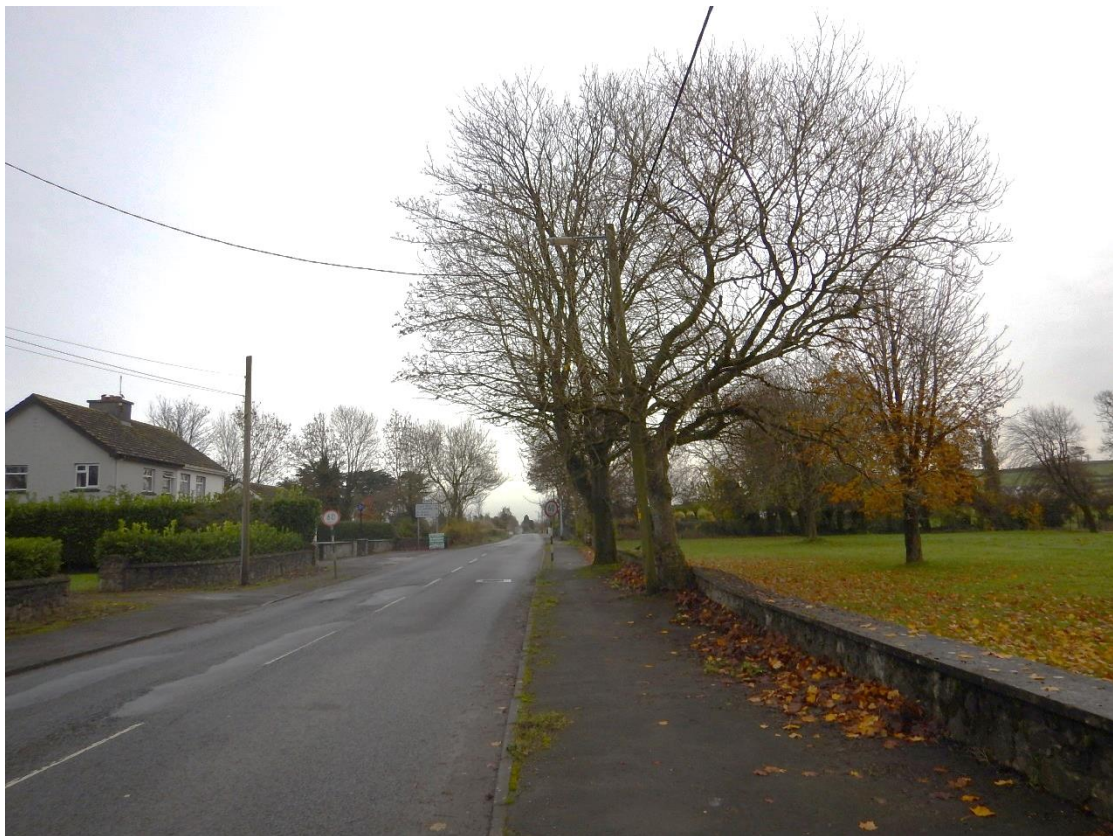
2. Ash tree T753 in the foreground, with larger Maple T754 a bit further east

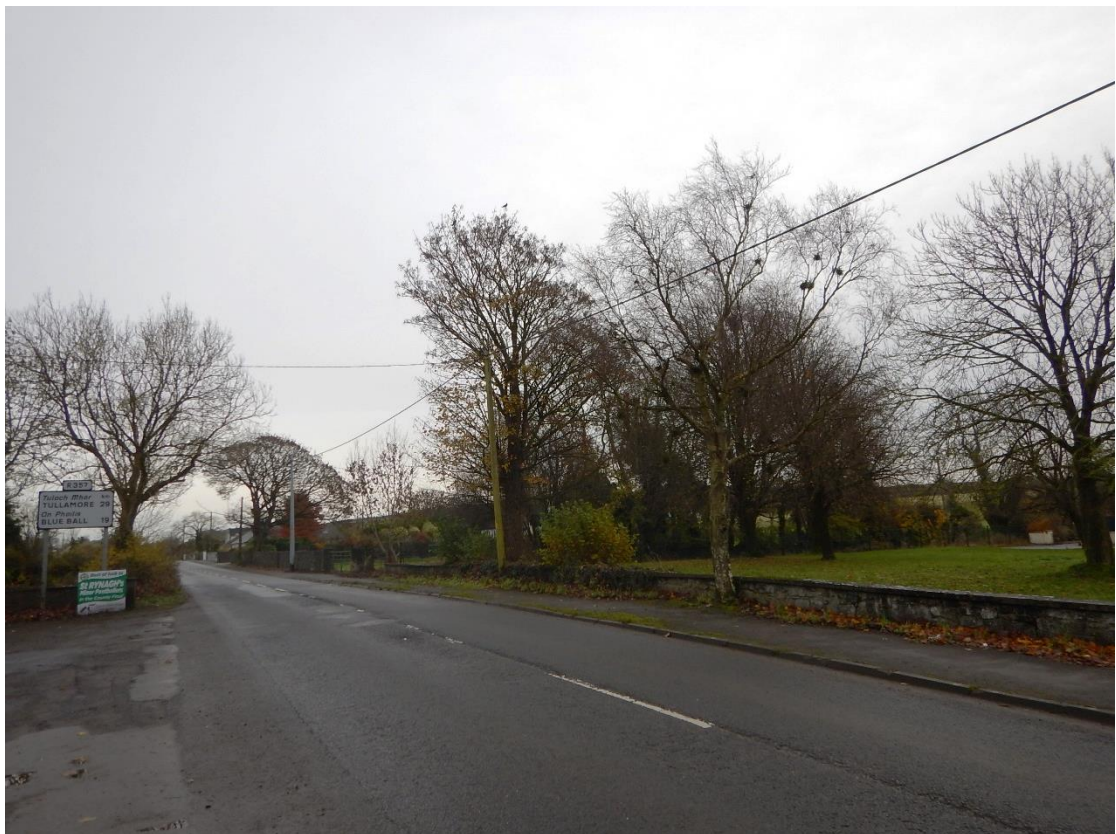
4. Trees T755-757 along the eastern part of the survey area, viewed from the northwest

The pruning works described in the survey schedule will be carried out on trees T756 and T757.

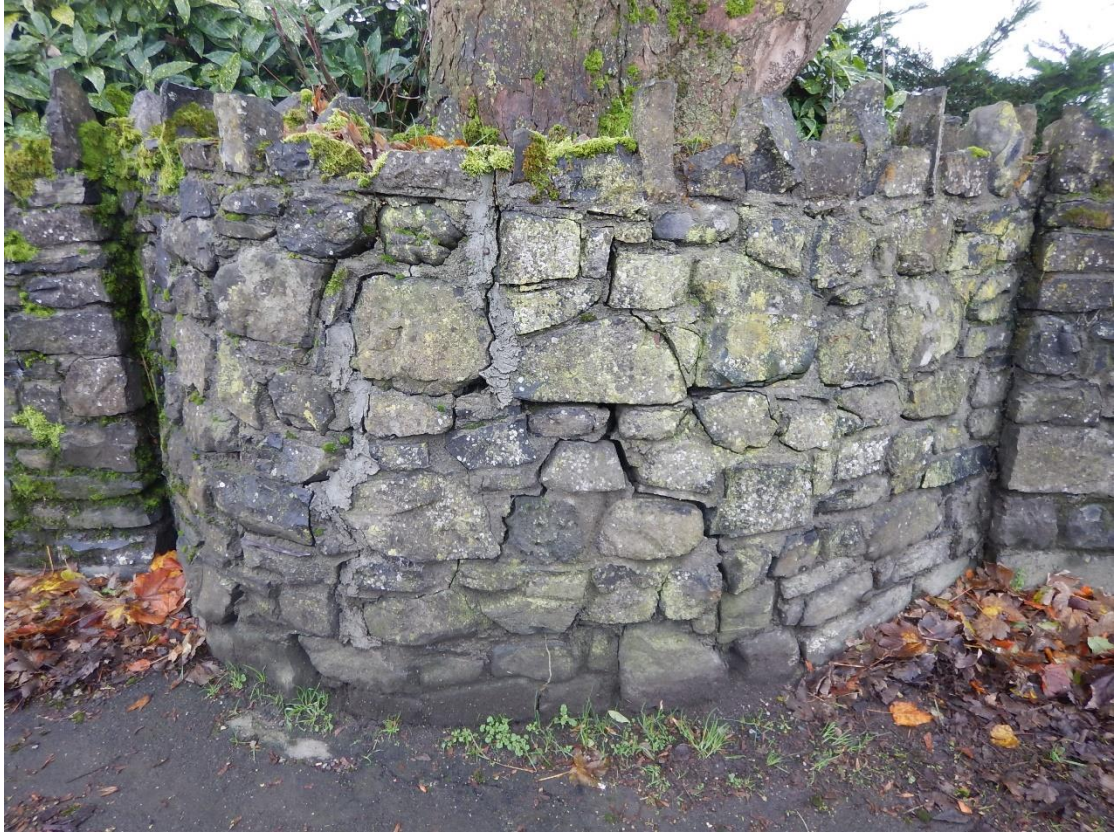
Trees T752, T753 and T755 are smaller trees of relatively low value/quality due to a combination of poor form, ill-health, and poor planting position. The larger Maple tree tagged T754 is in fairly good physiological and structural condition but is causing severe distortion to the footpath as well as significantly reducing the usable width of the path. The two Sycamore trees T756 and T757 also seem to be in reasonably good condition however, the stone wall next to tree T757 has been built too close to the tree stem and has evidently been pushed out and cracked by the continued growth of the tree. The curved section of stone wall seems to have been built to try and accommodate the tree stem; however, it looks like insufficient space was left between the inside face of the wall and tree, and the growth of the tree stem has resulted in cracking in the brittle sand and cement mortar joints of the wall.

*5. Short section of stone wall built around the stem base of Sycamore tree T757, note the significant cracking of the masonry*

Removal and replacement of the section of curved stone wall next to tree T757 has potential to impact the tree unless the works are well planned and executed with care. Some tree protection recommendations are included below.

If the curved stone wall next to Sycamore tree 757 is to be removed and replaced, this should be undertaken with great care so as to avoid unnecessary damage to the above-ground parts of the tree (stem and branches) and the root system. The wall should be dismantled carefully by hand, with the masonry being pulled back away from the tree stem. Any new excavation for new foundations should be minimised, with a series of small footings and supporting lintels being used rather than strip foundations. An alternative to a replacement wall would be to have a section of ironwork fence fabricated to fit across the gap created by the removal of the curved wall. Such fencing/railing could be fixed into place with small footings positioned away from significant woody roots (which could be identified by hand digging or the use of a compressed air lance or Vacuum truck), again avoiding the need for strip foundations.
