Birr Courthouse

HSF Grant Scheme 2021: Final Report

October 2021

This report was produced for Offaly County Council by Howley Hayes Cooney Architecture in October 2021 to determine the extent of repairs carried out at the Birr Courthouse for the Historic Structures Fund 2021. The overall project at this building is also part funded by the Heritage Council.

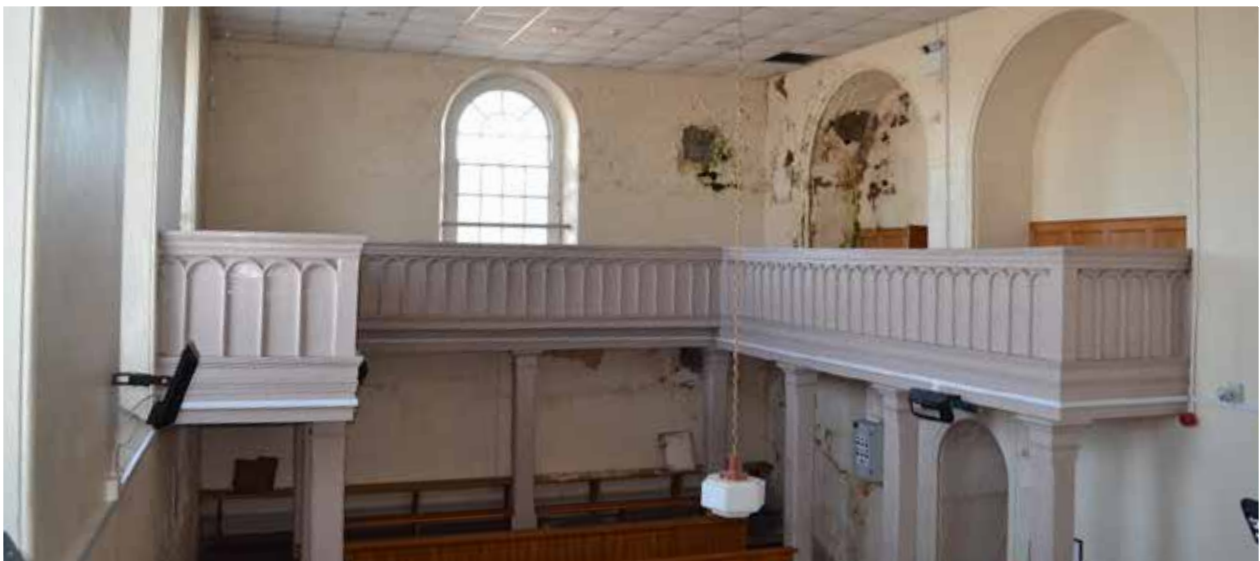
Interior of former courtroom, significant decay visible in corner of timber gallery.

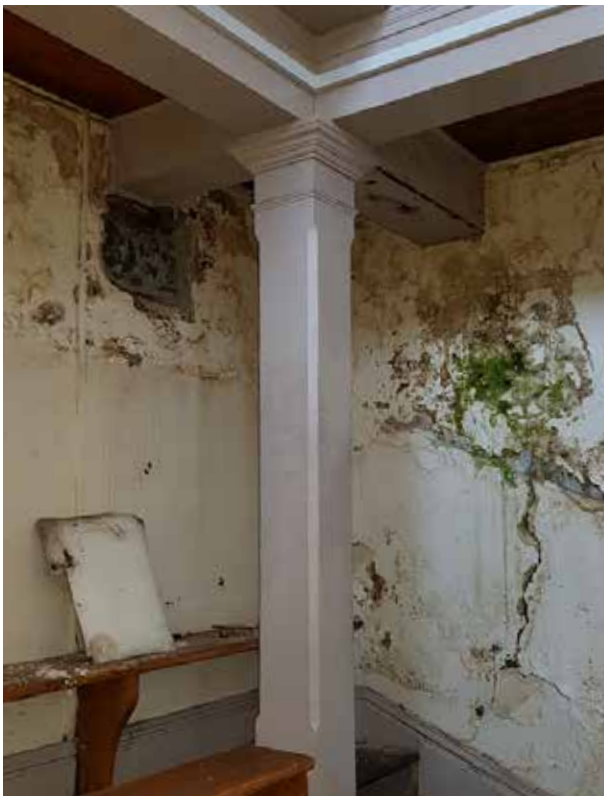
Decay continues below to ground floor level and in direct contact with timber beams. Previous plaster opening up works visible beneath beam of gallery.

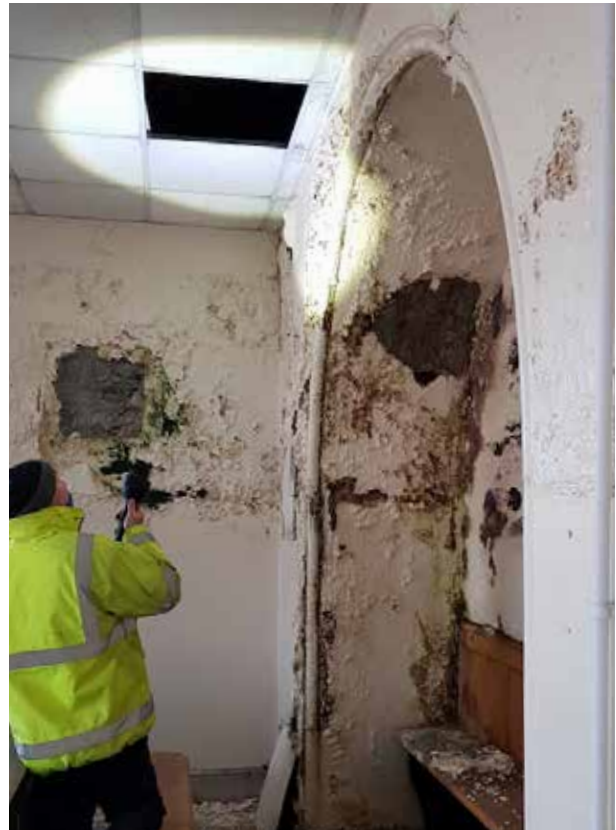
*Area of significant decay on corner of courtroom gallery
Water ingress and rot in direct contact with joinery*

ing the courtroom. Within the courtroom itself, this section of wall shows significant bubbling, missing sections of plaster, and bacterial growth in direct contact with the courtroom joinery. This has led to areas of timber decay. At ground floor level large cracks and mould can be seen in the plaster. On the other side of this wall at ground floor level flaking and bacterial growth can be seen in the ceiling above a fuse box, on the surrounding walls, and around an adjacent window reveal.

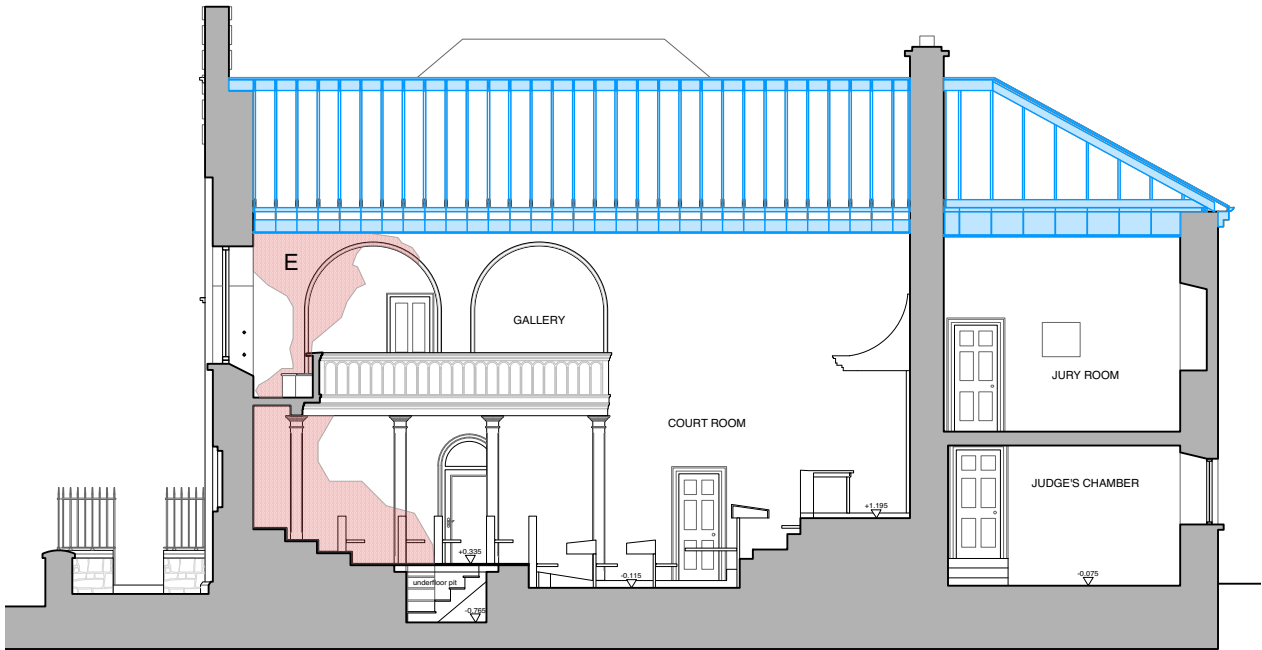
*Roof of courtroom replaced in late approx.1970s, shown in blue
Area in red denotes extent of decay, plaster cracking, and mould due to failing valley gutter*

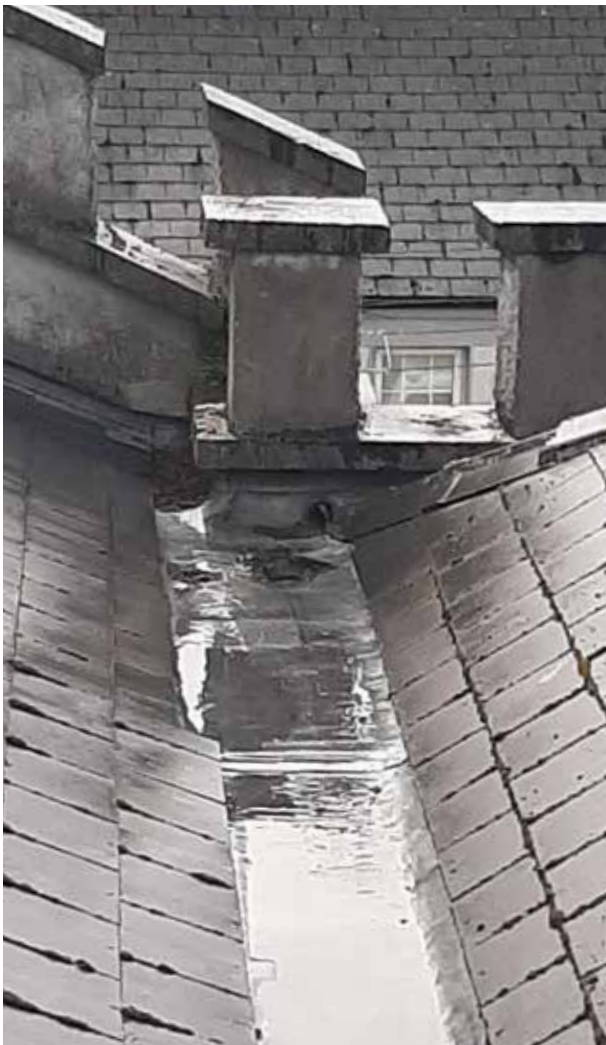
Water ponding on the existing leadwork valleys

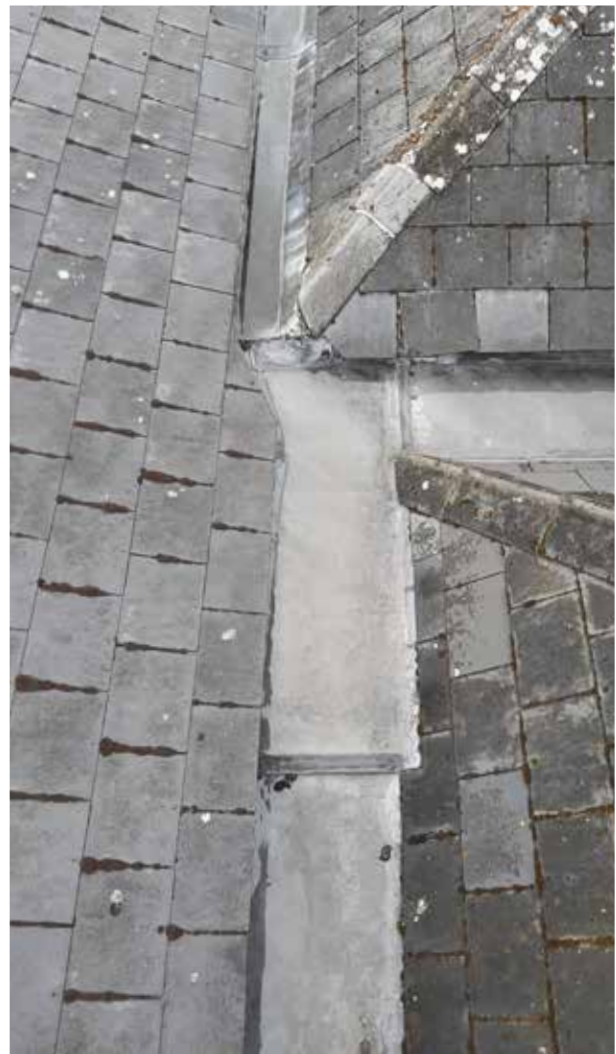
A roof inspection was carried out from a MEWP in June 2021 and the roof was inspected by Howley Hayes Architecture and the roofing company Bar-bary / Skyline. The leadwork to the roof is relatively recent but has been installed poorly.

Poorly detailed leadwork - excessive water ingress noted at this location

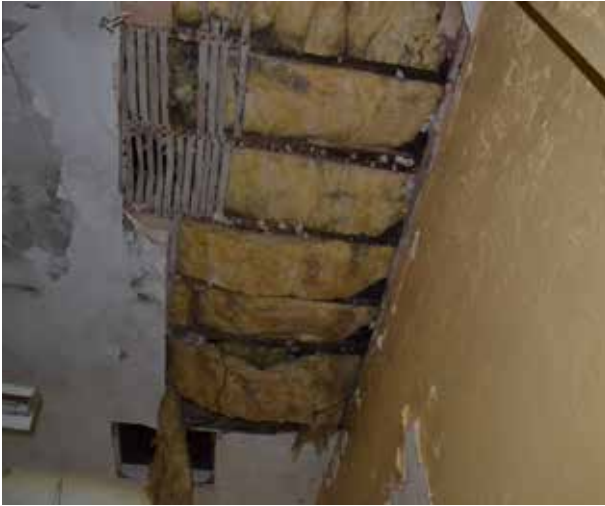
To the rear of the building, along the same central wall, a considerable section of the lath and plaster ceiling has collapsed at first floor level. Water damage and mould can be seen on the walls and skirting boards in a toilet on the level below.

Area B: Collapsed lath and plaster ceiling

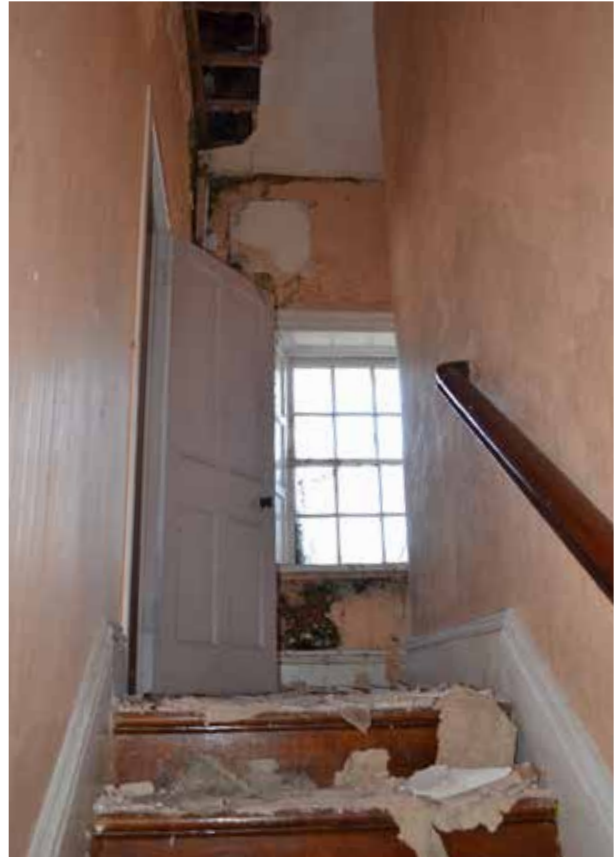
In the stairwell serving the court gallery, a portion of the plasterboard ceiling has collapsed. Flaking and bacterial growth can be seen on the wall adjoin-

Collapsed ceiling in stairwell, decay around window.

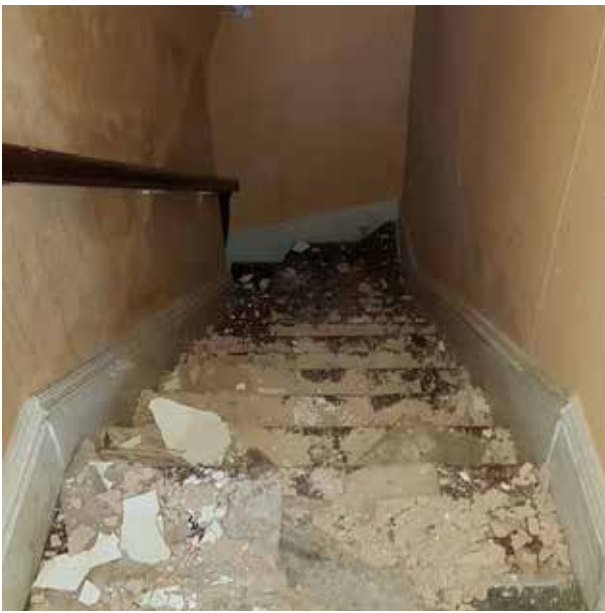
Area D: Collapsed ceiling in stairwell

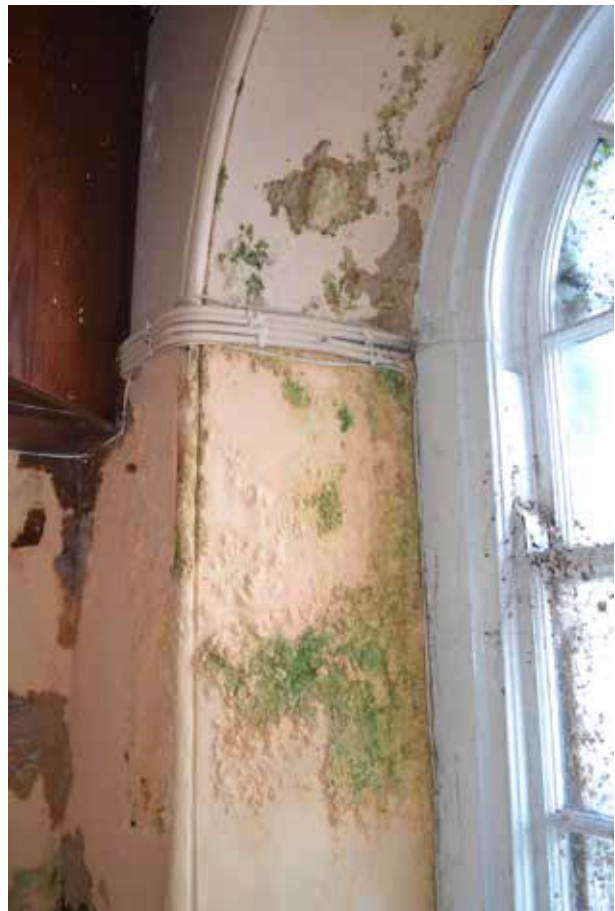
Area A: Mould and bubbling plaster in window reveal on ground floor.

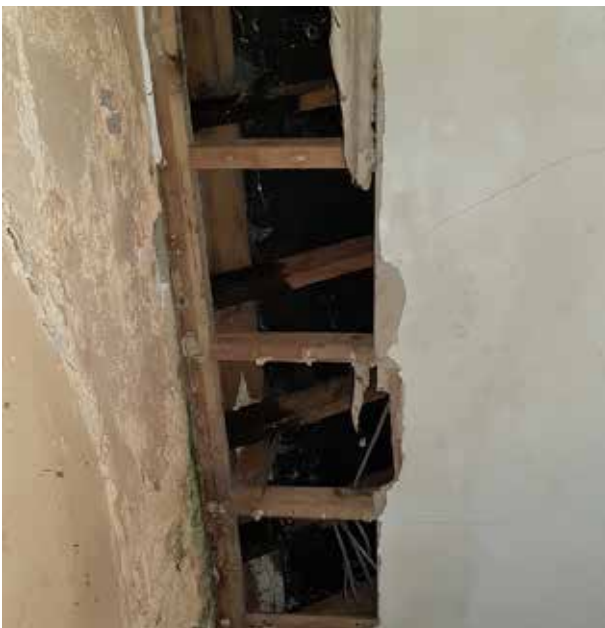
Area D: Collapsed ceiling in stairwell

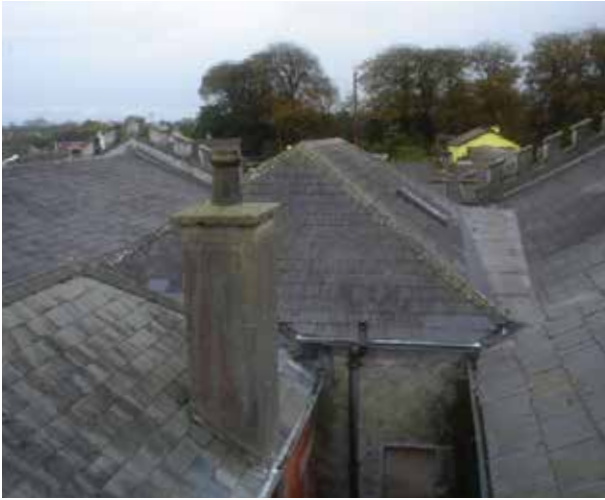
The existing valley gutters were a 20th century failing addition and are not considered to be of historic value. They were not installed correctly, laid to shallow falls with shallow steps. They were removed and the timber boarding beneath was fully inspected and replaced where necessary with 18mm marine ply. New code 6 leadwork valleys were installed throughout detailed in full accordance with the Lead Development Association guidelines by experienced an experienced heritage contractor. The eaves level fibre cement slates running along the valley will were removed and replaced during this process. The lead & copper works were carried out in full accordance with all guidelines.

Approximately 60% of the roof has been reslated in fibre cement slates, lead valley gutters are a defective 1970's intervention

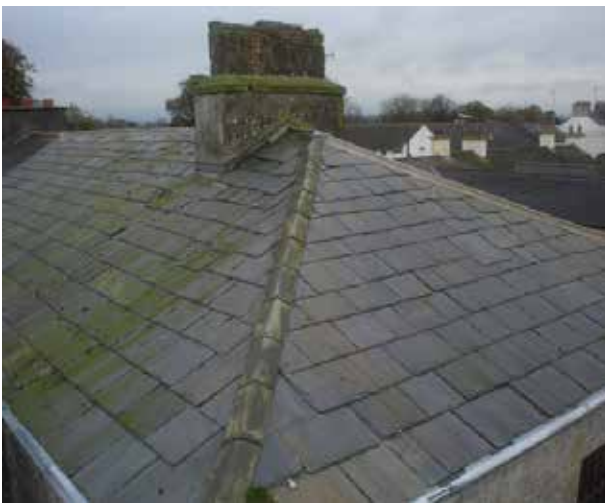
Natural slate on roof of prison range, some displacement around chimney

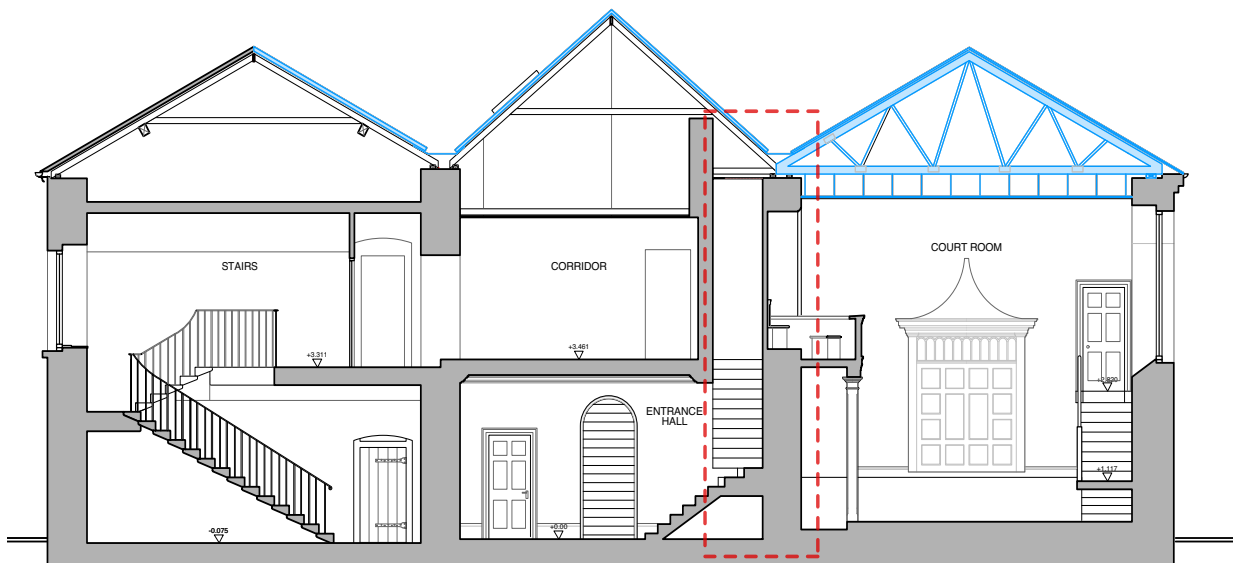
Blue denotes areas of fibre cement reslating and new timber roof structure over courtroom range
Red denotes general area of decay, plaster cracking, and mould due to failing valley gutter
