Proposed Fire Station for Ferbane

Architectural Impact Assessment Protected Structure at Ferbane, Co. Offaly

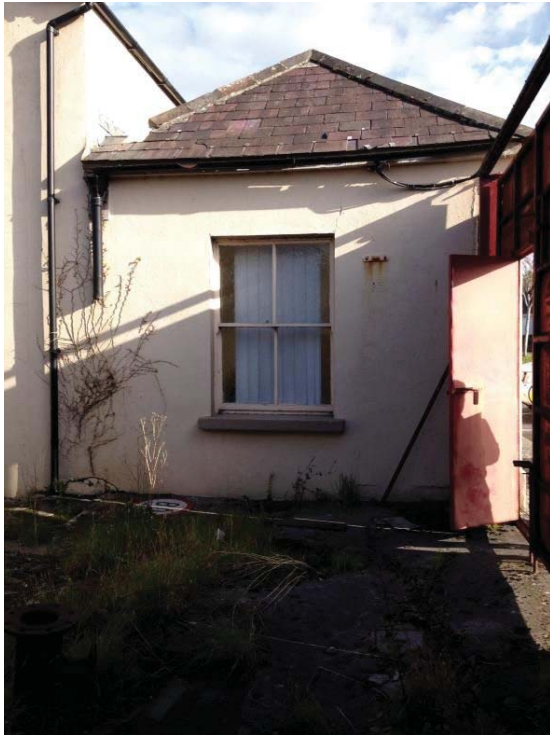
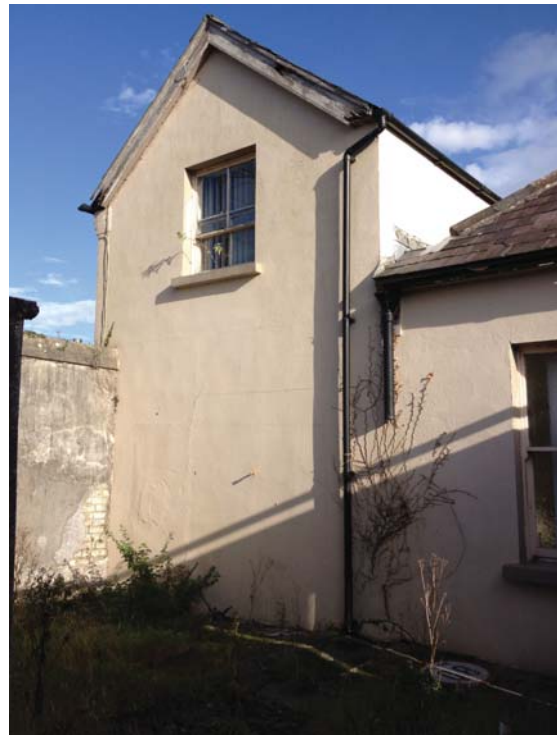
Window overlooking courtyard

The existing windows are generally in good order both externally and internally. They would benefit from painting on the exterior. The locks and sash cords are all in place and are in working order. The first floor window overlooking the courtyard does not appear to be in good order and is painted closed. It will need to be restored to working order.

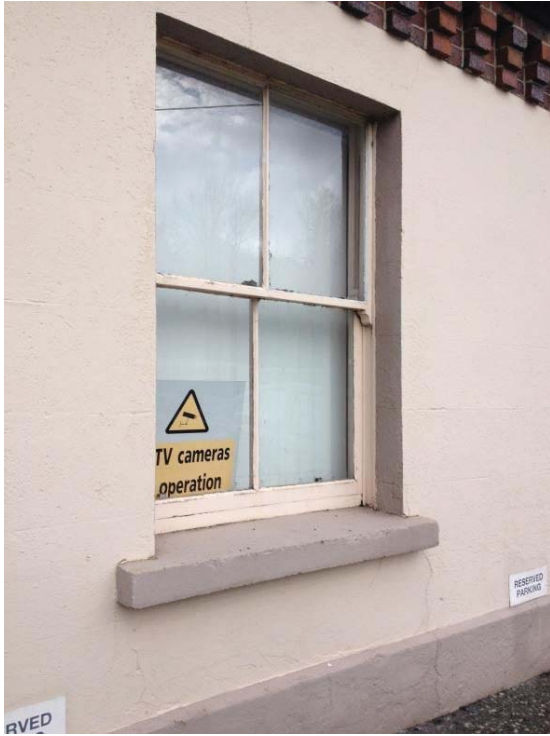
External view of window

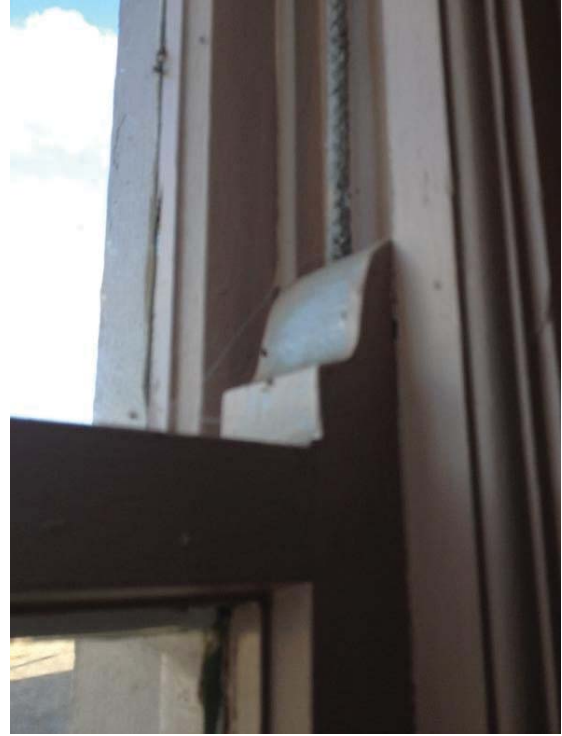
Sash horn and cord in place

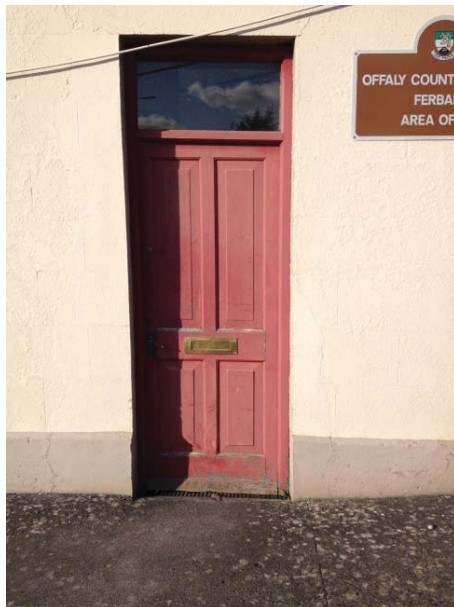
Front door

The two external timber doors are identical and are in reasonable order and can be retained and repainted. They both have a square headed clear light over the door.

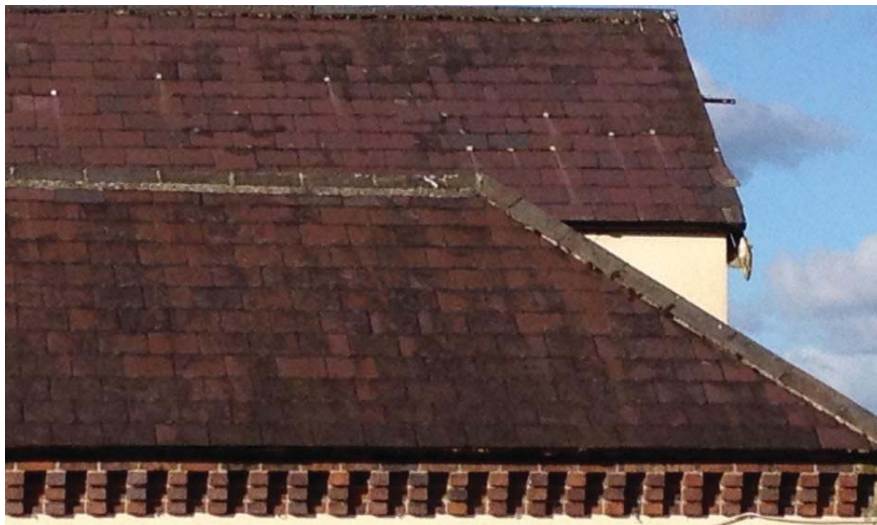
The roof is of natural slate construction and will require some repairs. A few slates have slipped and may need to be replaced with similar natural slates. There are slates on the shed which is to be demolished. It is proposed to retain these slates and use them for all future repairs on the roof of the main building. The slates are a heather colour and are probably Welsh in origin. One can see a few grey slates used for repairs that do not match the heather colour.

Slate roofs

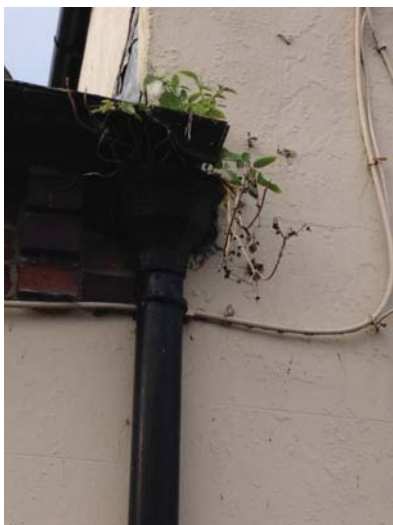
The ridge and hip tiles are clay. The hoppers, gutters and downpipes are cast iron. They will require painting and some maintenance but are in reasonable order and will not require replacement.

Hopper at roof junction

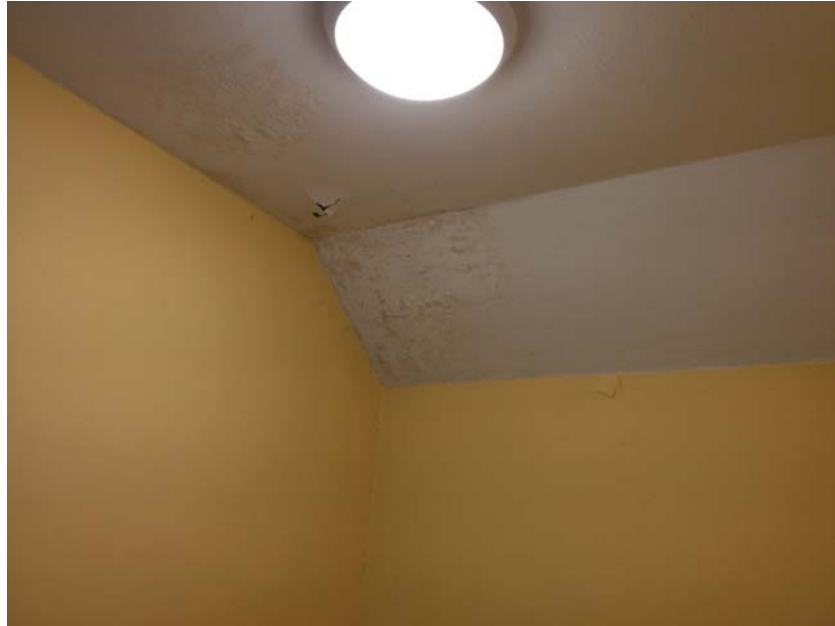
There is also signs that the roof is leaking over the stairs.

Evidence of leak over stair

No remedial action apart from heat and ventilation is proposed for the dampness on the walls. The internal finishes will be repainted.

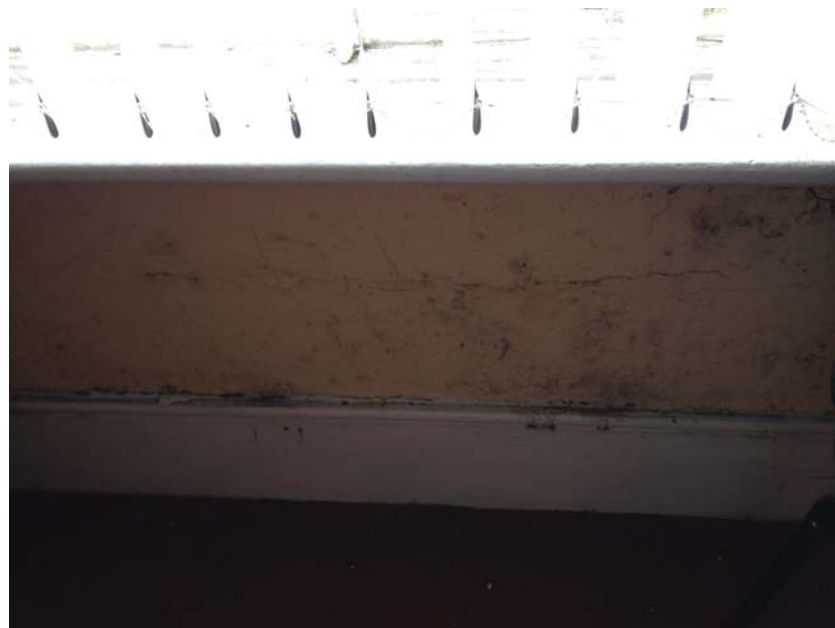
Internally there are signs of dampness on all of the walls.

Dampness under first floor window

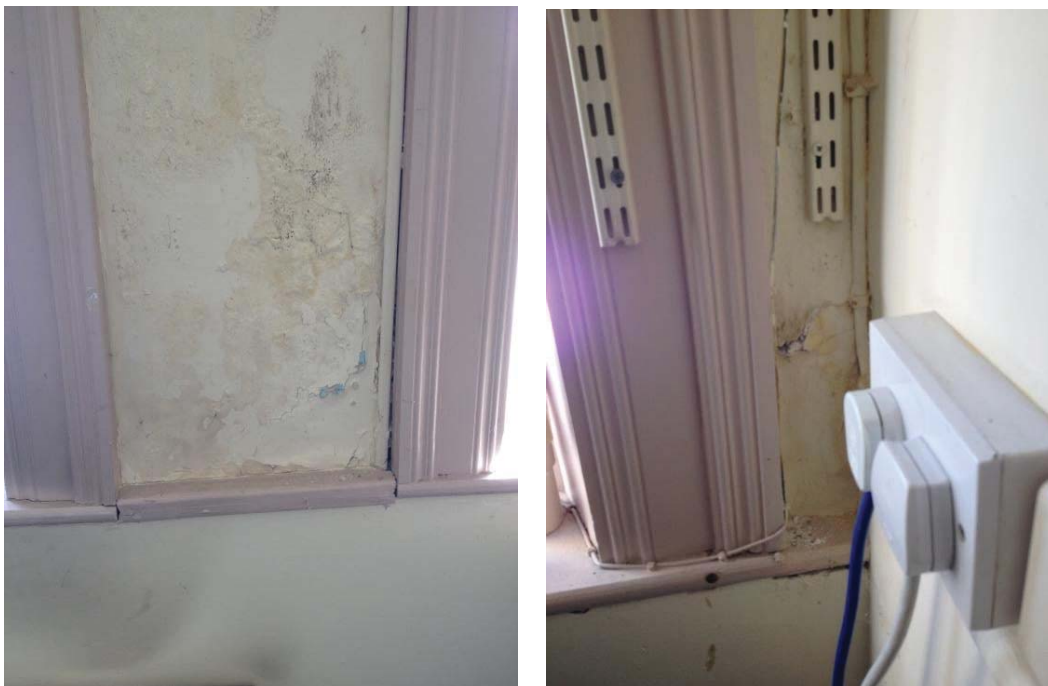
Dampness between ground floor window, dry lining blow window boards hides dampness

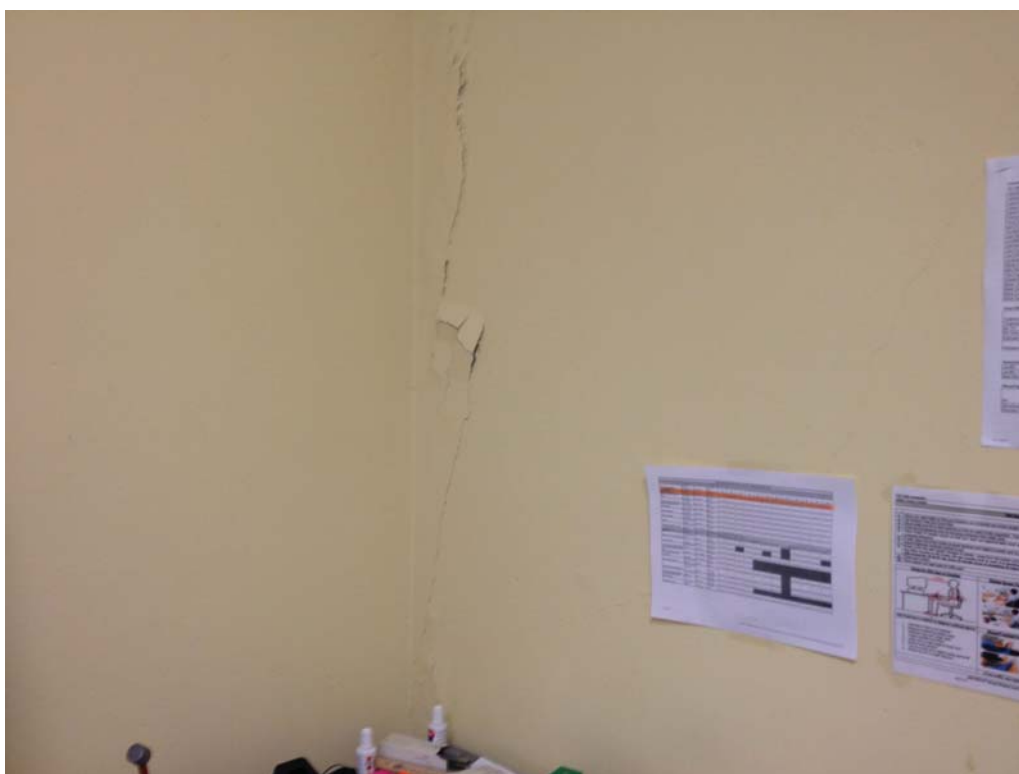
Crack in wall in ground floor office

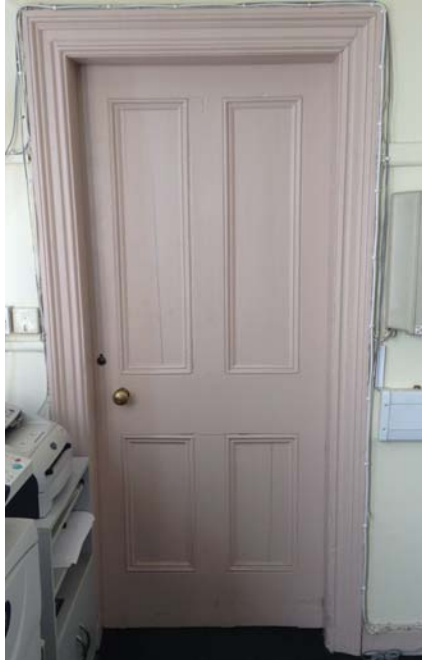
Door 9

It is also proposed to demolish the wall dividing the main room in the single storey section in two. This wall is a stud partition and would not appear to be original. The layout of the room and the new skirting would suggest that the wall is not original, as would its stud work construction however the door in this wall is an original door (Door 9). We propose to save the door and use it to replace one of the newer doors.

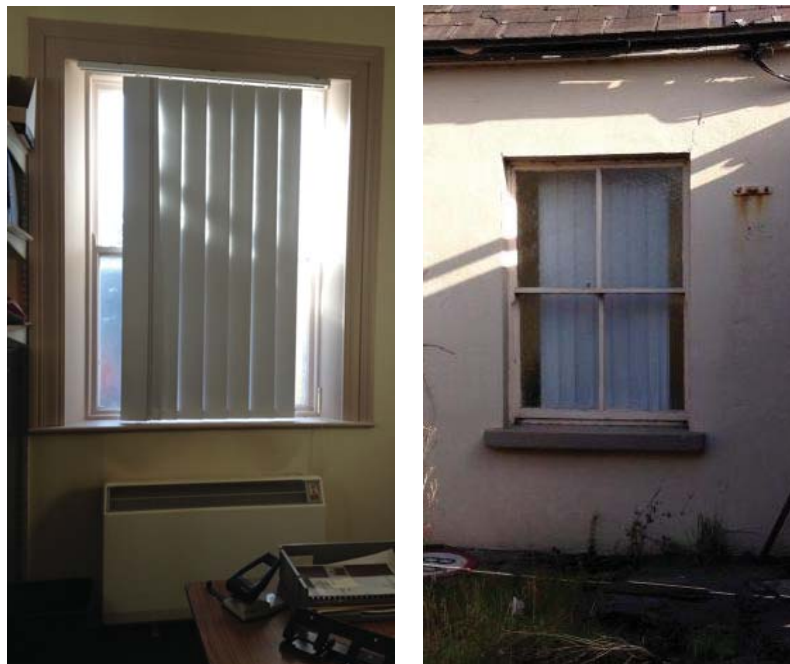
Relevant window, which is to be turned into doorway.

To form the link with the new section of the fire station, it is proposed to remove the window, cut the wall down to ground level, leaving the existing lintel in place over the door. The existing window surrounds are to be left in place.
