**Blundell Mine, Edenderry
Co. Offaly**

Report on Investigation of
Old Mine Workings

October 2011

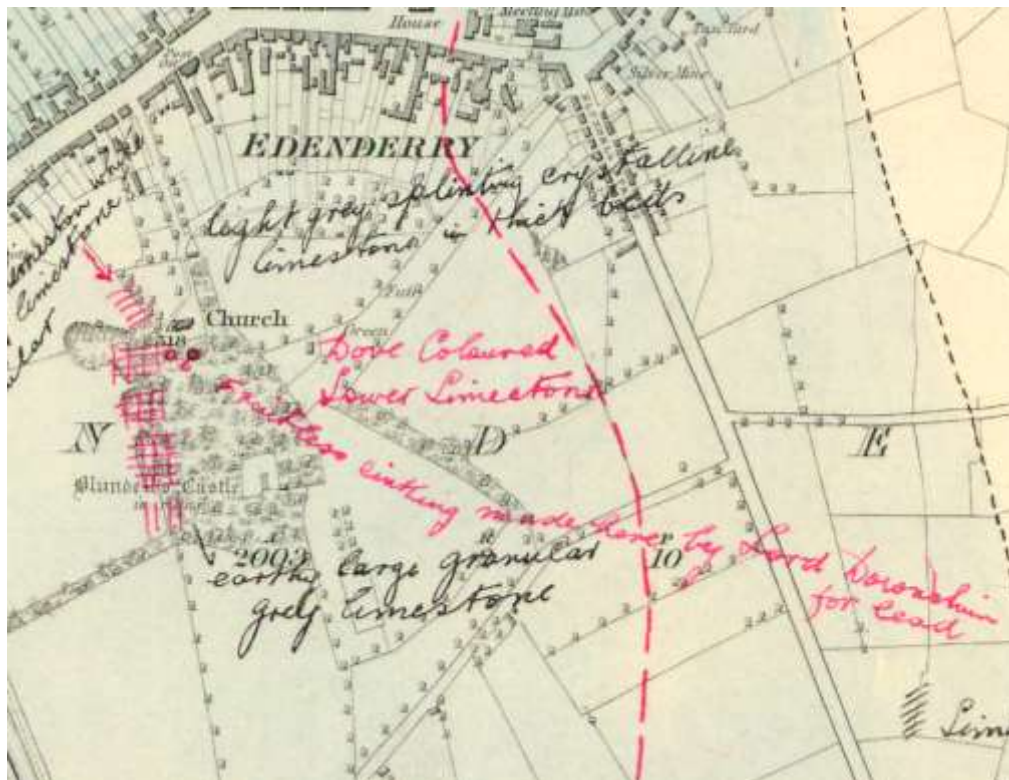
Figure 5. Fair copy geological field map (circa 1850's) showing three shafts and note "Fruitless working made here by Lord Downshire for lead"

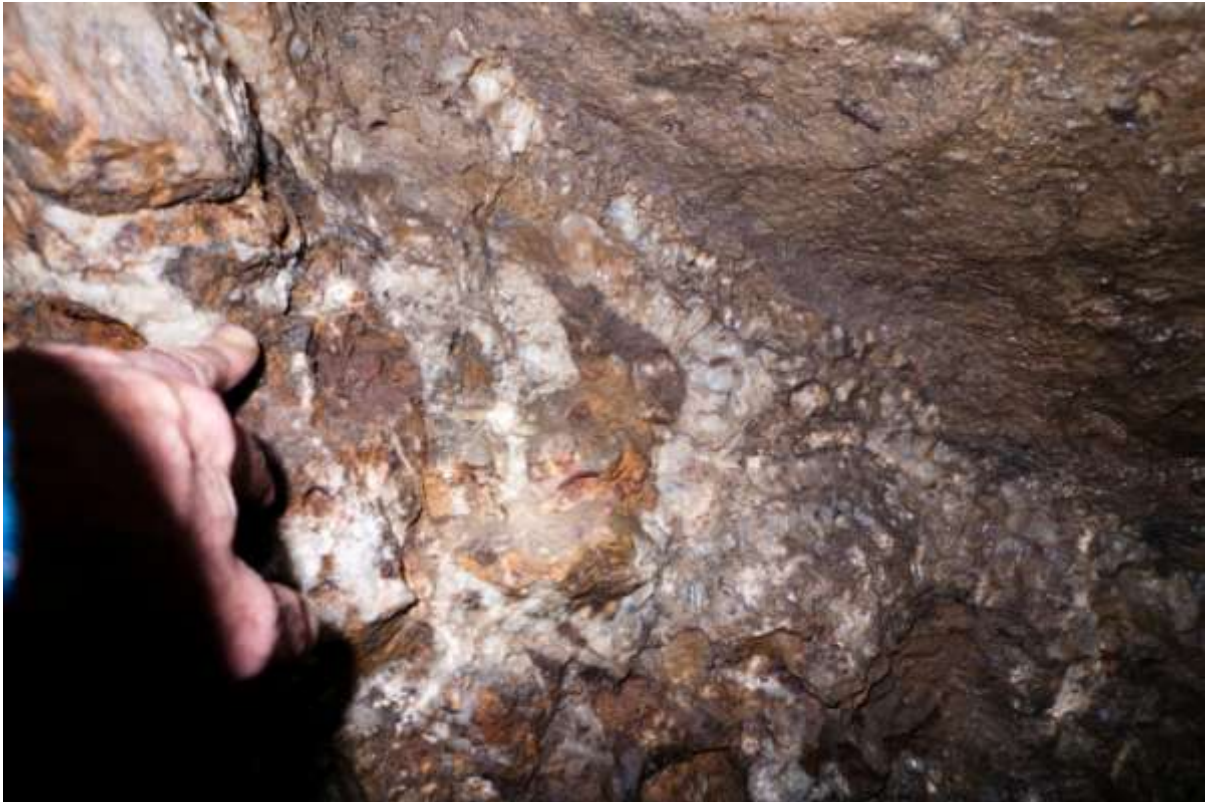
Figure 8. Breccia style mineralisation in the underground workings at Edenderry showing clasts of dolomitised and iron stained limestone in a matrix of coarse calcite crystals

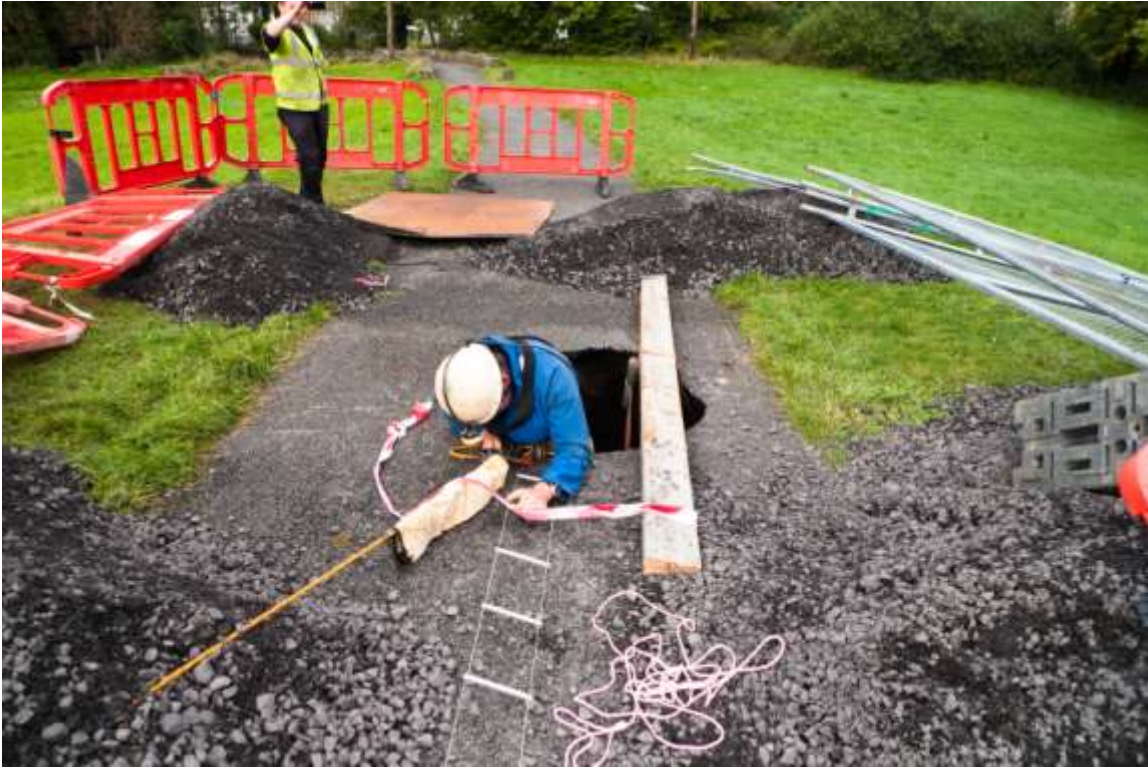
The opening in the tarmac was about 1m circular in diameter but was undercut all around for about 50cm to the sides of the shaft below (Figs. 14). The shaft itself was square cut to a depth of 4-5m deep with the remains of stone collaring on the southern side and with fragments of stone-lining to a depth of just under a metre, holding back the soil cover. Although the shaft was about 2m in diameter when investigated it would appear that the sides have partly collapsed and the original diameter would have been smaller. A modern water mains pipe was encountered cutting across the shaft about 1m below the surface and it is surprising that the shaft was not found when this pipe was laid back in about 1969, suggesting that the shaft was covered over just beneath the pipe (Fig. 15). Typical methods of covering old shafts in the past would be with rocks placed upon timbers or a circular 'beehive' of rocks over the shaft collar. At the bottom of the shaft a two metre long level lead off to the north-east (034 degrees). Some digging (and removal of traffic cones which had been thrown into the shaft) was necessary to gain access to the level. Our digging did not reveal the bottom of the shaft and there were at least three traffic cones still embedded in clayey soil with boulders. The shaft may be only as deep as the level which leads off to the north but a deeper continuation to lower workings cannot be ruled out.

Figure 14. Entrance Shaft which appeared in the footpath in October 2011

Following our site investigation it is understood that the mine shaft was sealed by tipping of hardcore into shaft.

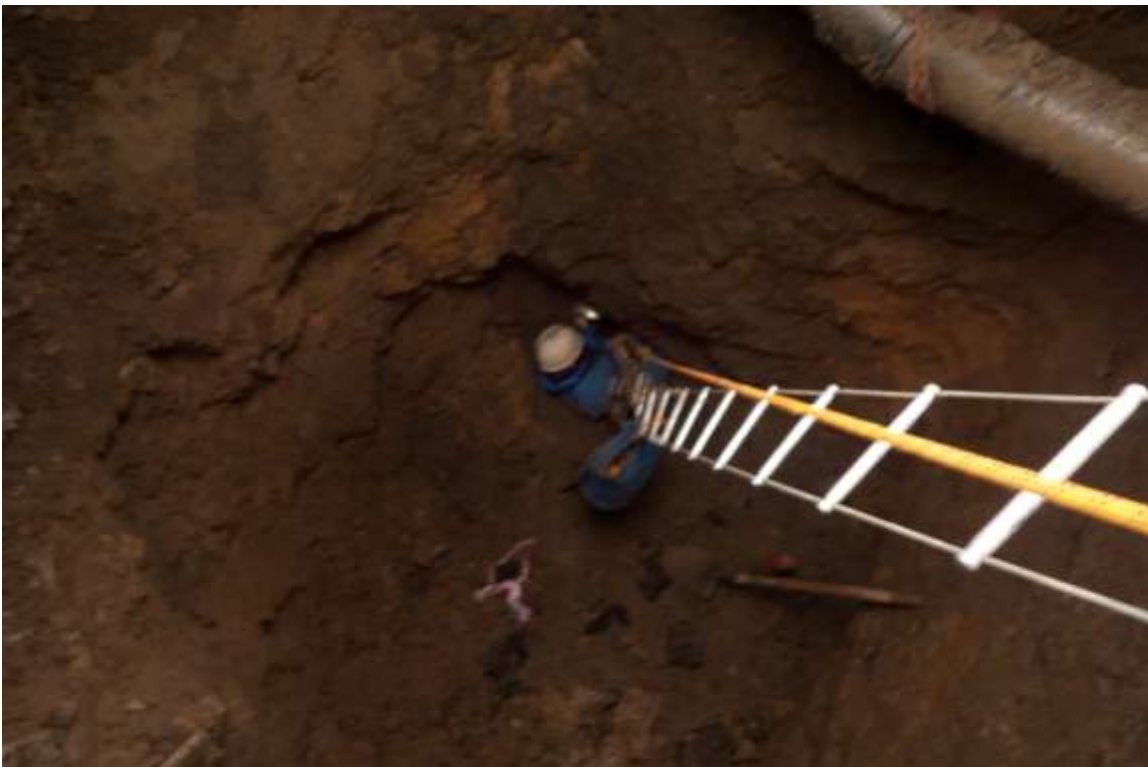
Figure 15. Looking down the entrance shaft showing water main in the top right

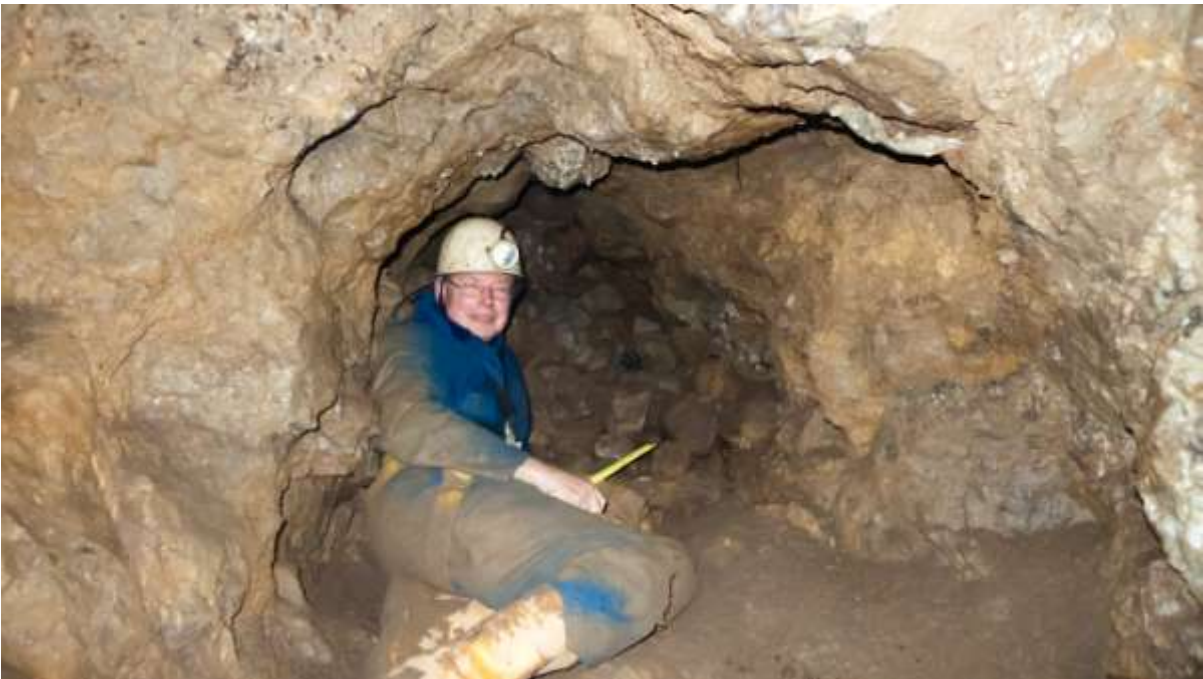
A 5.5m long horizontal branch level from the chamber to the east (090 degrees) terminated at a shaft going upwards which was filled with unstable boulders (Fig. 17). The location of this shaft corresponds to another shaft on the surface that apparently collapsed on the surface about 25 years

ago and was in-filled. Fragments of plastic debris in the rubble at the foot of this shaft would seem to confirm this as being of modern derivation. A second branch level from the chamber to the north (010 degrees) slopes downwards by about 30 degrees and terminates where the debris from the shaft collapse and gravel in-wash fills the passage to the roof. Due to time constraints we were unable to determine if the passage continued past this point as digging would be needed to remove the gravel.

Figure 17. Foot of filled shaft at the end of the workings (this was the shaft which opened up in 1985)
