Birr Courthouse

Conservation Masterplan

October 2021

This conservation master plan was produced for Offaly County Council by Howley Hayes Cooney Architecture in September 2021 to assess the history, significance and possible reuse of the former courthouse and bridewell in the town of Birr, County Offaly. This plan was part funded by the Heritage Council under the Offaly County Heritage Plan 2017-2021 programme; Creative Ireland and Birr Municipal District.

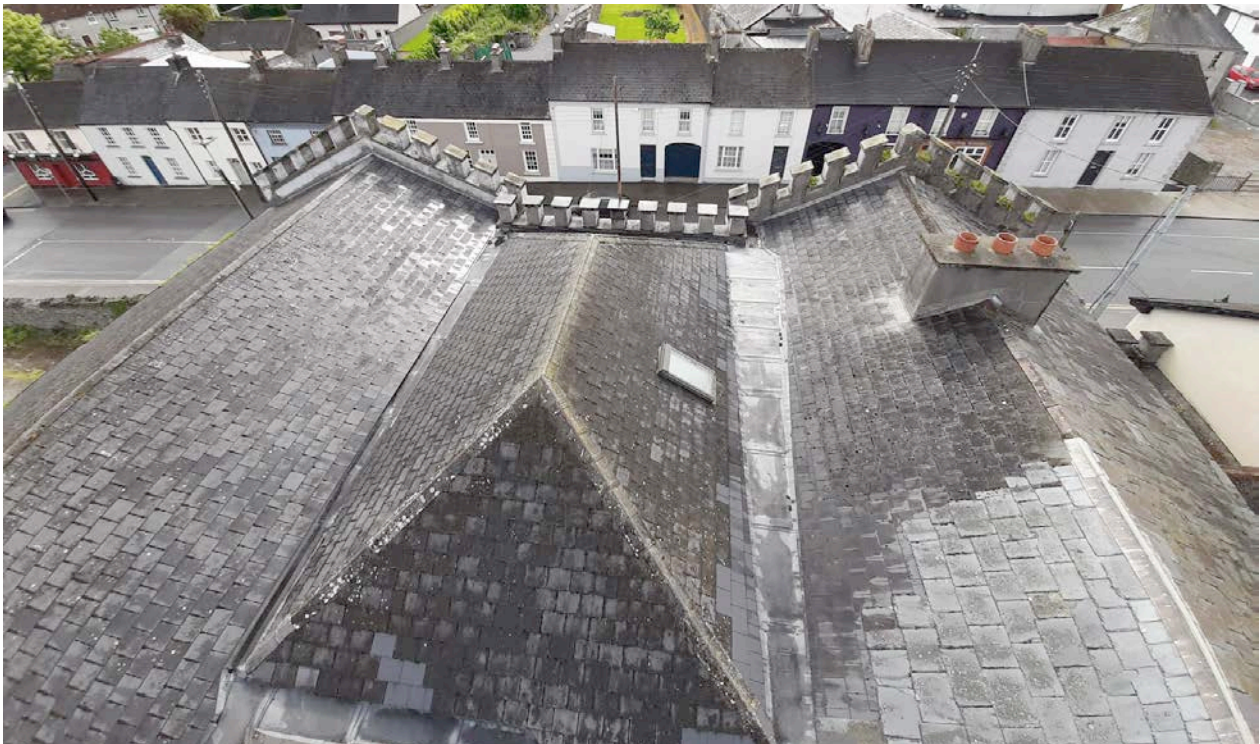
On closer inspection it can be seen that some slates have been poorly repaired in the past with inferior quality or ill-fitting slates, or the insertion of artificial Tegral slates, and this unsightly patching is clearly visible across the south range roof in particular.

Fig 19: Photo of roofs of Birr courthouse taken from a MEWP

The roof valleys have been replaced in recent years and the leadwork has been inadequately installed, to incorrect falls and with poor detailing. This is causing leaks and ponding across the roof, in particular behind the front parapet, where the water is gathering and failing to discharge adequately through two undersized chutes that drain the front parapet into hoppers on the front façade. A significant leak has occurred at the junction between the north range, central range, and the rear extension. Valleys and gutters are also blocked in a number of locations throughout the roofs due to general lack of maintenance.

There is an ad hoc mixture of roof ridge and valley tiles with lead rolls in some locations, such as on the south range roof, and which should be replaced. A small lean-to extension between the rear brick extension and the south range is covered in cement tile and appears to be in fair condition. The asbestos survey from 2018 noted the presence of asbestos in this tile, and it is possible that some of the other fibre cement tiles, found elsewhere on the roofs might also contain asbestos.

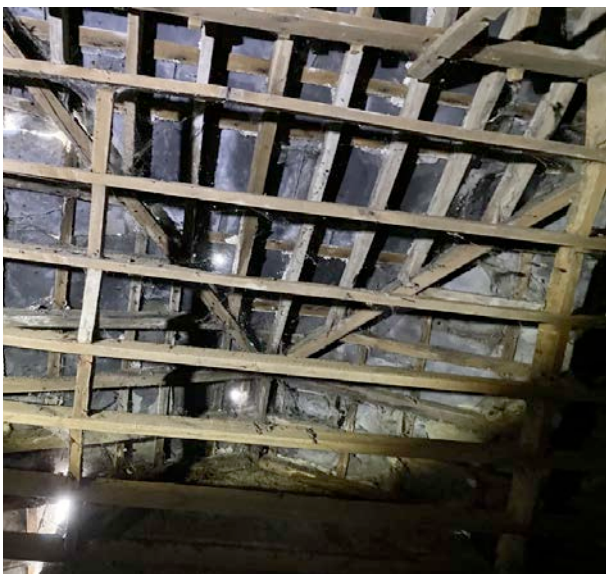
Based on limited inspection from below, the roof to the central range also appears to have been replaced during the twentieth century with new timber members. The south range appears to contain original timbers and is covered with Welsh slate, although the eastern end has some Tegral replacements. It is not possible to inspect all of the south range from below due to the brick vaulting above the cells, although the room at the east end has no vaulting, and the roof timbers in this location are in very poor condition, are in danger of imminent collapse and should be replaced immediately. The rear brick extension appears to have its original slate roof.

Fig 20: Underside of south range roof

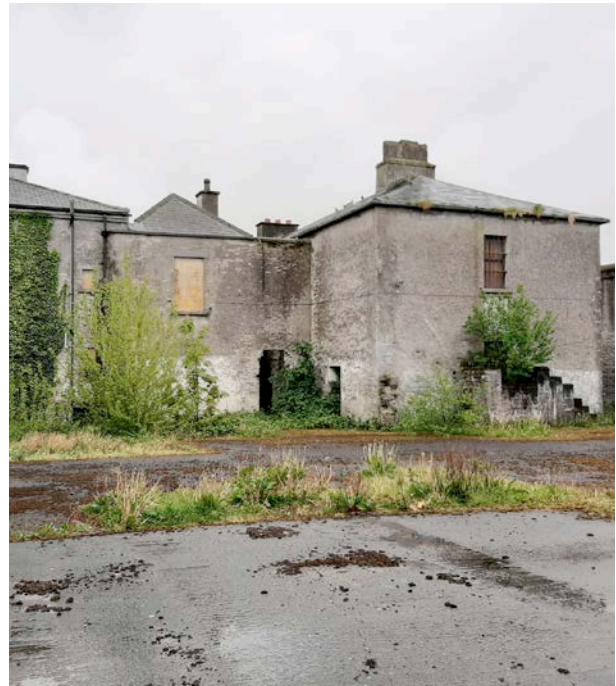
The main walls appear to consist of load-bearing masonry walls with a cement rich, painted pebbledash render on the front (east) and north elevations. In contrast the render finish to the south and west elevations is a softer lime coating that has come away from the facades in a number of locations.

Fig 22: External view of the back of the courthouse

The application of the unsightly cement based pebbledash render is damaging, and can disfigure and hasten the decay of historic masonry behind, as the underlying stone or brick is softer than the render. A common problem with hard cement coatings is that over time sections of render may crack or detach from the skin of the building, which will result in the trapping of water behind. This will cause the masonry to decay or become water-logged. Portland cement became particularly popular after the Second World War, often replacing the softer lime renders that were used originally. Older layers of render are evident on the front facade and should be analysed to determine the original mix and colour of the render, a yellow sand is certainly visible within the mix. The condition of these coatings, both historic and more recent, is poor in certain locations, particularly where there are failing rainwater goods. This is due to water getting trapped within the masonry walls and is particularly evident on the gable wall to the south east corner of the courtroom where the wall is considerably saturated.

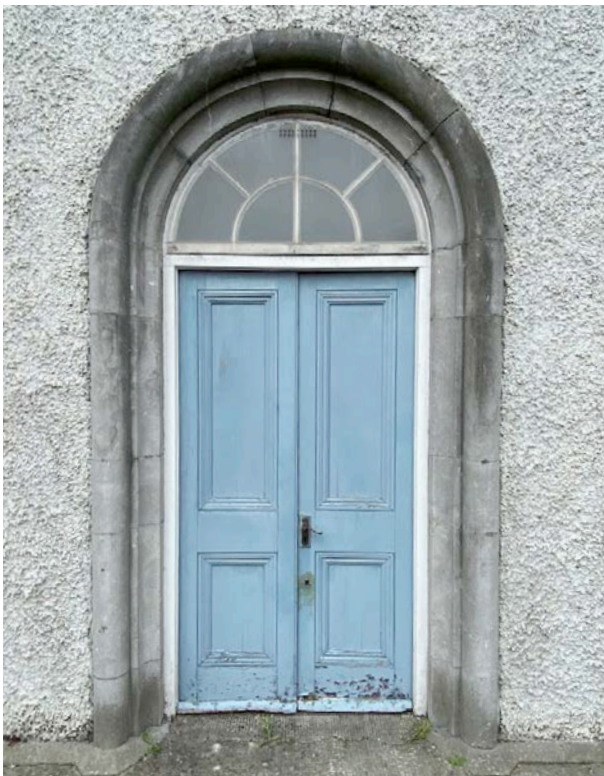
There is one main set of double entrance doors to the central entrance lobby on the front façade. These panelled doors appear to be in a reasonable state of repair but require repainting and some localised replacement of timber, likely to the bottom rail. These are a modern insertion as are the frame and fan-light above, which differ from the doors shown in Cooke's front elevation. A short flight of steps leads up to the front door.

Fig 23: Double entrance doors to the courthouse

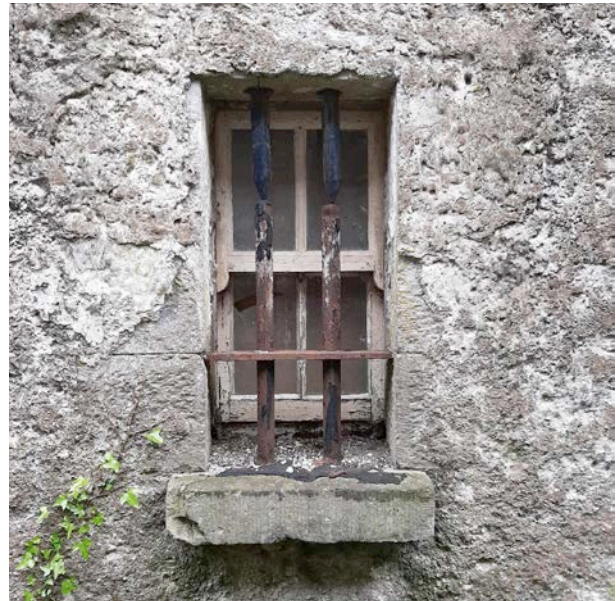
Fig 24: Timber cell window with rusted iron bars in stone sill

Smaller window openings to the cells contain rusted iron bars, which are causing damage to the stonework. The condition of the timber framing behind is also quite poor and these windows should be repaired. A number of the windows to the rear façade are boarded up likely due to the on-going problems with leaking and security.

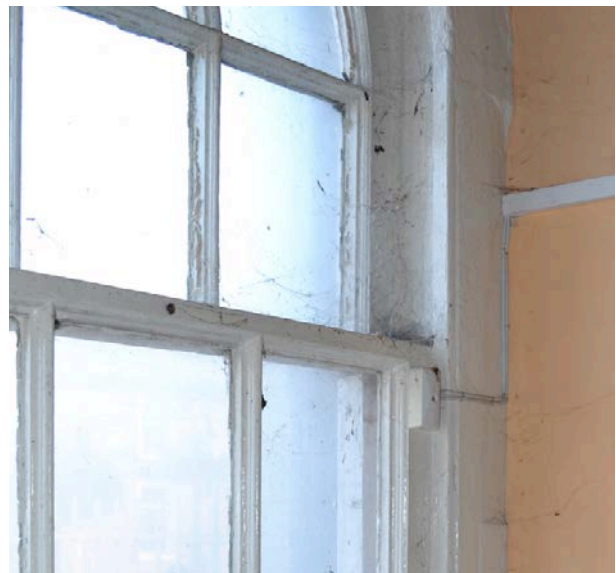
There is an ad hoc collection of windows from different periods across all four façades. Three original timber sashes with an elegant, lambs tongue profile remain on the front of the building, and these should be retained and repaired.

Fig 25: Historic window with lambs tongue profile on ground floor of courthouse

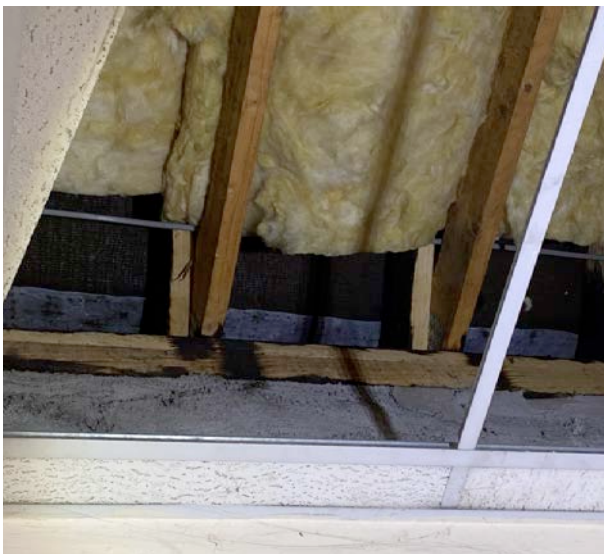
There is a roof space running the length of the north and south ranges; although this was not accessible during our site visits, some features could be made out through openings in the ceilings. The roof structure to the north range is a simple A-frame structure of collared rafters, of recent construction. Cement repairs are also visible to the wall tops and there appears to be a new wall plate has been installed. A loosely fitting, insulation blanket has been placed along the roof joists.

Fig 26: View into roof space over courtroom with concrete ring beam, modern creosoted timbers and blanket insulation

A careful inspection of each roof space should be carried out to check for insect attack, and water damage to the timber structure. It would also be prudent when roofing works are carried out that the contractor thoroughly clean the roof space and remove any bird habitation and guano over the trusses and above the ceilings. Due to the lack of any access route into the roof space it may not be practical or safe to carry this out until re-roofing works are completed and the attic space can be inspected from above. Given the period of neglect the south range roof has undergone it is likely that there may be a large amount of original carpentry that, which will need to be replaced.

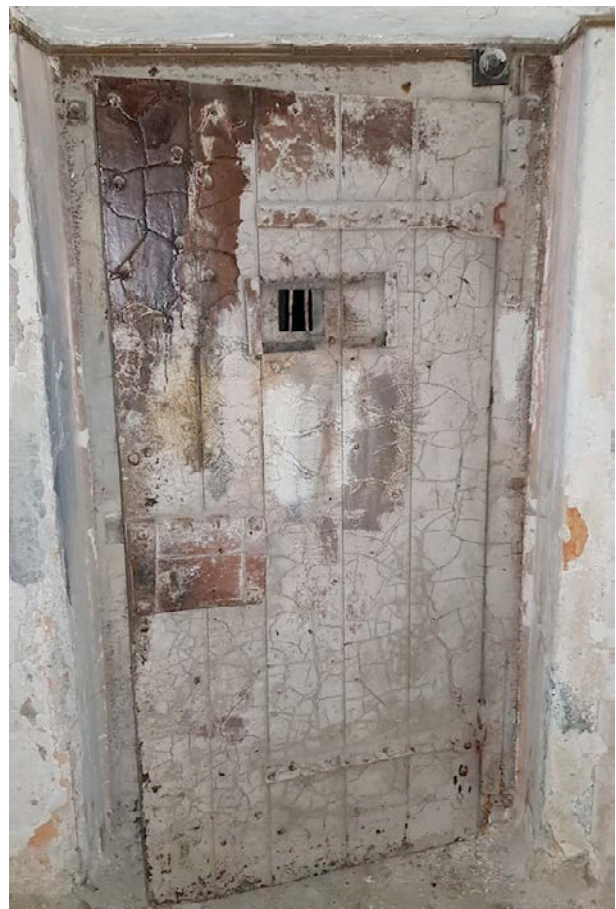
Fig 29: Original cell door with strap hinges

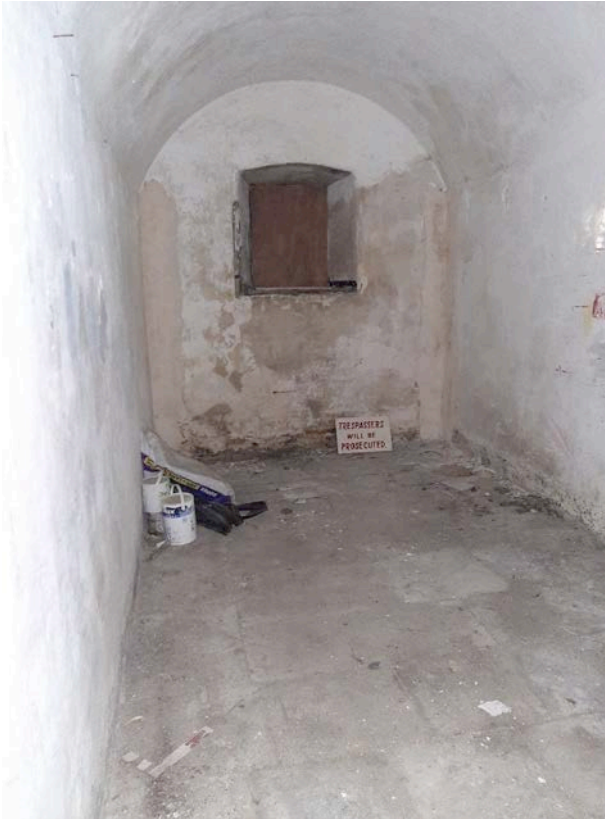
Fig 30: Plastered walls inside the cell

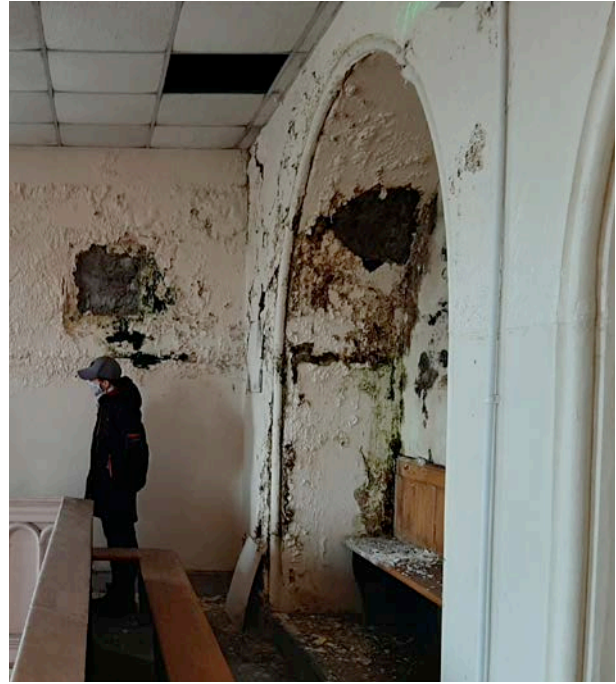
The internal wall finishes in most cases consist of the original painted plaster walls applied directly onto the underlying masonry walls, albeit much affected by water ingress and mould growth in certain locations, such as in the entrance lobby and courtroom. These are areas of severe damage and organic growth is clearly evident. The remaining

Fig 32: View of damaged plaster on gallery level in courtroom

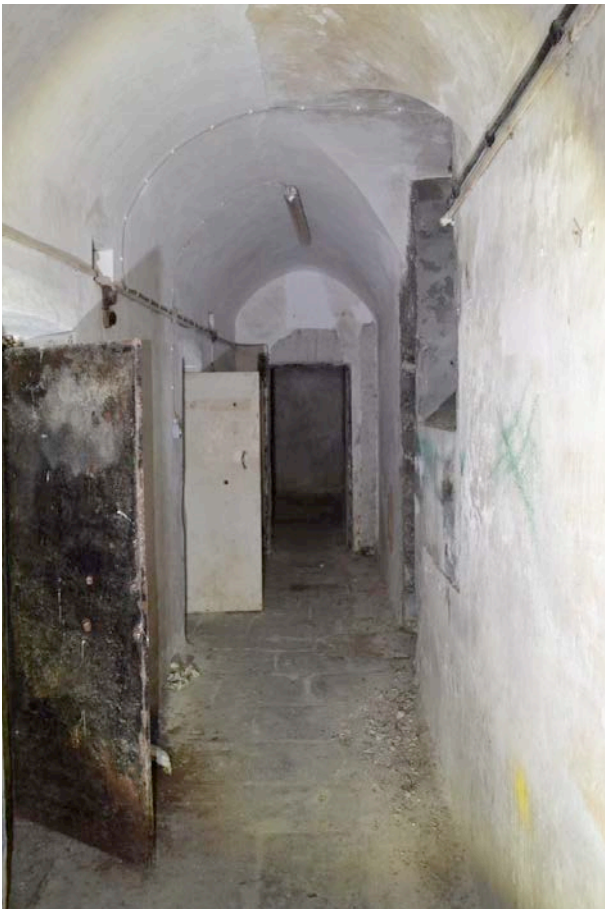
The ceilings to the cells on the ground and first floor of the cell block are plastered brick vaults and appear to be in good structural condition. These should be fully inspected from above when roof repairs are carried out to the south range roof.

The original stone flags are still in place throughout the cell block and are in need of localised repair, and cleaning. They are likely bedded on a lime base, but this should be investigated further. The remaining rooms throughout the central range and rear extension contain timber floors with carpet.

Fig 31: View of corridor down cell block with brick vaulted ceiling and stone flag floor

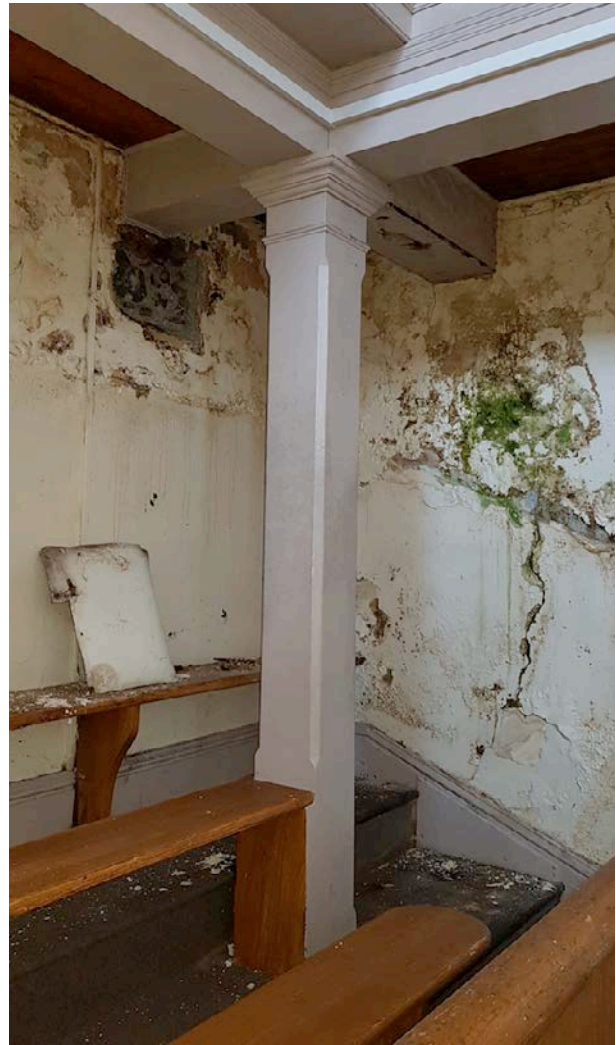
Fig 33: Damage to plaster due to excessive water ingress

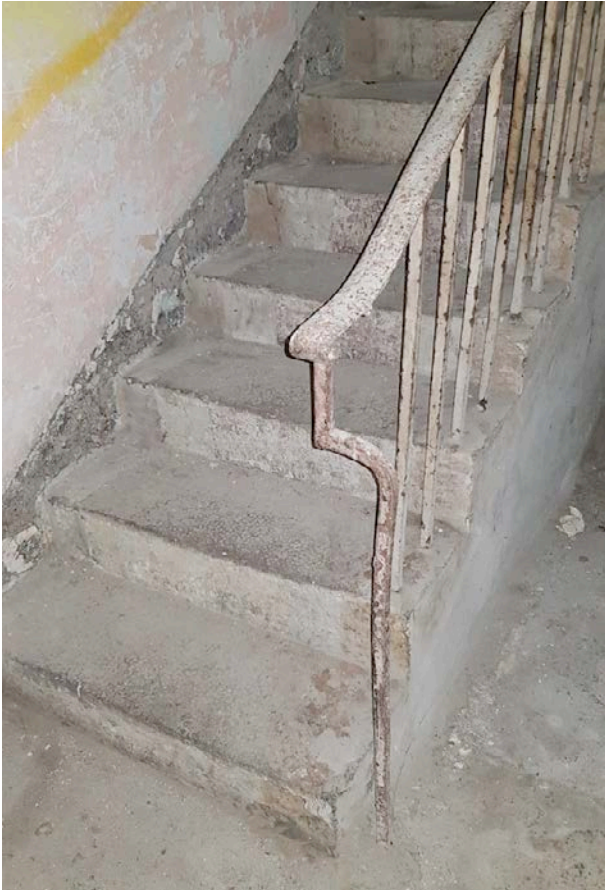
Fig 34: The stone cantilever stair in the south range with rusted handrail

There is one cantilevered stone stair in the building, in the south range or cell block. It is in fair condition, aside from a badly rusted handrail. There is some evidence of repair to the underside of the landing in the stair, and it has been plastered in a number of locations. See structural assessment for further information.

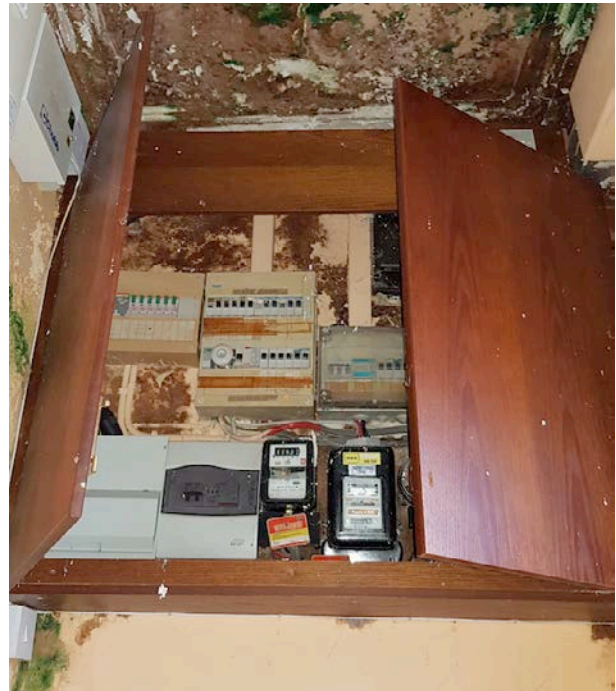
Fig 43: Electrical panel in entrance lobby

The electrical installation throughout appears to date from a range of periods and conditions. The main ESB boxes and fuse boards are located within the central entrance hall, and should be fully

replaced as there is considerable water ingress behind the boxes. There are a number of poorly located conduit runs throughout the entrance lobby although fortunately, these have been placed away from the historic cornice.

would highly recommend a full survey of the electrical and mechanical services within the building, all of which requires substantial upgrading.

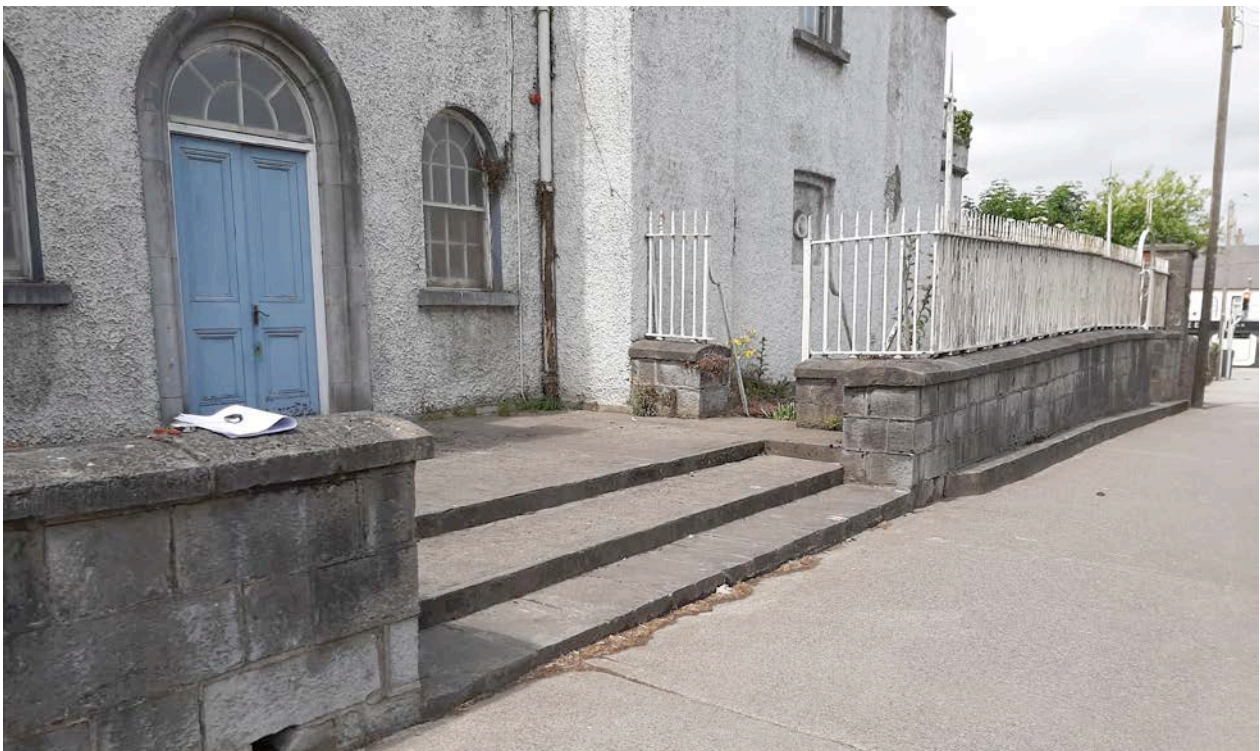
The primary entrance route to the building is via three shallow stone steps leading up to the front entrance doors. Low level stone walls separate the public pavement from the shallow forecourt areas in front of each projecting bay. A simple painted iron railing is fixed on the cap stone of the walls. The concrete surfaces in these front areas are unsightly and will require upgrading or replacement.

Fig 48: Front entrance steps to the Birr Courthouse

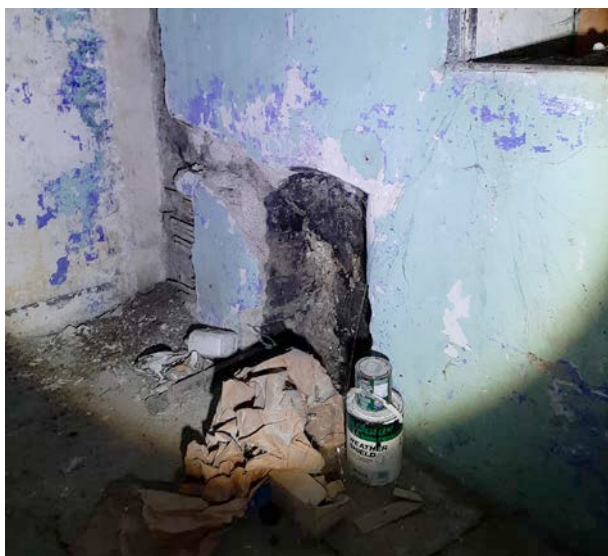
Fig 49: Evidence of continual deterioration in the south range

It is a priority that steps be taken to conserve this area of the building, which if neglected any further might be irreparably damaged.

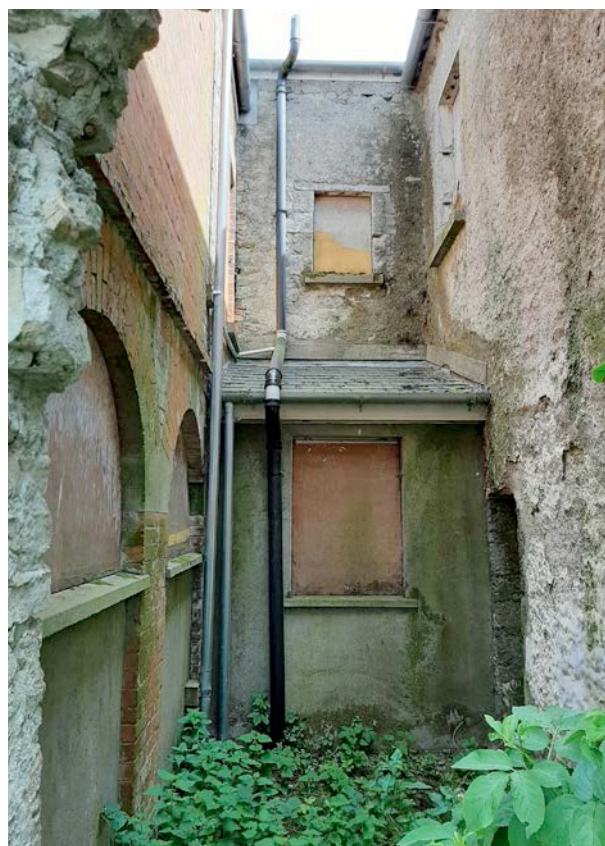
Fig 50: Single storey lean-to shed with asbestos tile roof to the rear of courthouse

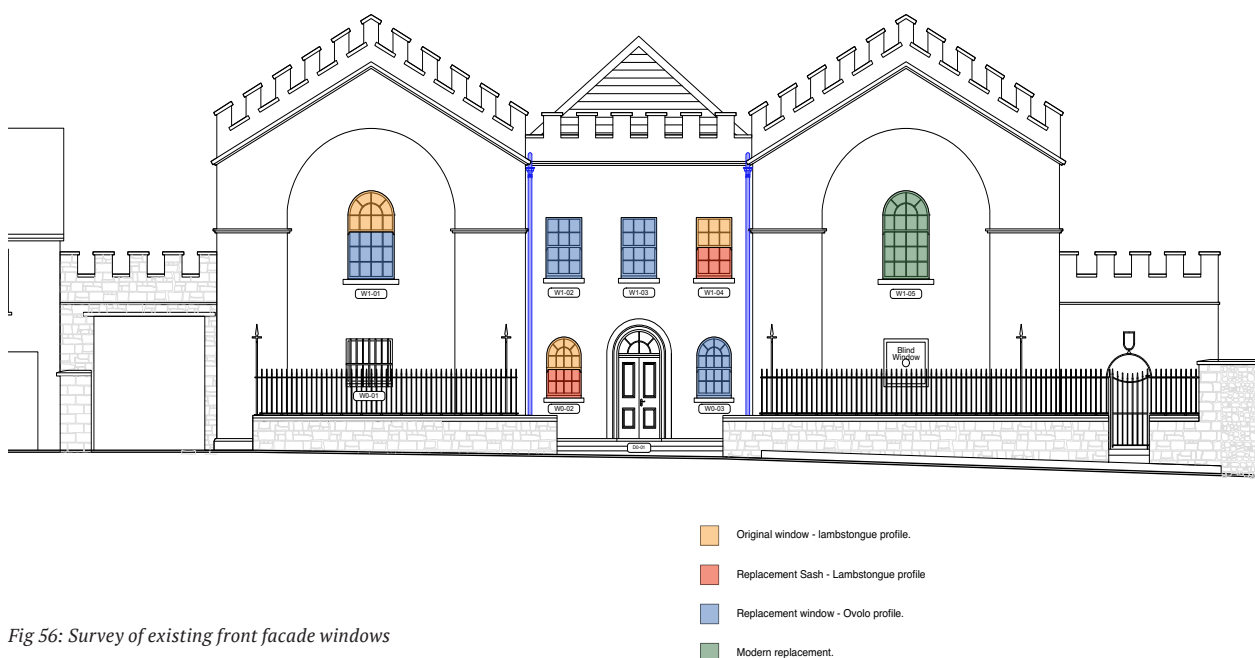
Fig 56: Survey of existing front facade windows

The windows throughout the whole building should be fully overhauled and repaired or replaced, to prevent any ongoing water ingress. Rotten timbers are evident in particular along the south façade, as are rusted bars causing damage to the stone sills. The windows to the courtroom are modern and poor replicas and these should be replaced with historically appropriate replicas. In an effort to improve the efficiency of the building and as a more sustainable approach, the use of slim-line double glazing should be considered on the north, south and west facades. The windows to the front façade should be repaired and replaced with a suitable lambs-tongue profile, to match the ground floor window just south of the entrance door.

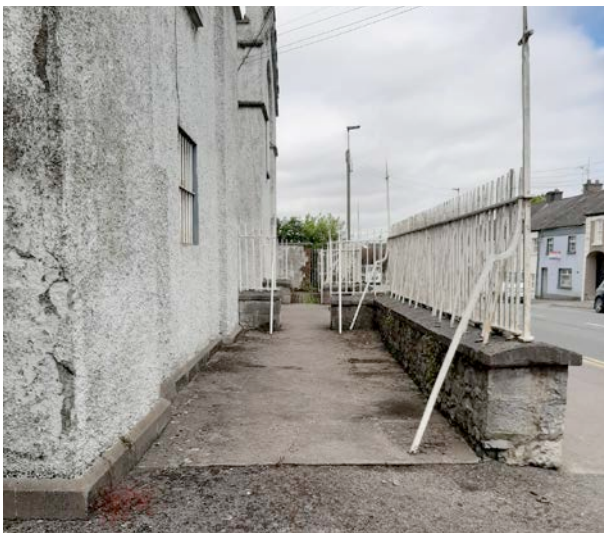
Fig 57: Ramped entry to front of courthouse

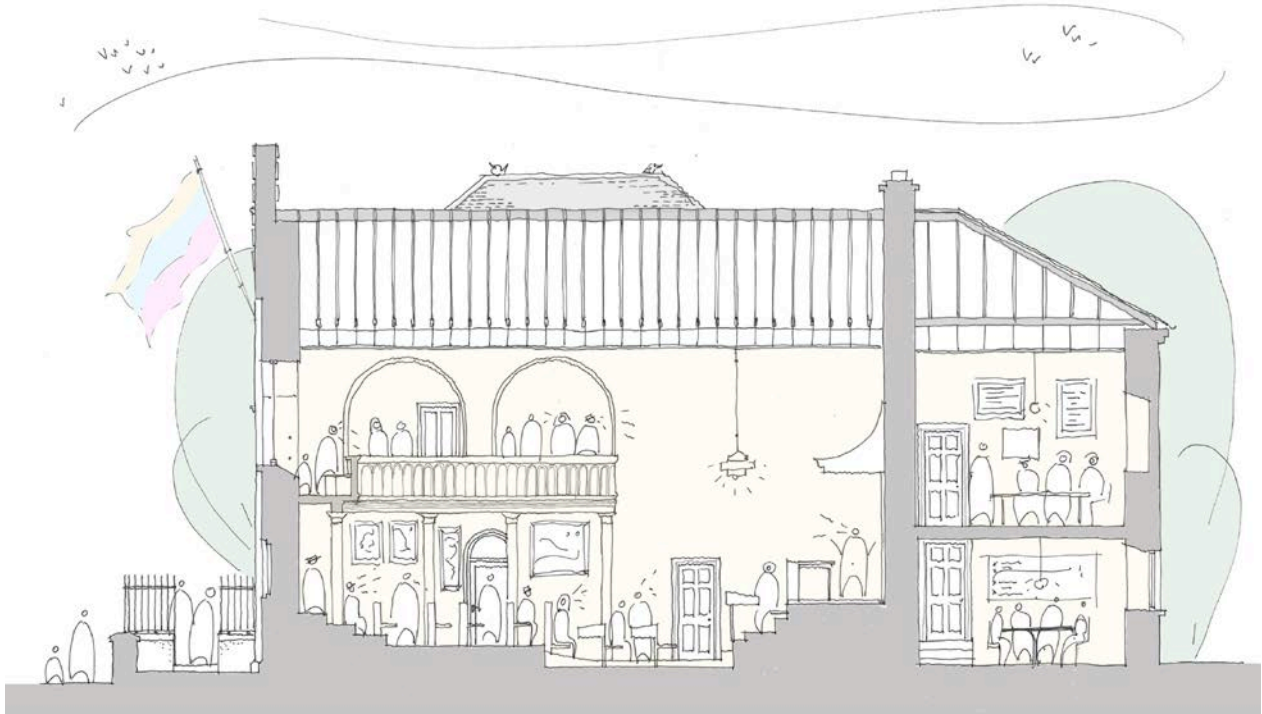
Fig 70: Sketch of section through Birr courthouse by HHC Architecture
