HTI Birr Courthouse Windows

Window repair: Howley Hayes Cooney Report 'There is an ad hoc collection of windows from different periods across all four facades. Three original timber sashes with an elegant, lambs tongue profile remain on the front of the building, and these should be retained and repaired. replacement windows with an ovolo profile have been installed elsewhere, and the large spoked windows in the courtroom have been replaced with poorly detailed single glazed modern replicas. Secondary acrylic screens have been installed to the internal side of these windows as a measure to prevent heat loss. Tooled limestone sills are still in place throughout.'

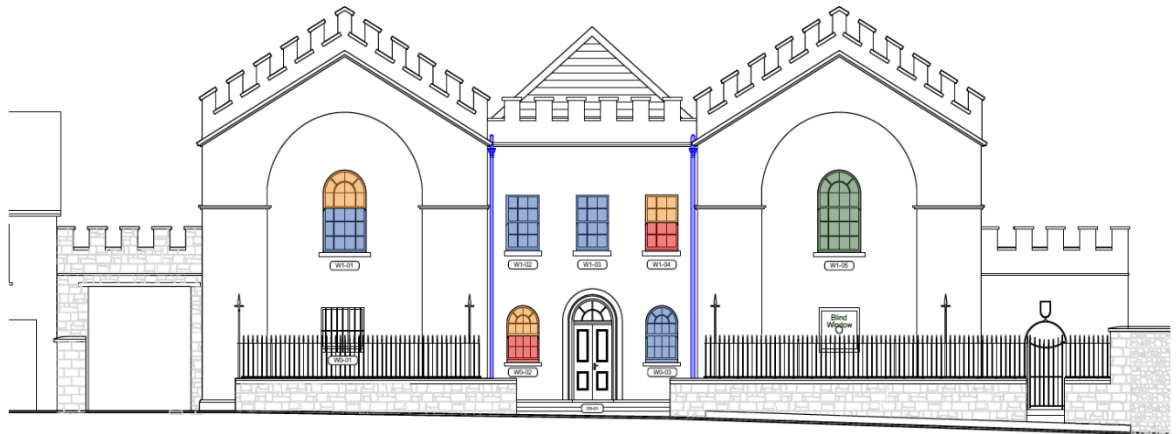
Survey of existing front facade windows

- Original window - lambs tongue profile.
- Replacement Sash - Lambs tongue profile
- Replacement window - Ovolo profile.
- Modern replacement.

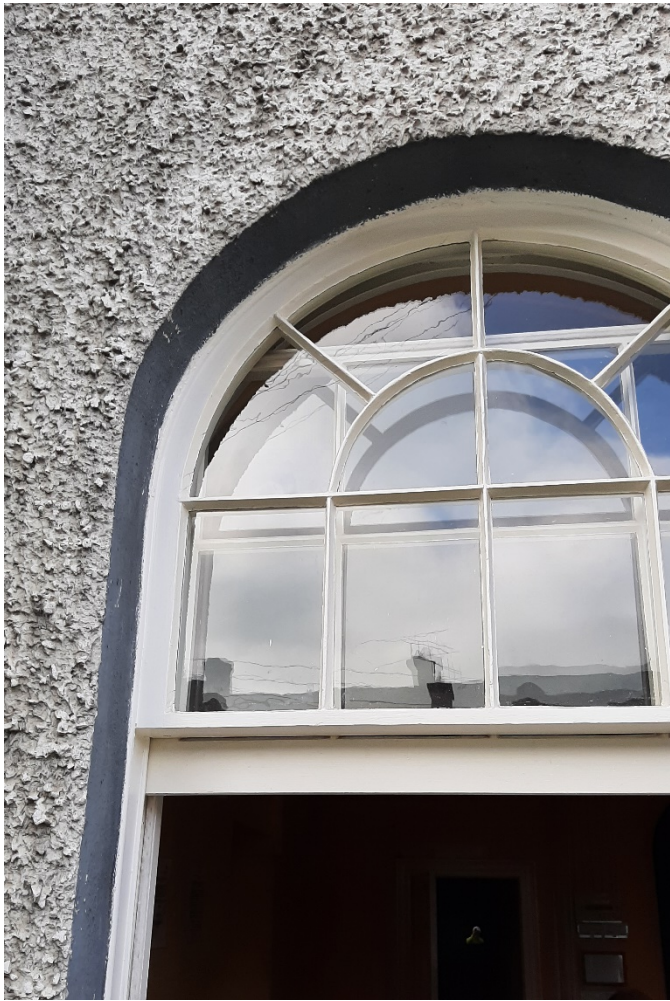
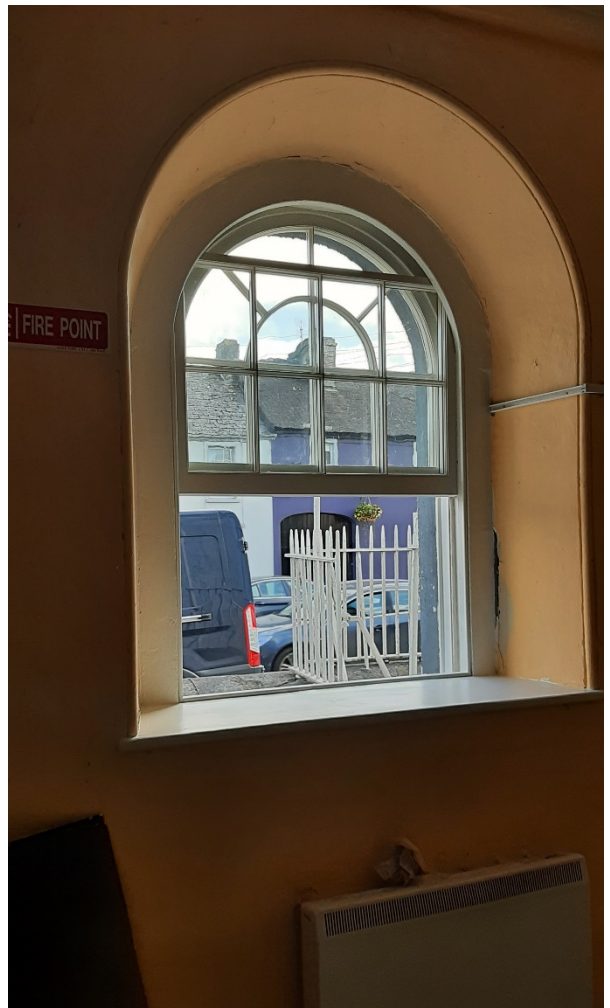
Entrance lobby with upper historic sash repaired, replacment lower section with matching glazing detail

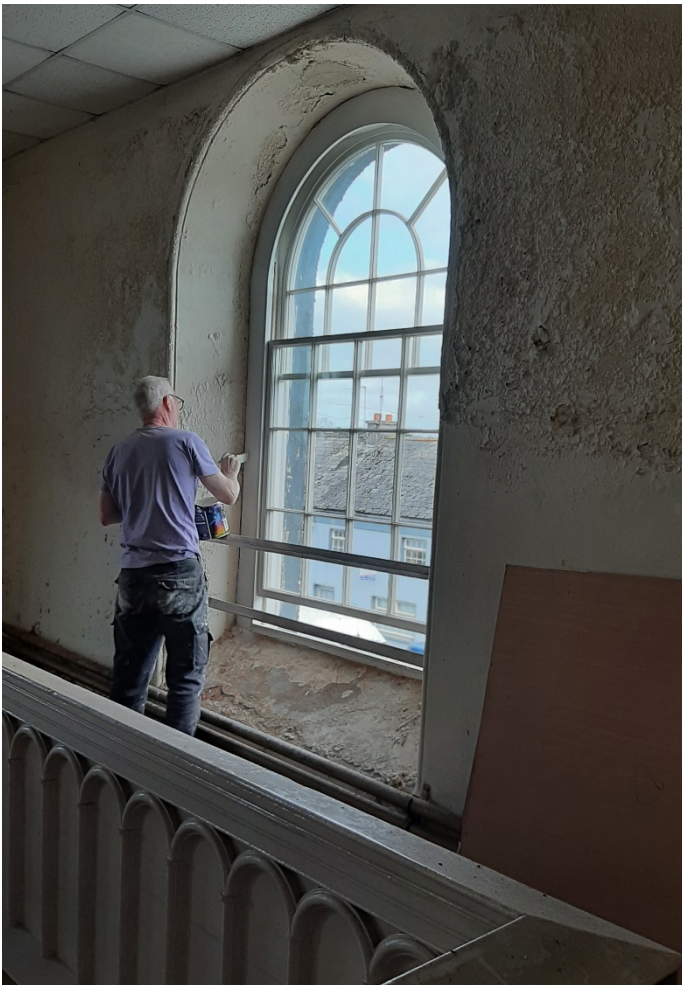
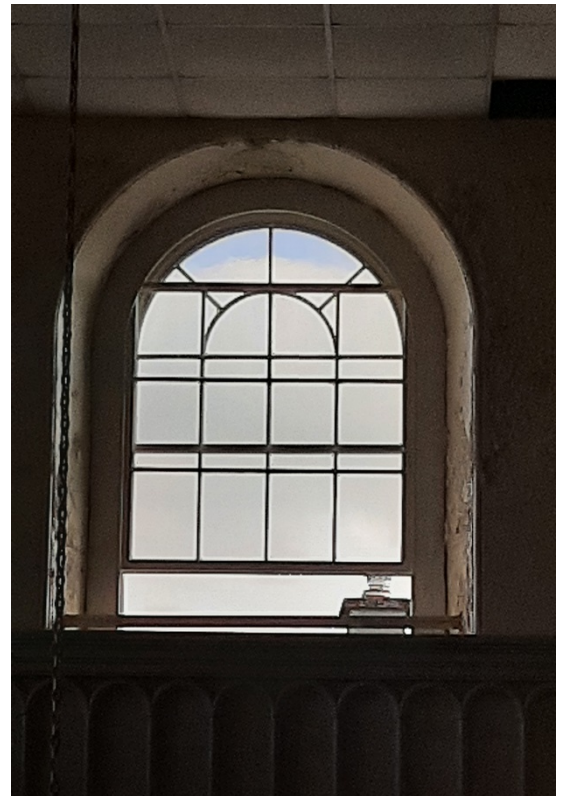
8/4 sash window and large courtroom sash – final coat of paint
