Proposed Fire Station for Ferbane

Architectural Impact Assessment Protected Structure at Ferbane, Co. Offaly

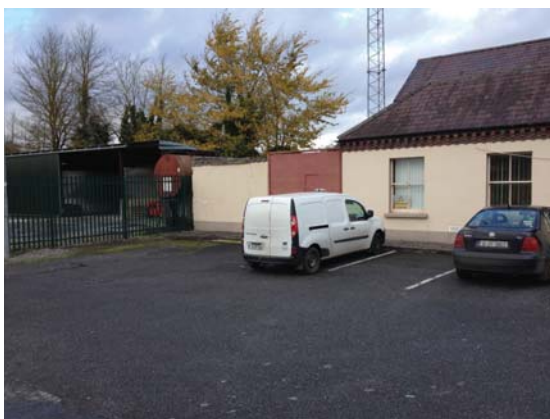
A small enclosed courtyard adjoins the building. It contains a shed. A ground floor window and first floor window overlook the yard. This yard cannot be accessed from within the building. It would appear that a doorway from the building into the courtyard was closed up in the past. The outline of the doorway can be seen in the render. Another opening that would have opened onto the platform is also blocked up. A large painted metal gate allows access to the courtyard from the car park. This courtyard area is not currently in use.

Adjoining courtyard with metal gate

It is proposed to demolish the courtyard and the shed within the courtyard completely. The slates from the shed are to be used to repair the main roof.

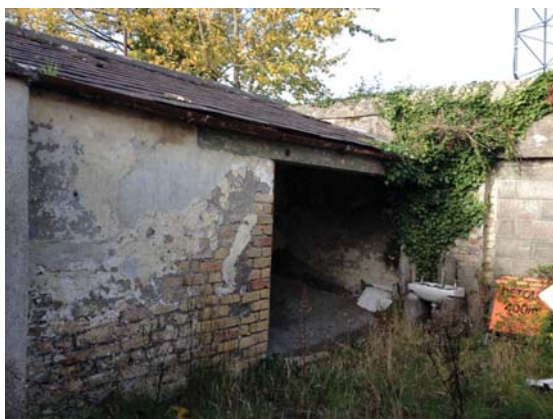
Adjoining courtyard with shed, mast to visible rear

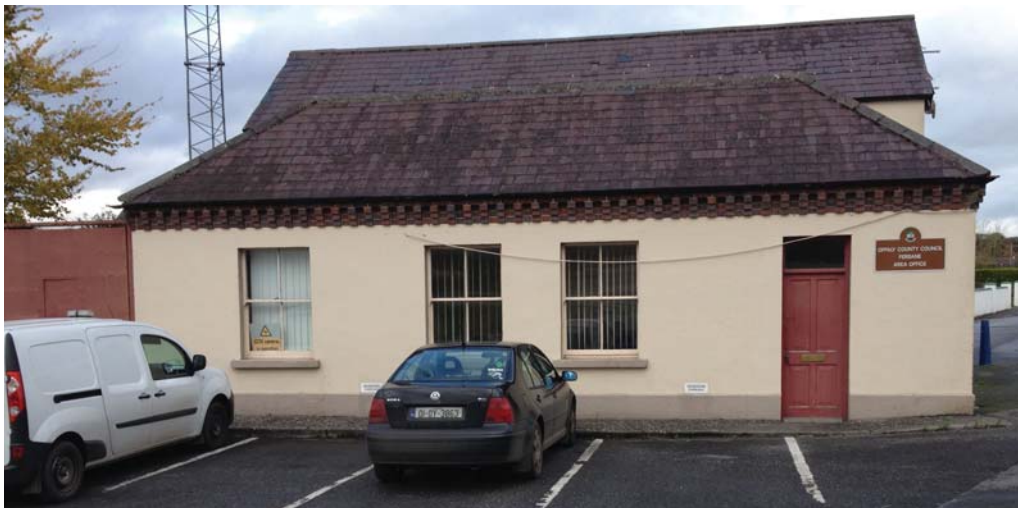
The railway track has been removed. The platform adjoining the building has also been removed. This area has been infilled and now accommodates car parking. Further to the rear of the site near the stone shed, a section of the platform remains in place, although in poor order. The current county council offices no longer exist in their original railway station context.

Elevation of building, which would have faced onto platform.

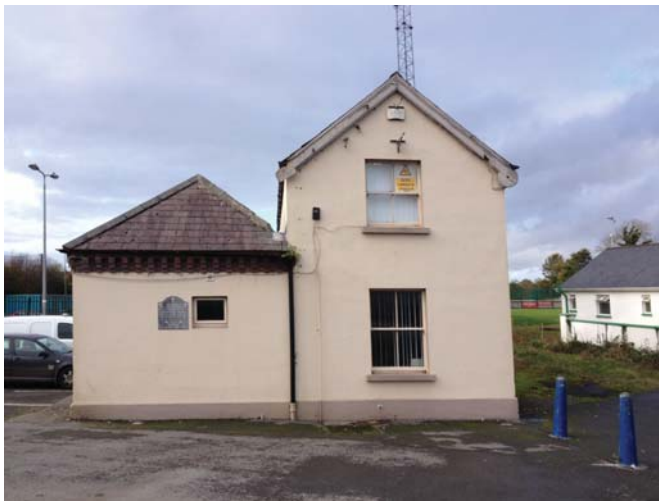
Street Elevation

The building comprises of a two storey section with a pitched natural slate roof and gable. This part of the building would originally ave faced onto the train platform. The single storey section has a hipped roof. There is a lead valley between the hipped roof and the wall of the two storey section. The gable of the building faces onto the public road. On the gable are attractive timber fascias with a decorative circle at the end. This fascia is rotten and one of the circles is damaged. There are no doors on this elevation.

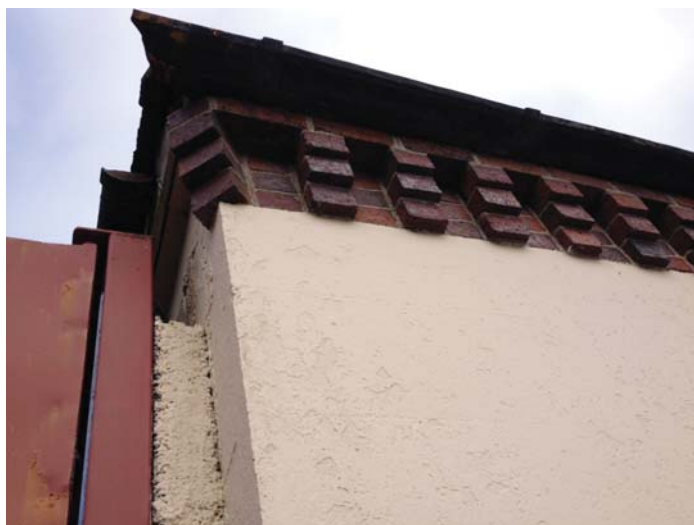
The brick eaves-cornice includes a beautiful stepped detail. These bricks are brownish purple in colour. The brick detail is only on two sides of the single storey section and does not continue onto the courtyard elevation.

brick detail

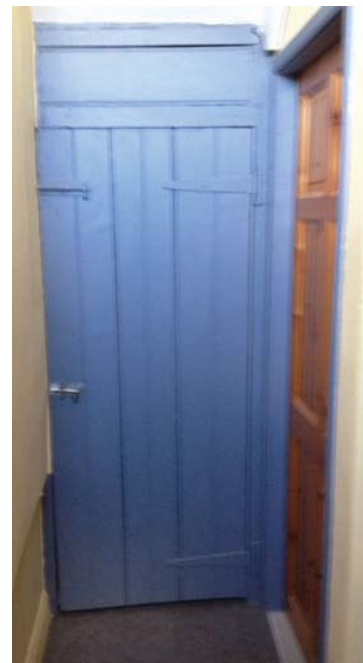
Door 3 & 2 (to side)

Doors 3, 6, 8 & 9 are original

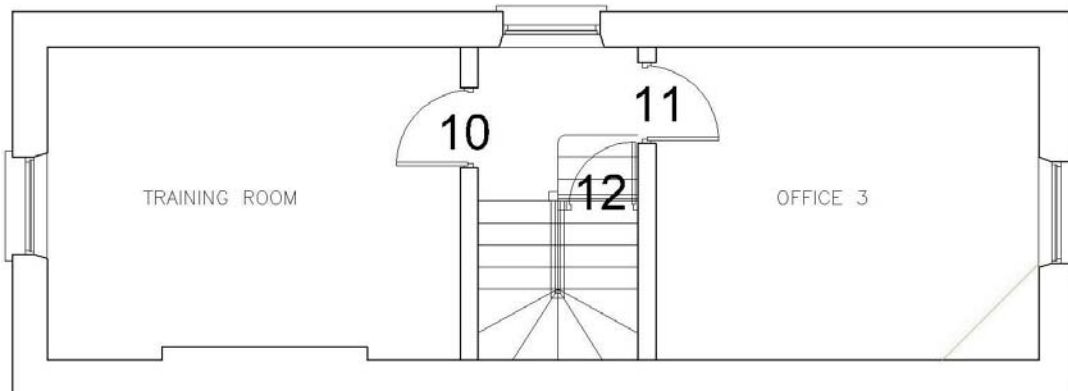
First floor plan.

Doors 10 & 11 are original
