ELEVEN FOLLIES IN COUNTY OFFALY

CONDITION SURVEY & MEASURED DRAWINGS

October 2013

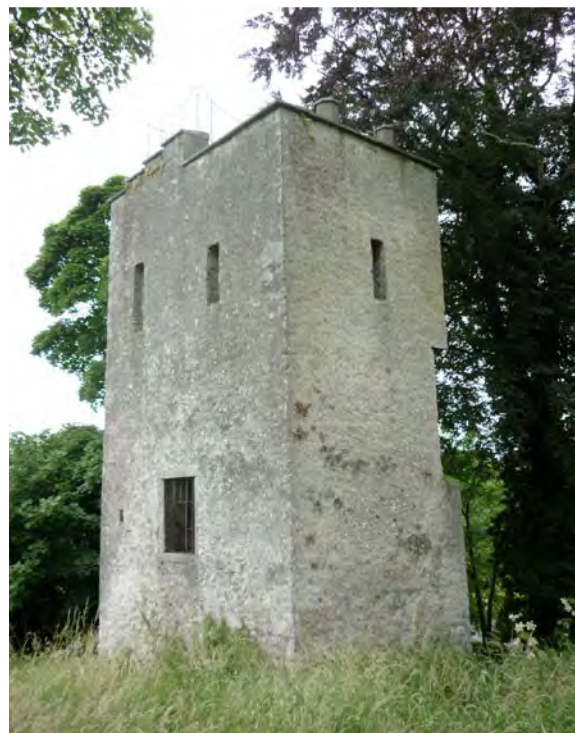
1. View of south east elevation from town park
2. North east elevation of folly.
3. Unusual detail at corner.
4. View of parapet with stone copings, chimney pots and remains of a handrail.
5. Scar of the former staircase to the south west elevation.

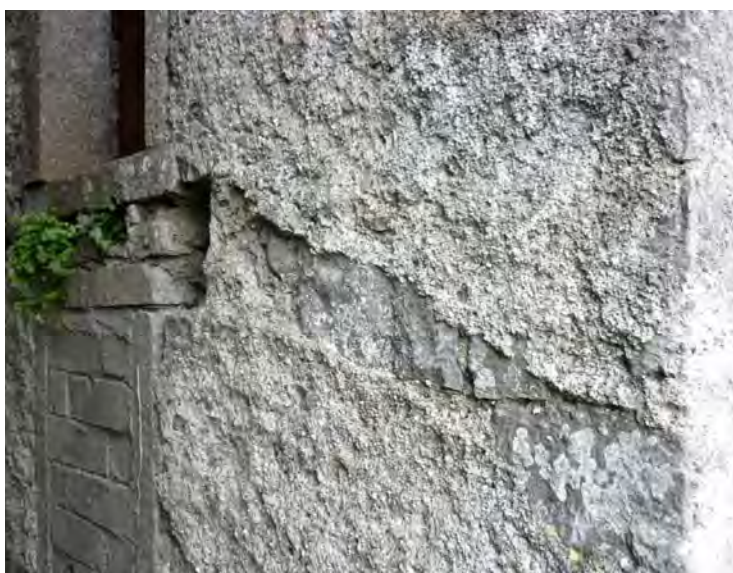
The structure is completely derelict with the roof and roof terrace now entirely gone and only some rotten floor joists remaining from the original first floor. Similarly the timber staircase has been removed in its entirety leaving only an imprint in the plaster as to its former presence. Most of the internal cross wall, which like the floor vault was constructed of brick, has fallen and all of the original door and windows and chimney pieces are now missing. The original entrance door and window to the undercroft have been in-filled with concrete blocks. Despite this advanced state of dereliction the structure is relatively sound and appears to be at rest. This is partly due to the excellent limestone copings that will have protected the wall heads. However, these have only been viewed from the ground using binoculars and should be inspected at close quarters to ensure that they are not loose and at risk of falling. A similar inspection should be made of all the window surround and structural heads, the railings and chimney pots, together with the fragmented cross wall, brick vaulted

1. Carry out a high level inspection, using a cherry picker, of all wall heads and interior of the structure with an experienced stone mason in attendance.
2. Take down or consolidate any loose masonry, plaster or rotten timbers.
3. Clear out all debris from ground floor and undercroft.
4. Unblock door and window in southwest elevation and make good reveals.
5. Install metal grilles in three openings in ground floor and undercroft.
6. Consider installing internal metal staircase, guard rails and decking to first floor and roof levels to restore rooftop viewing gallery.
7. Thin back some of the mature surrounding trees to improve views to and from the structure.

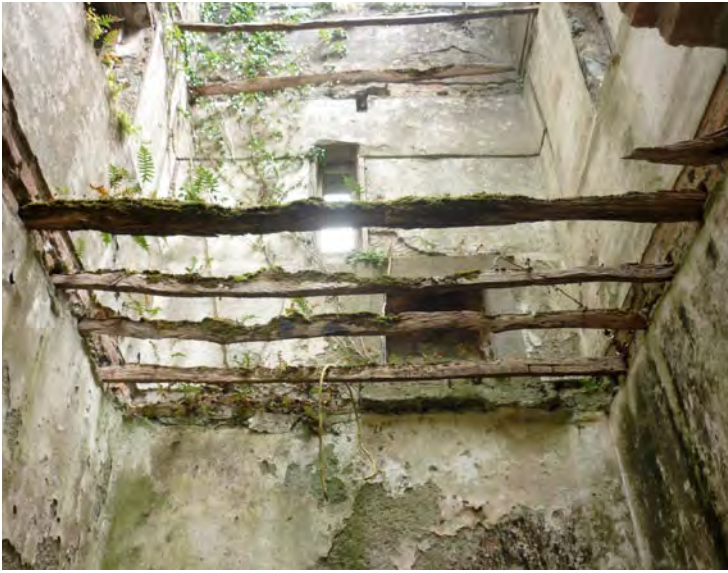
1. Internal view of remains of first floor.
2. scar of staircase in north west corner.
3. Former opening for fireplace.
4. Remains of former cross wall.
5. Vaulted basement.

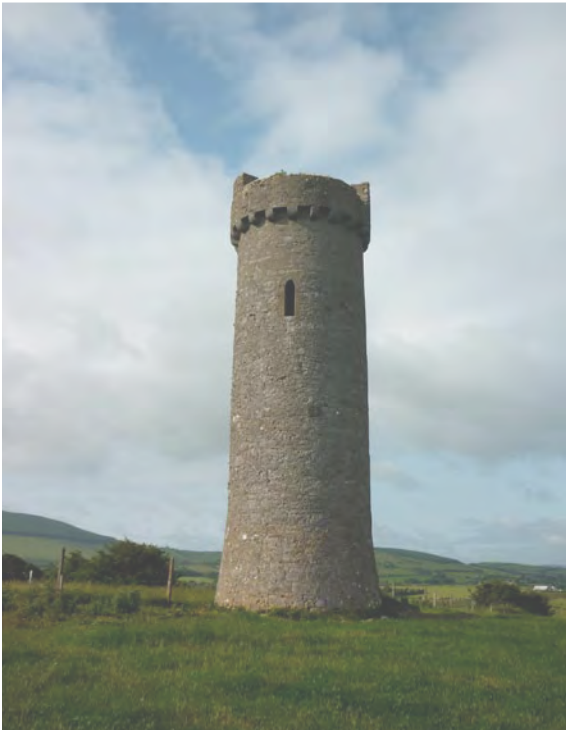
1. View of tower from Busherstown house.
2. West facing elevation of the tower.
3. North facing elevation of the tower.
4. South east elevation of the tower.
5. Detail view of the parapet of the tower with missing battlements.

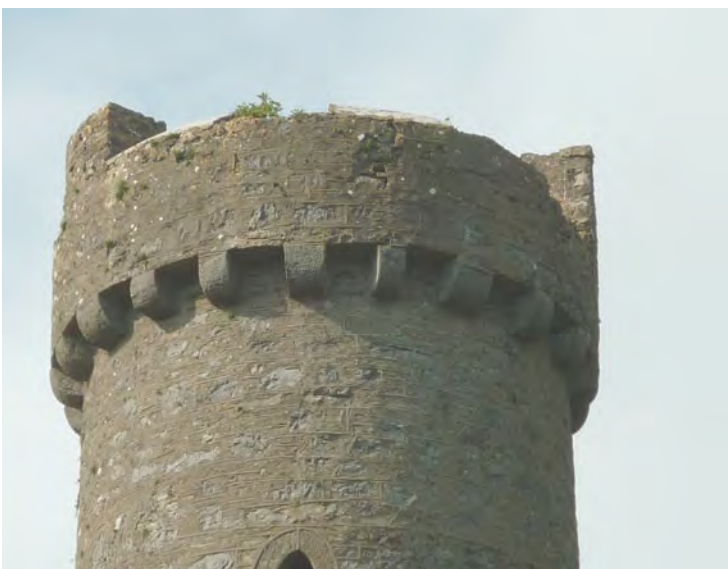
The condition of the tower is generally good with the exception of two of the battlements on the north side of the parapet, which have fallen or been pushed over. There are a number of small holes and a few limited areas of masonry that are severely weathered, which would benefit from pinning and pointing. Much of the upper levels have been cement pointed, which is unsightly but for the moment not causing any significant damage. The makeshift metal gate is unsightly and the light chain and lock used to close it are far from secure. Leading up to the entrance door was a flight of stone steps that have been dislodged, probably by cattle. The greatest structural damage is to the internal cast iron staircase, many of the treads of which have been broken, most likely as a result of vandalism, or removed deliberately as in Belview, Kilclare. This is not only a great loss of an important early cast iron, highly decorative staircase, but denies access to what would have been one of the finest vantage points in Offaly.

1. Carry out a high level inspection, using a cherry picker, of all wall heads with an experienced stonemason in attendance.
2. Take down or consolidate any loose masonry to wall heads and flaunch in sand and lime to weather.
3. Clear out all debris from the interior of the tower – set aside the iron fragments of the staircase.
4. Spray any plant growth on the structure with approved biocide.
5. Pin and point holes and minor areas of weathered masonry.
6. Repair the original stone steps leading up to entrance door.
7. Install a secure metal gate to the entrance door.
8. Consider restoring cast iron staircase and guardrails to restore rooftop viewing point.
9. If funds were ever available the cement pointing should be removed and the masonry repointed using sand and lime.
(The latter two items are highly desirable but relative expensive to undertake.)

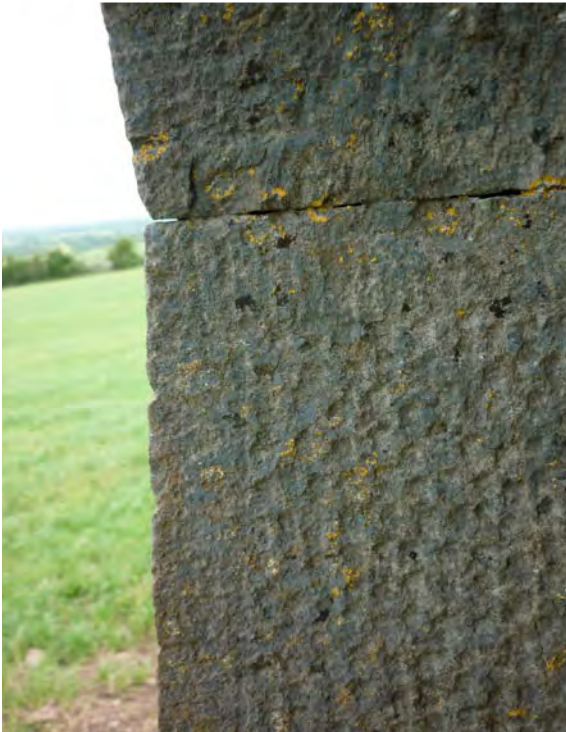
1. The makeshift unsightly metal gate to the entrance.
2. General view of the internal cast iron staircase showing damage.
3. Detail of dressed limestone enrichments forming door jamb.
4. Detail of the cast iron stair treads.
5. Detail of area of loose masonry.

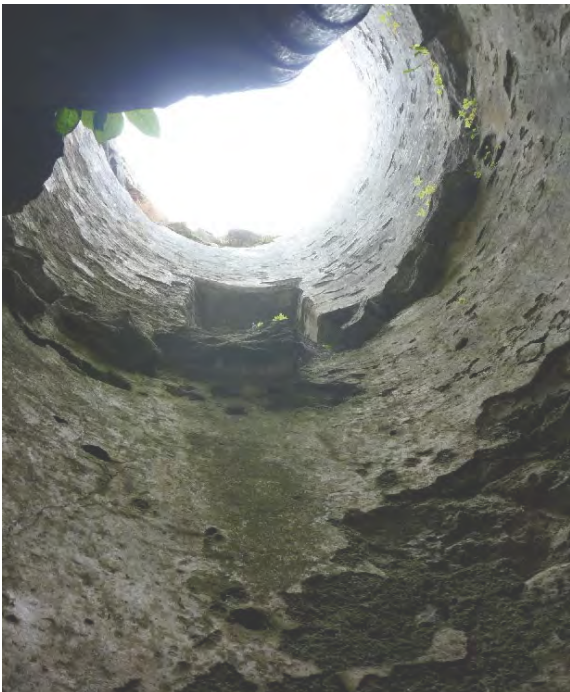
With the exception of the internal staircase and the wall heads, the structure survives in a sound condition with very little damage apparent. Sadly several treads have been sheared off and tumbled down the staircase. It appears that this was done to restrict access to the top of the structure, which may have been considered a health and safety risk.

1. View of the south elevation of the tower above the treeline.
2. Detail of the ground floor of the tower filled with debris.
3. View of the upper levels inside the tower with missing stone stair treads.
4. Detail of the remaining stone stair at lower level.
5. Detail of small window to the upper level.

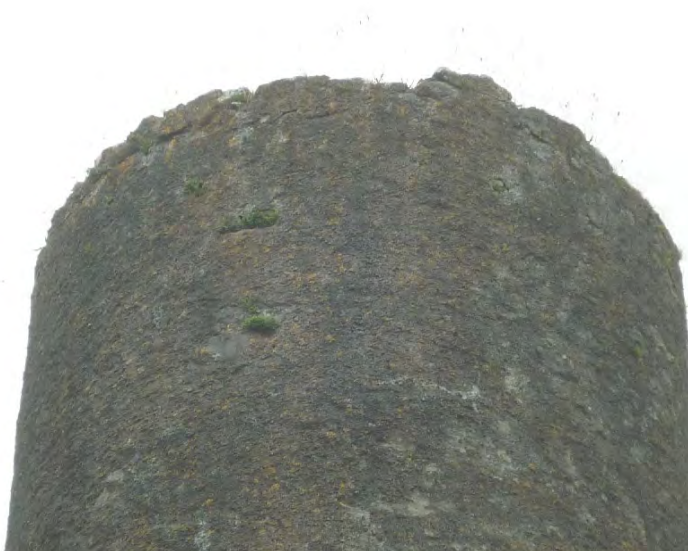
1. View of the tower just visible above the treeline.
2. View of the north facing elevation.
3. General view of single Gothic doorway with tooled limestone surrounds.
4. Detail of plaque AD 1817 carved in a delicate Roman font.
5. Detail view of the weathered wall heads.

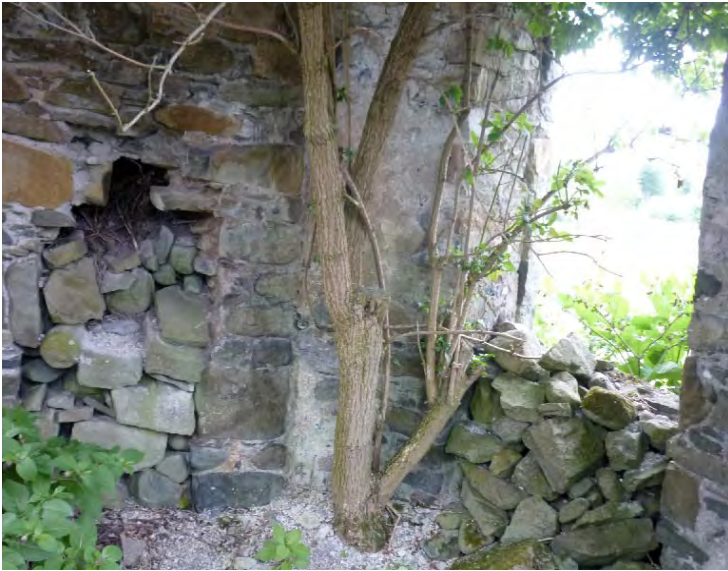
1. General view of gazebo on artificial mound from Ballycumber House.
2. Detail of one of the flying buttresses.
3. View of the entrance door which faces eastwards towards the river.
4. General view of the entrance.
5. Detail of the rubble stone walls with cut stone dressings.

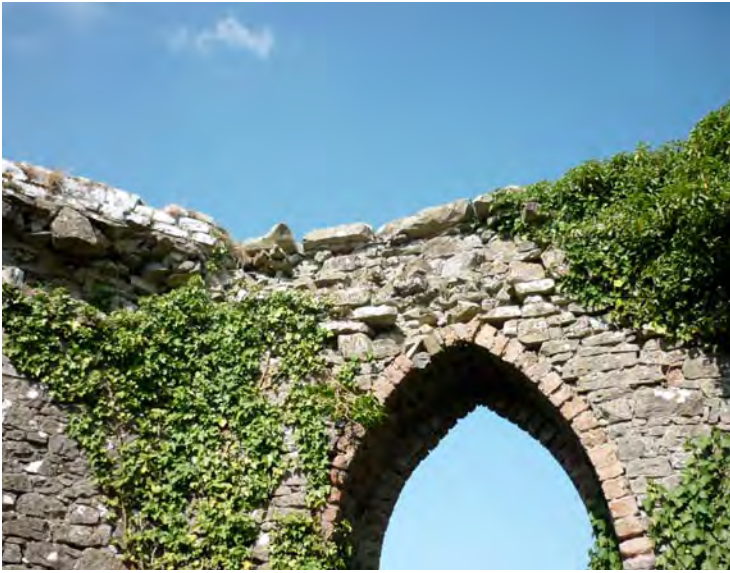
1. View from north showing gazebo on former tower house.
2. South facing elevation, from terrace showing heavy covering with ivy.
3. West facing elevation.
4. The lower opening to the building facing fields.
5. Detail of the vaulting on the tower house.

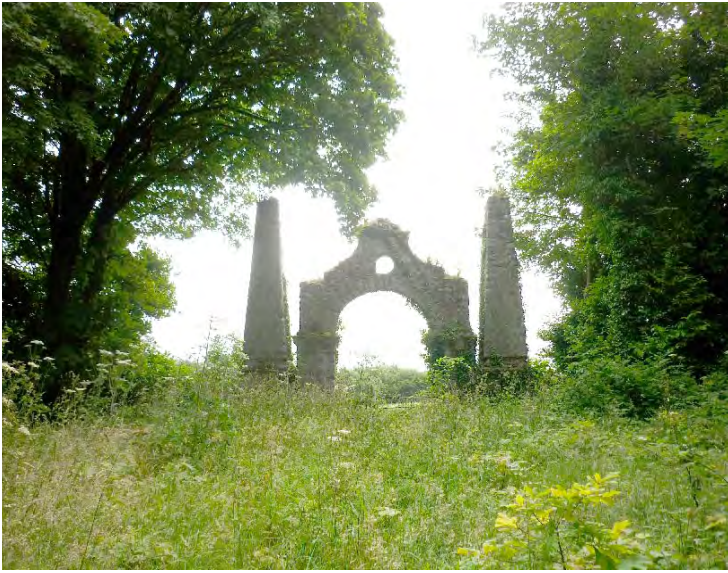
1. Silhouette of arch looking from Gloster House.
2. Partial view of the archway and obelisk with its thick covering of ivy.
3. The pyramidons capping the obelisk shafts have eroded, as has the crown of the arch and there are numerous areas of both rubble masonry and in the dressed stone courses, where the bed mortar has eroded significantly.
4. Detail showing squarish sandstone dressings at spring of arch.
5. Detail of the base of the rubble stone obelisks which have eroded significantly.

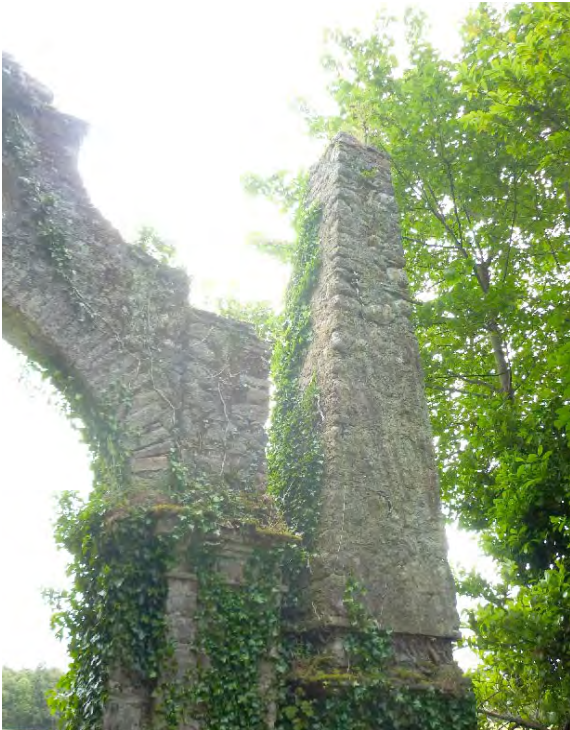
While the archway is largely intact it is currently in a very friable condition, with a thick covering of ivy from which adventitious roots have become deeply embedded in the masonry well above ground level. (This phenomenon can occur when the main growing stem is cut at ground level but the growth not removed higher up the plant causing new roots to tap horizontally into the masonry.) The pyramidons capping the obelisk shafts have eroded, as has the crown of the arch and there are numerous areas of both rubble masonry and in the dressed stone courses, where the bed mortar has eroded significantly. While the voussoirs of the stone arch appear to be at rest, some of the joints are eroded and if action is not taken promptly will become unstable and will collapse.

1. Spray ivy with approved herbicide and cut any primary roots. (Carry out this task only when masonry consolidation works are planned to begin.)
2. When ivy has died back carefully remove all ivy down to embedded roots.
3. Drill and poison all embedded roots.
4. Take down all loose masonry to wall heads and pyramidons and set aside for reuse – remove any embedded roots.
5. Rebuild wall head, pyramidons, top of arch and flaunch with sand and lime.
6. Consolidate loose and missing areas of rubble masonry.
7. Rake out and point any open joints and allow for inserting slate wedges in voussoirs of the arch.
8. Spray any plant growth in immediate vicinity to create sterile zone immediately around the base of the structure.

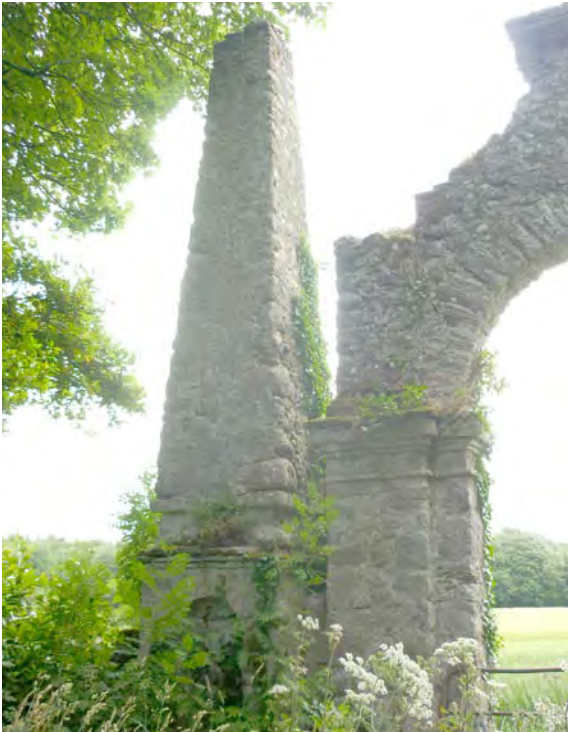
1. View of a Baroque crown with an elliptical opening from the east.
2. Detail showing the ivy growth.
3. View of the north west facing rubble stone obelisks.
4. Detail showing the base of the niche.
5. Detail of the base of the rubble stone plinth which has eroded significantly.

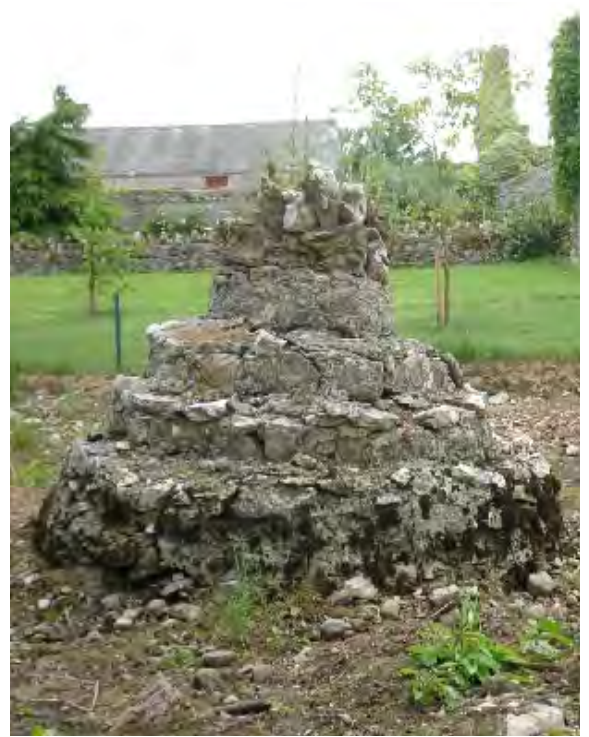
1. View of the zigurats looking north towards Hollow House.
2. Detail view of the north zigurat.
3. Detail view of the east zigurat.
4. Detail view of the rubble limestone construction which has eroded significantly.
5. Detail view of the crown of the north zigurat with plant growth.

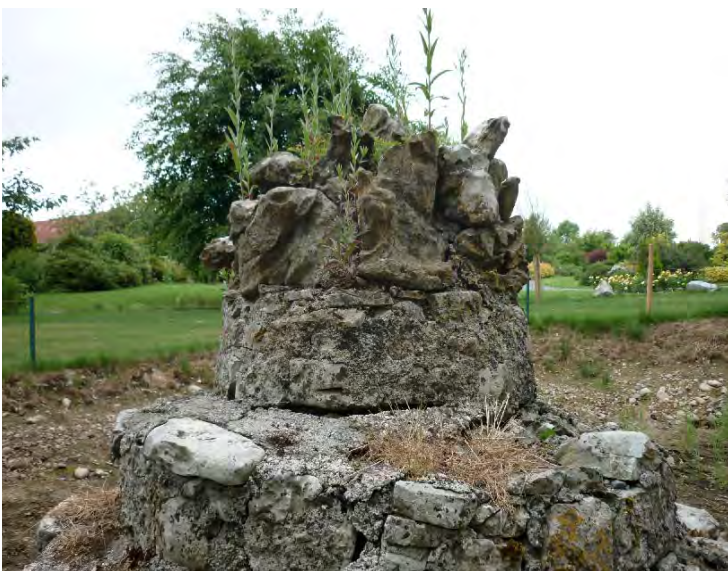
4.

Both structures are in a very poor state of repair, with much disturbed and loose masonry. The structural deterioration has been accelerated by cement rich pointing and repairs that have been carried out previously, most of which have failed. There are some holes in the face of the pointing which reveal that much of the mortar in the core has been washed out over time. There are some vertical cracks in the upper sections of both structures that suggests the footings or bearing strata has been disturbed in some way, which is not surprising as the foundations of the structures are under water for much of the year.

1. Remove all sand and cement pointing, consolidate any loose masonry, re-point and flaunch in sand and lime to weather.
2. Fill interior of structure with sand and lime grout.
3. Spray any plant growth on the structure with approved biocide.

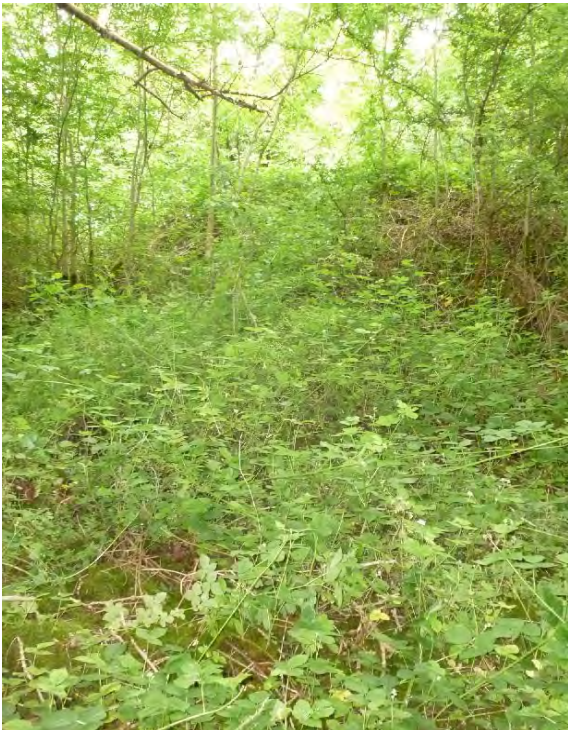
1. General view of setting it is a dense thicket of trees and is heavily overgrown with briars, nettles and saplings
2. View of one of the mature ash trees which surround the structure.
3. View from bottom of mound.
4. Detail of the fallen rubble stonework construction.
5. Apex of the mound with loose stonework.

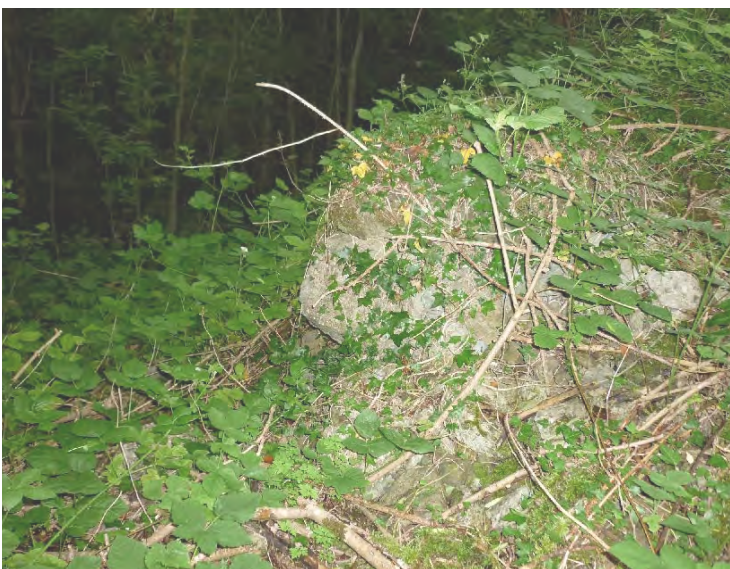
4.

The condition is hard to judge as the original form remains unclear. Clearing all vegetation off the mound will no doubt reveal considerably more information and may reveal the original form and constructional method. There are areas of small sized rubble stone and large isolated stones lying in the undergrowth near the base of the structure, which suggests it has been vandalised at some point in its past.

1. Remove all plant growth from on top of mound and from around the base of the structure out to the ring of ash trees.
2. Sort and grade any loose masonry that comes to light during the clearing and set aside for possible reuse.
3. Spray the structure with an approved biocide.

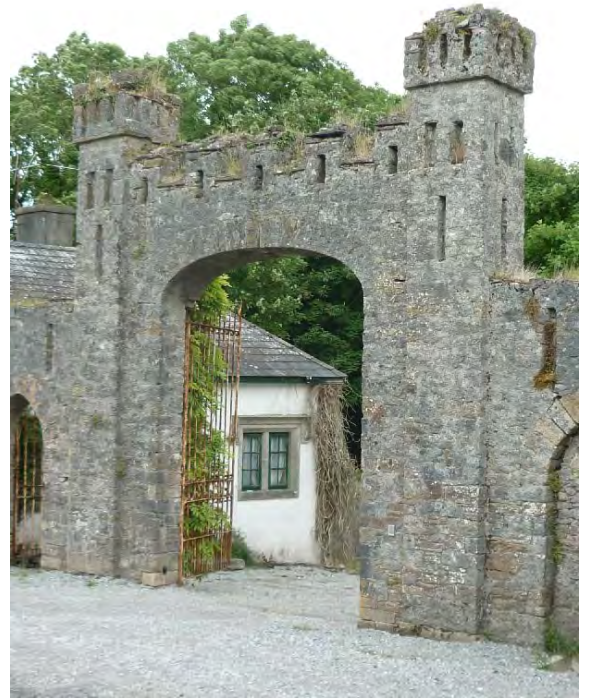
1. View of the front elevation of the gateway.
2. Detail view through main entrance archway with iron gate visible.
3. View of the side archway.
4. Detail of battlements.
5. View of the gateway and flanking walls.

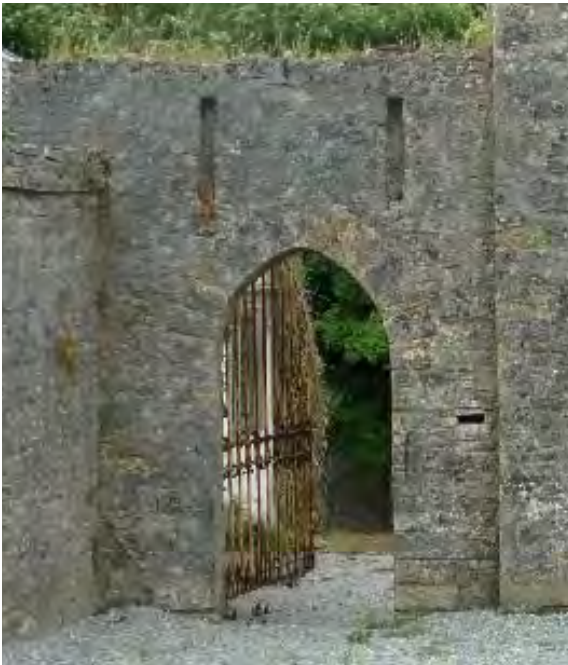
The structure is generally in a reasonable state of repair with only minor repair and re-pointing necessary, together with the removal of some minor plant growth. In the voussoirs of the wide central arch and the blind arch to one side, the joints are opening and should be repaired to avoid more serious damage occurring. The gates are rusty and need of preparing and painting.

1. Consolidate any loose masonry, re-point and flush in sand and lime to weather.
2. Wedge open joints of voussoirs of central arch and arch to blind doorway with slate and re-point.
3. De-rust and paint gates.
4. Spray any plant growth on the structure with approved biocide.

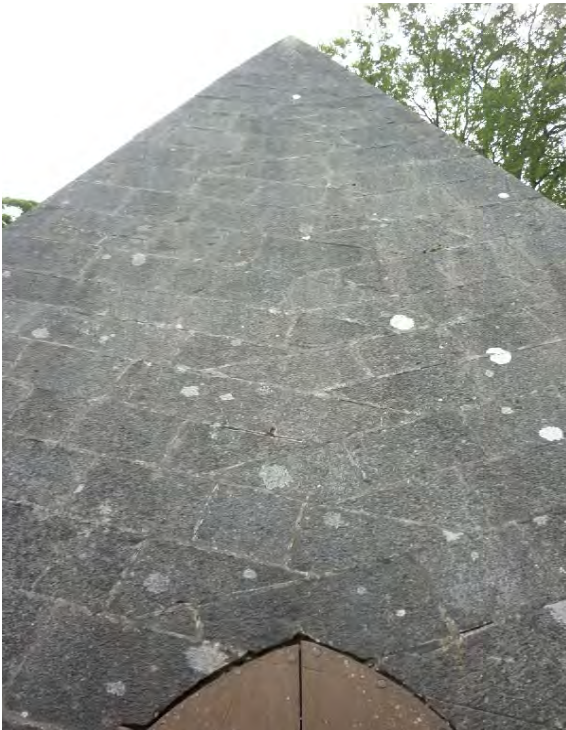
The pyramid/mausoleum is in a very good state of preservation and a more than reasonable state of repair. Some cement rich re-pointing has been carried out in the past, but this is unsightly rather than damaging. There is a little loose masonry at low level to the right of the entrance doorways to the vault, which would benefit from consolidation.

1. General view of the approach to the mausoleum.
2. View of the south west elevation.
3. Detail of the pointing.
4. View of the steps to the north east of the entrance.
5. Detail to the corner of the mausoleum.

1. Remove cement pointing and re-point in sand and lime.
2. Consolidate rubble masonry at base of north-facing entrance face of the pyramid and re-point.
