# Independent Tree Surveys Ltd

## Tree Survey Report Cloghan Active Travel Scheme Hill Street Cloghan Co. Offaly

November 2023

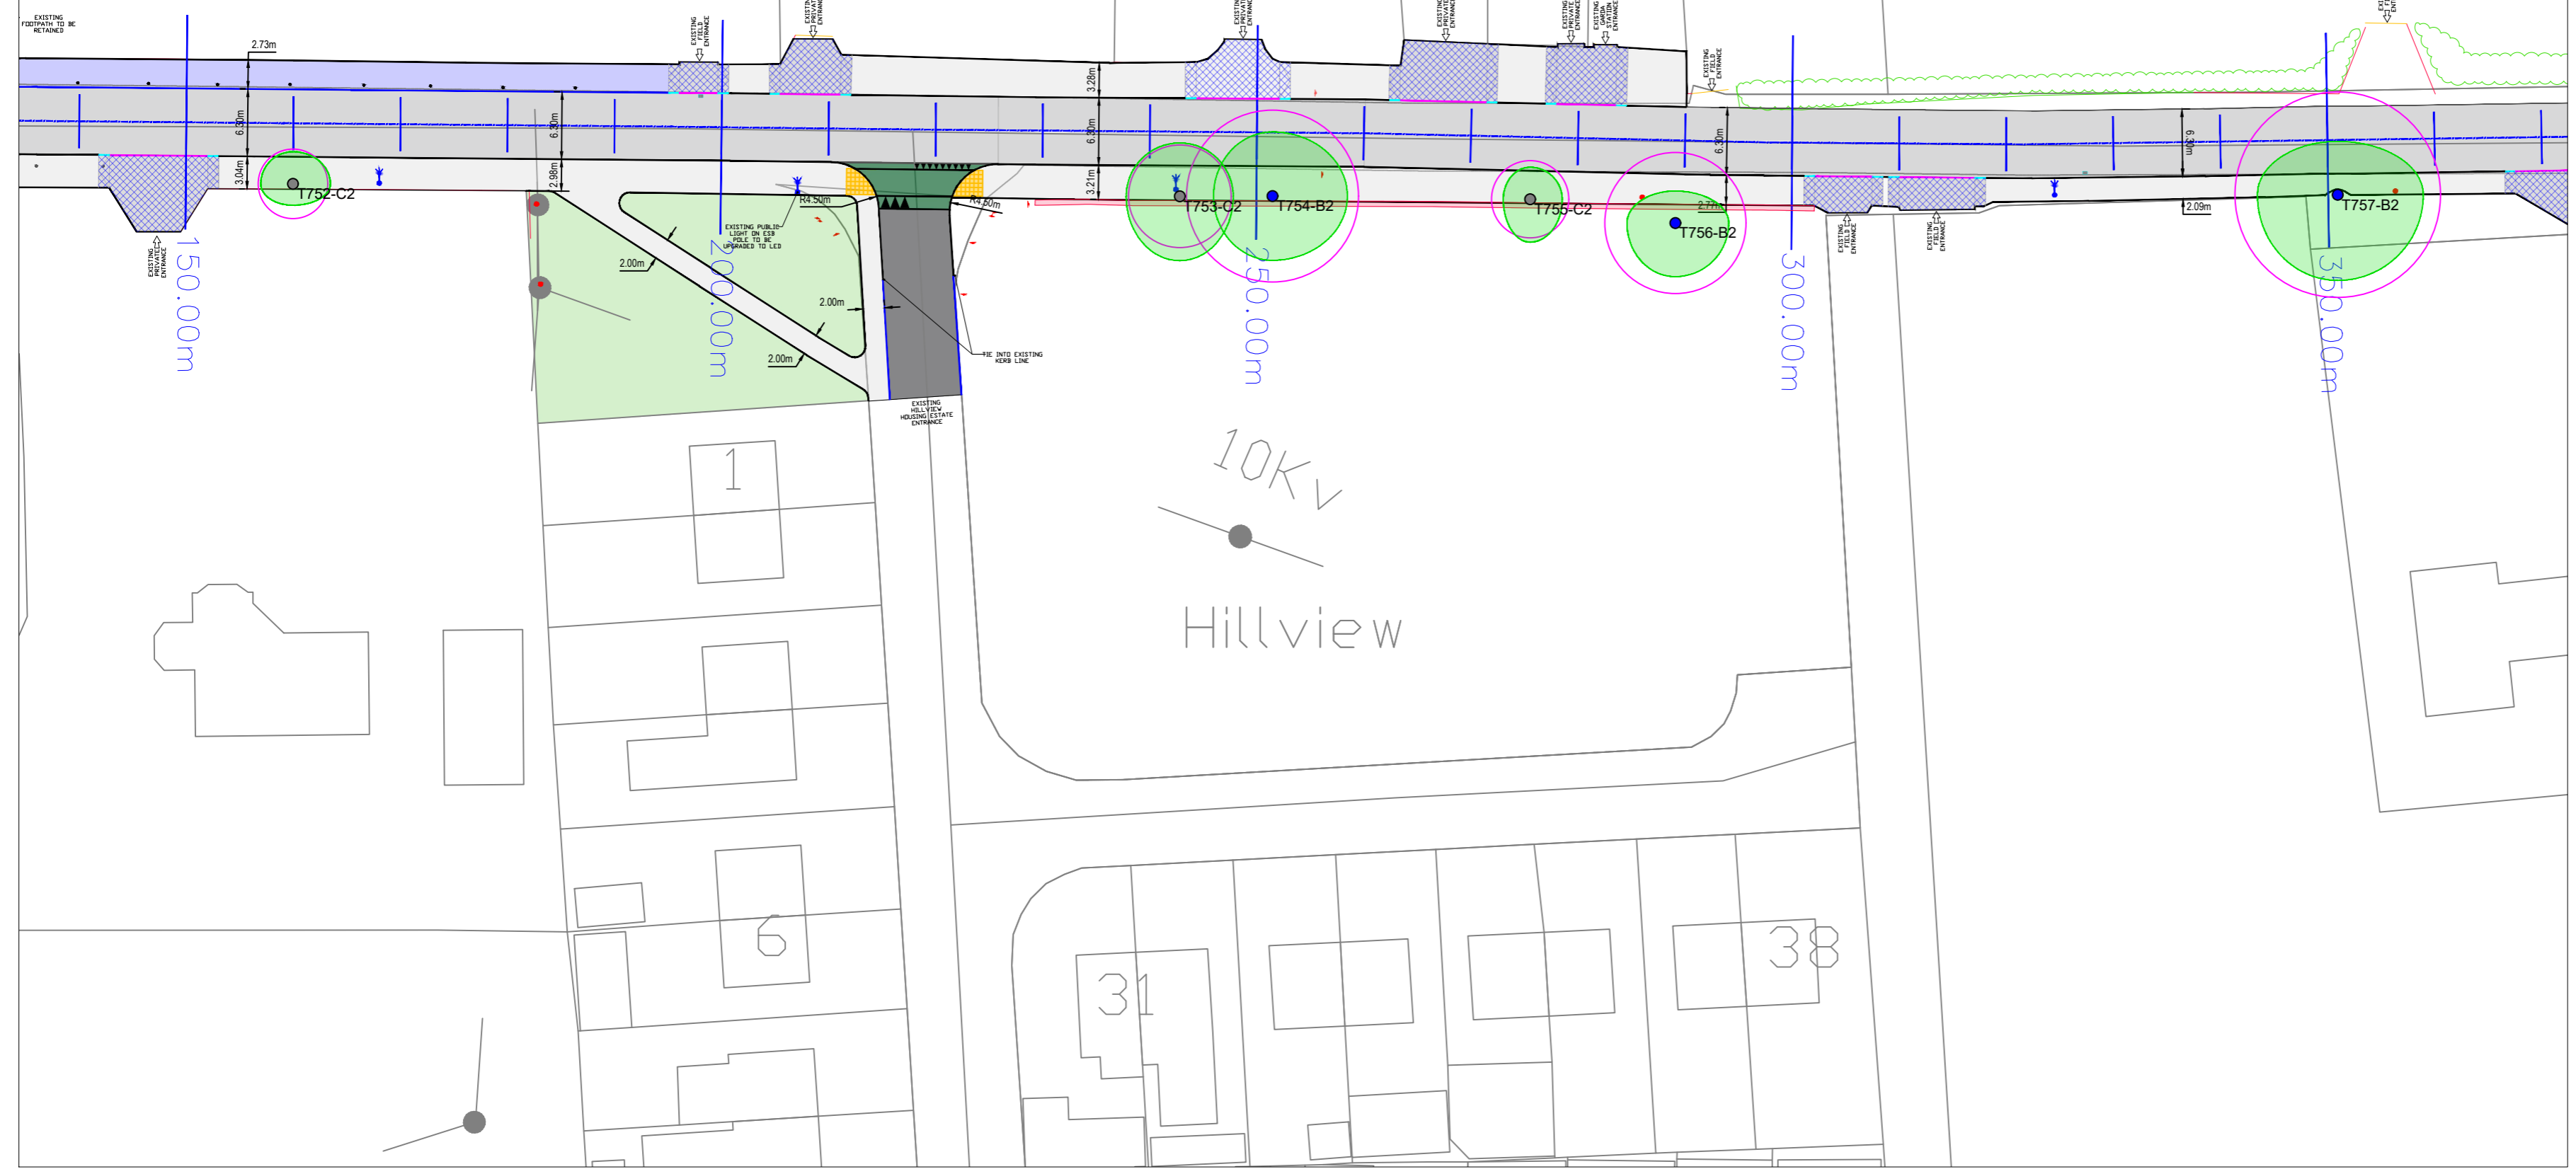
Type	No.	Species	Age	Ht m	Dbh mm	St	Cr	N	S	E	W	ERC	Phys Cond	Structural Condition/Comments	Preliminary Recommendations	RPA m	Cat
T	752	Acer platanoides (Norway Maple)	SM	8	270	1	2.5	3	3.5	2	3	10	Fair	Fair. Small tree that was planted into tarmac footpath, very close to the masonry wall and directly below overhead ESB wires. Tree is of poor shape & form, having been crudely cut back during ESB line clearance works, which will have to be repeated as it grows back. Low amenity value and limited potential to grow into maturity.	Prune tree clear of ESB wires. Consider removal as part of good long-term management.	3.24	C2
T	753	Fraxinus excelsior (Ash)	EM	10.5	400	1	2.5	5	5	6	5	10	Poor	Fair. Medium sized tree growing very close to low retaining stone wall, seemingly causing significant damage to the masonry. Poor shape & form as a result of being 'topped' and disfigured by ESB line clearance works. Branches restricting street light. Epicormic shoots on branching throughout crown indicative of infection by Ash dieback disease (ADB). Tree growth is causing significant damage and distortion of footpath surfacing.	Monitor tree condition to track progress of ADB disease; fell tree if condition deteriorates significantly. Prune branching clear of ESB wires. Consider removal as part of good medium-term management.	4.8	C2

T	754	Acer platanoides (Norway Maple)	M	16	670	1	2.5	6	7	6	5.5	20+	Good	Fair. Medium sized tree. Tree crown develops from 2.5m as the main stem forks into 4 upright scaffolds. Some central branching has been cut in the past to allow the passage of the overhead ESB cables through the tree. Woody roots and the root flare of the tree are causing significant lifting and distortion of the tarmac surfacing of the footpath. There is also some cracking of the adjacent stone wall that seems likely to have been caused by the growth of the tree.	Prune branching clear of ESB wires. Explore options to resurface or re-align footpath. If footpath space is restricted and/or the rise in levels required for new surfacing is not practicable, the tree may have to be removed.	8.04	B2
T	755	Betula pendula (Silver Birch)	EM	8.5	300	1	1.5	3	3	4	2.5	10+	Fair	Fair. Smaller sized tree planted very close to the low masonry wall. Previously topped during poor quality pruning works in past resulting in poor shape & form. Roots lifting adjacent tarmac paving, but are not distorting the surface severely yet. Some light branching close to ESB cables.	Prune tree branches clear of ESB wires. Consider removal as part of good long-term management.	3.6	C2

T	756	Acer pseudoplatanus (Sycamore)	EM	14	550	1	2.5	3	5	5	4.5	20+	Good	Fair. Medium sized tree growing in park to the south of the footpath. Epicormic growth on stem and some suckers around stem base. Some light branching close to ESB cables.	Prune tree branches clear of ESB wires.	6.6	B2
T	757	Acer pseudoplatanus (Sycamore)	M	13.5	800	1	3	5	8	8	7.5	20+	Good	Fair. Larger tree growing in garden just behind the stone boundary wall; this curved wall has been built around the lower stem of the tree, with some cracking and bulging of the masonry probably caused by the growth of the tree now evident. Somewhat unbalanced crown shape. Some branch stubs left from previous poor quality pruning works.	Target prune branch stubs and crown lift to improve clearance over the road. Consider removing short the section of curved stonewall and re-building it with a gap between wall and tree stem or replacing it with an iron fence.	9.6	B2
