Birr Courthouse

HSF Grant Scheme 2021: Final Report

October 2021

This report was produced for Offaly County Council by Howley Hayes Cooney Architecture in October 2021 to determine the extent of repairs carried out at the Birr Courthouse for the Historic Structures Fund 2021. The overall project at this building is also part funded by the Heritage Council.

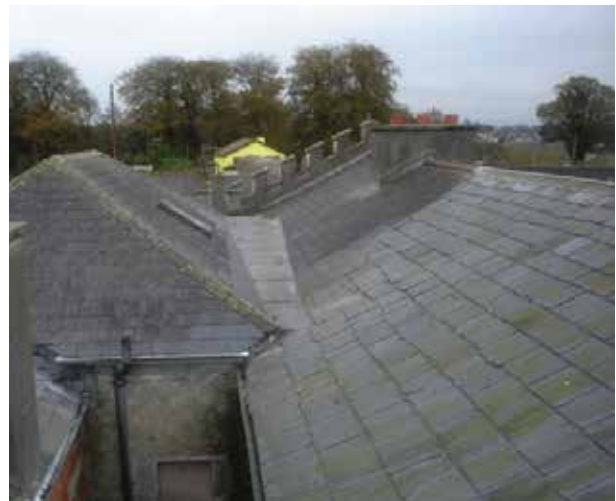
Roof of prison range on right with mix of natural and fibre cement slates. Entrance range roof fully slated in fibre cement slates

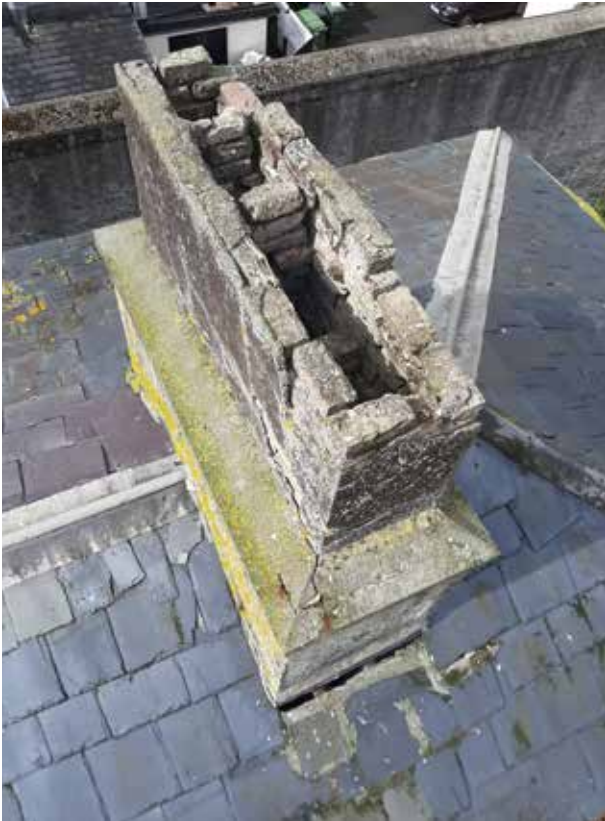
View of the chimney on the west end of the south range roof

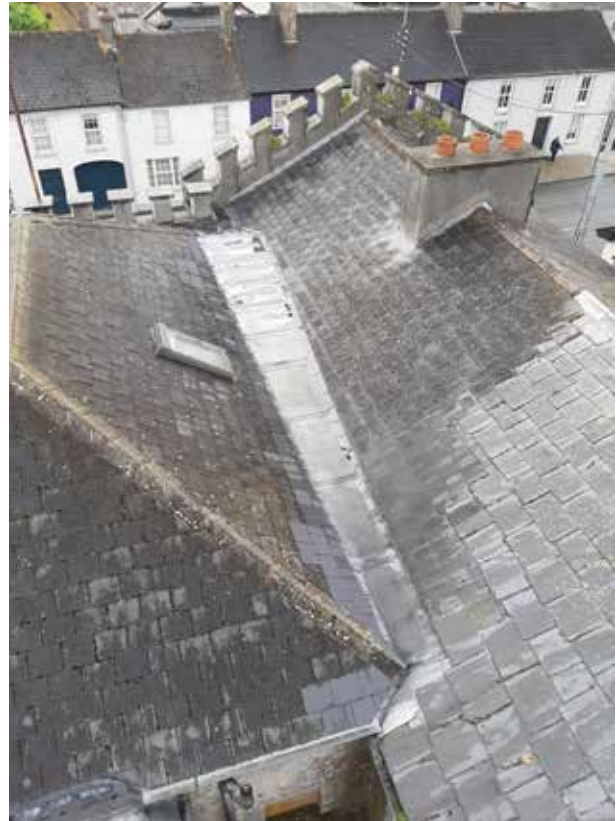
View of the leadwork valley between the south range and central range

The existing valley gutters were a 20th century failing addition and are not considered to be of historic value. They were not installed correctly, laid to shallow falls with shallow steps. They were removed and the timber boarding beneath was fully inspected and replaced where necessary with 18mm marine ply. New code 6 leadwork valleys were installed throughout detailed in full accordance with the Lead Development Association guidelines by experienced an experienced heritage contractor. The eaves level fibre cement slates running along the valley will were removed and replaced during this process. The lead & copper works were carried out in full accordance with all guidelines.

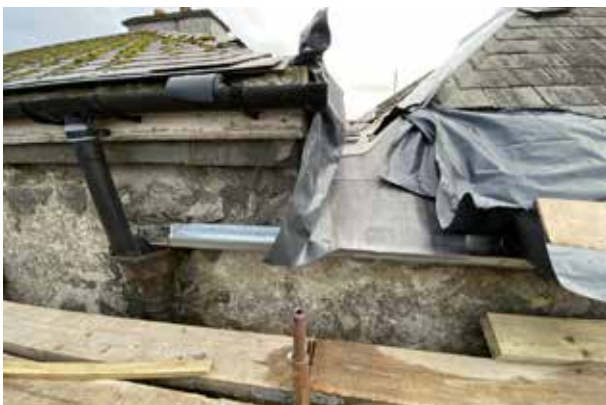
Lead Valley / Gutters 3&4 - Before works were carried out.

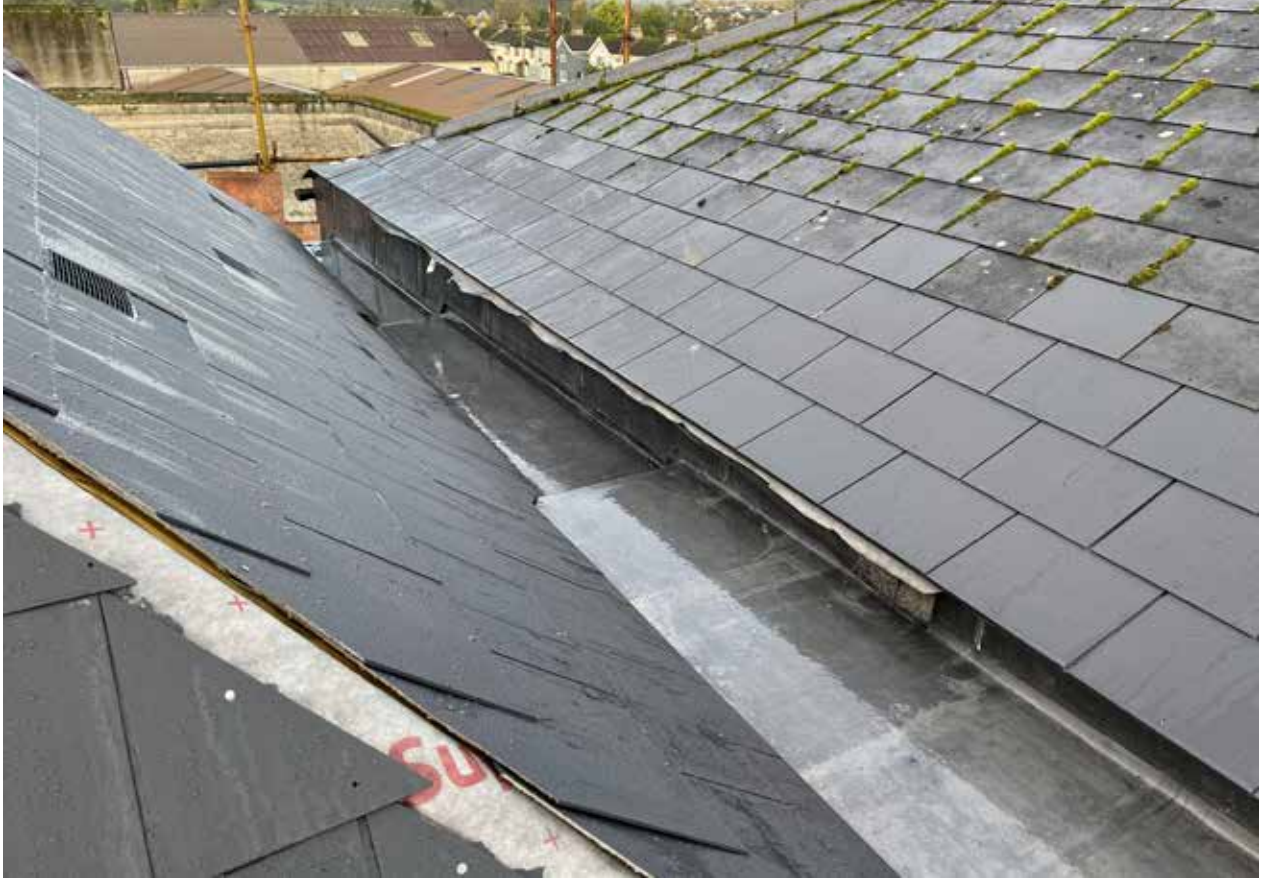
Lead Valley / Gutters 3&4 - Upon completion of the works.
