Daingean Courthouse

Daingean, Co. Offaly

Conservation Masterplan

December 2024

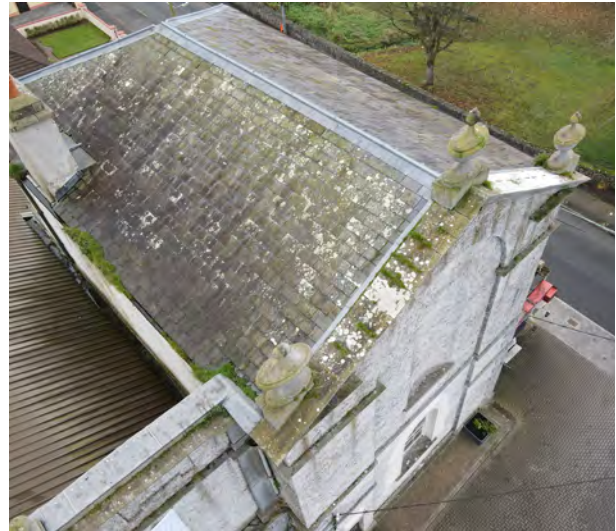
Figure 21 - View of the south range roof.

The north range roof is pitched with the ridge line running from east to west with a hipped end section on the east and a masonry parapet wall upstand on the west. As noted above, extensive repair works were carried out to this roof previously including a natural slate covering, lead ridge / hip rolls and structural roof timber repairs. Other than a slipped slate on the northern pitch, which needs to be refixed, the roof appears to be in good condition.

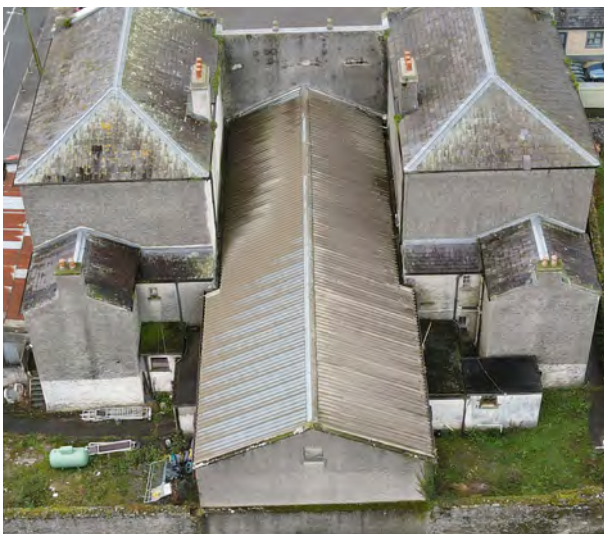
Figure 24 - View of the rear of the courthouse.

There are four flat roof areas, to the eastern ends of the north and south ranges, which are more recent additions to the building that cover the male and female WCs and storeroom. These roofs are a mixture of constructions including flat concrete slab and bituminous felt which were not repaired as part of the previously completed works. On initial inspection the roofs appear to be in a reasonable condition but nevertheless we would recommend a close inspection be carried out at roof level and a regular maintenance routine. There are no rainwater goods to any of these lower roofs, which has resulted in water sitting on roof tops or dripping onto wall faces, causing dampness and extensive organic growth, which needs to be treated and removed.

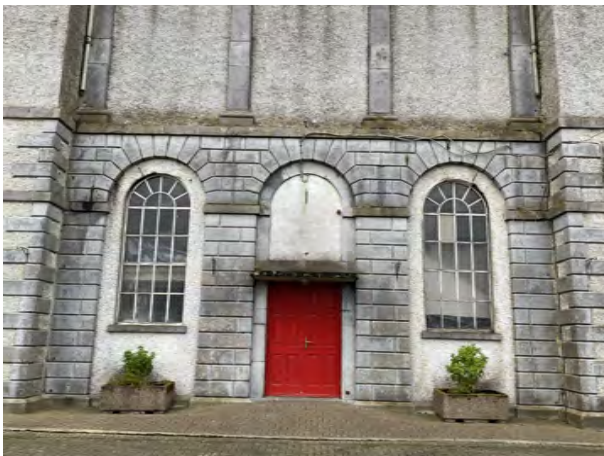
Figure 28 - View of the front entrance.

There is one main set of double entrance doors to the central bay of the screen wall; the two ancillary doors to each end bay are later additions, although it is noted that the door into the southern range does appear in historic photographs. The main entrance doors consist of a pair of painted pine six panel doors under a concrete canopy constructed in the 1950s, which appear to be in a good state of repair. The adjacent doors, made from timber boarding are also in a good state of repair. Due to the changes of level between the external ground level and the internal floor level, granite slabs have been added to create stepped entrances.

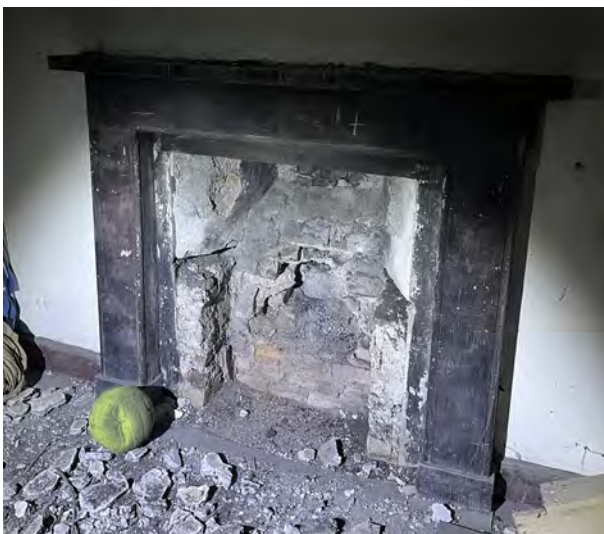
Figure 32 - View of a fireplace.

There are several fine original fireplaces remaining in the building. In the ground floor court anteroom there is a fire carved limestone

surround with cast iron insert which is missing its grate. Similarly in the judge's anteroom above there is a carved limestone surround, which has been painted black, the insert and grate are missing. In the schoolroom there remains a cast iron fireplace with original grate whilst the fireplace to the anteroom above the kitchen has been sealed up.

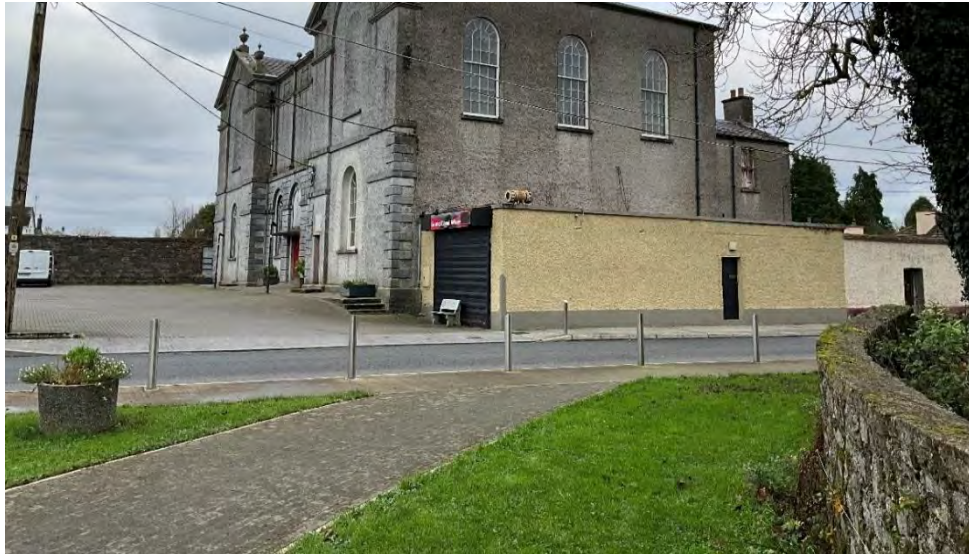
Daingean courthouse with large forecourt to front (west) and single storey cycle club building to south in foreground of photograph.

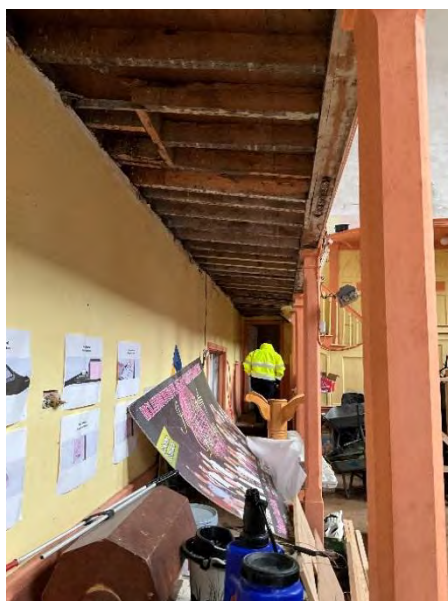
The southern wing contains a substantially intact courtroom within the full height void of the wing. The timber framed viewing gallery around this space is intact but has suffered considerable settlement at each of its supporting posts. There is a rear room at both ground floor and first floor with interconnections to the courtroom to allow private access for and robing of judges etc.

Below the courtroom in the south wing. Left detail of the underside of gallery showing extent of settlement of inboard columns

As mentioned previously there is considerable settlement of the inboard posts to the gallery in the south courtroom. This may be a result of a later iteration of court layout being inserted with out recourse to inserting new foundations under the posts. It is likely that most of the movement has now occurred and if the courtroom floor is to be retained then a method of scarfing in new timber to the posts and jacking up the balcony should be investigated.

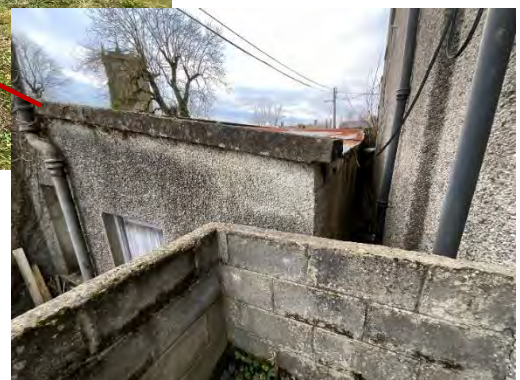
In the south wing there is much staining at high level to the north wall. This appears to be the effect of moisture movement through sooty chimney brickwork. There are also signs of water ingress to the front wall likely associated with the front elevation parapet.

The north wing is suffering water ingress in the reciprocal areas, i.e. to the south wall, again likely associated with the chimney location and perhaps deteriorated flashings to the up-roof slope side of the chimney and adjoining areas. There is also damp staining associated with the front parapet.

Both roof areas are likely to require structural repair to the roof timbers in these areas.

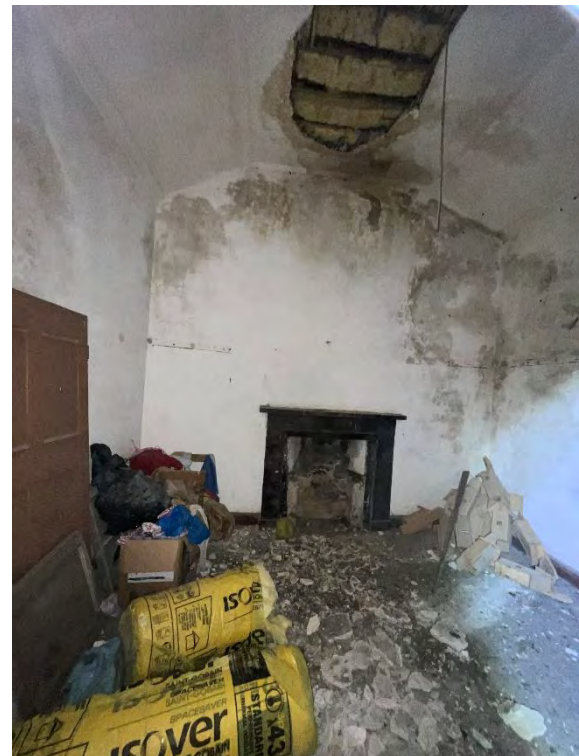
The areas to the rear of both court rooms are in poor order with both timber rot and furniture beetle infestation to much of the timber flooring – it should be assumed that entire new floors are required in both these areas.

The roofs should also be regarded as suspect over these areas.

*Rear return south wing,
first floor and underside of roof*

The existing rotten first floors to the rear returns will be replaced in their entirety. New floors will also generally be constructed in timber. The only exception is the reinforced concrete lid to the entrance area RC WC block - see Structural Scheme Drawings Appendix B.

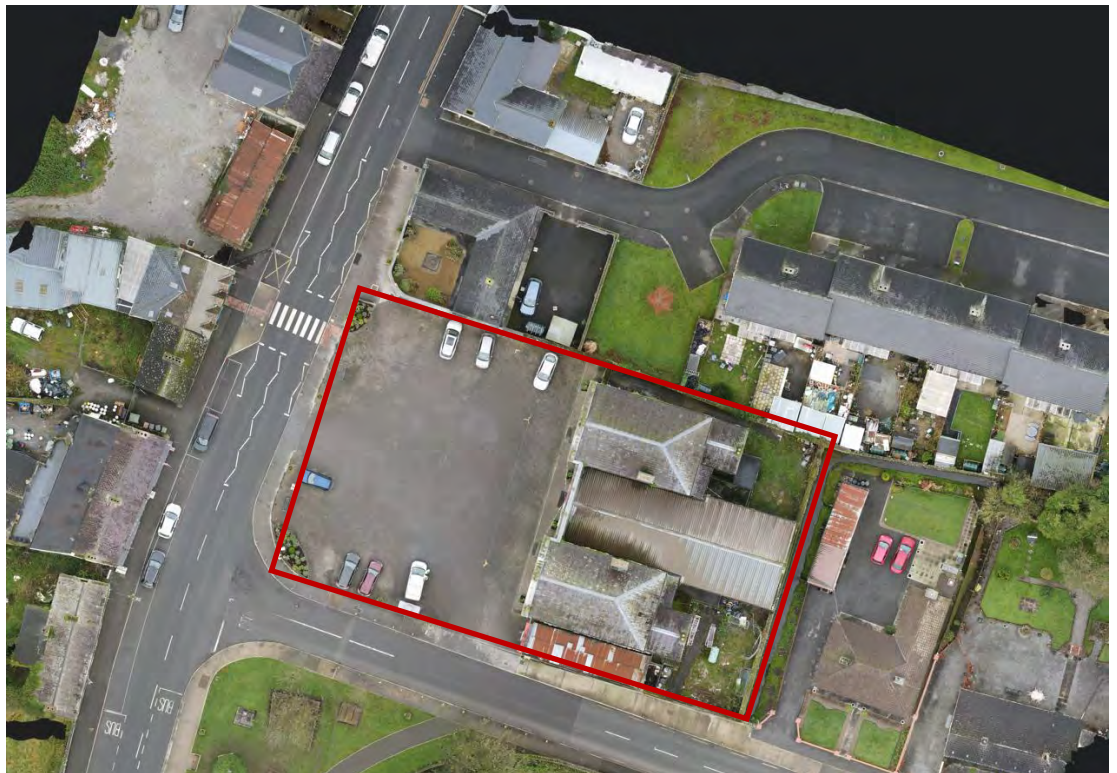
*Aerial view from drone survey, north to top of page.
Approximate red line of site shown.
Note vehicular ingress and regress to the forecourt should be kept clear of the junction.*

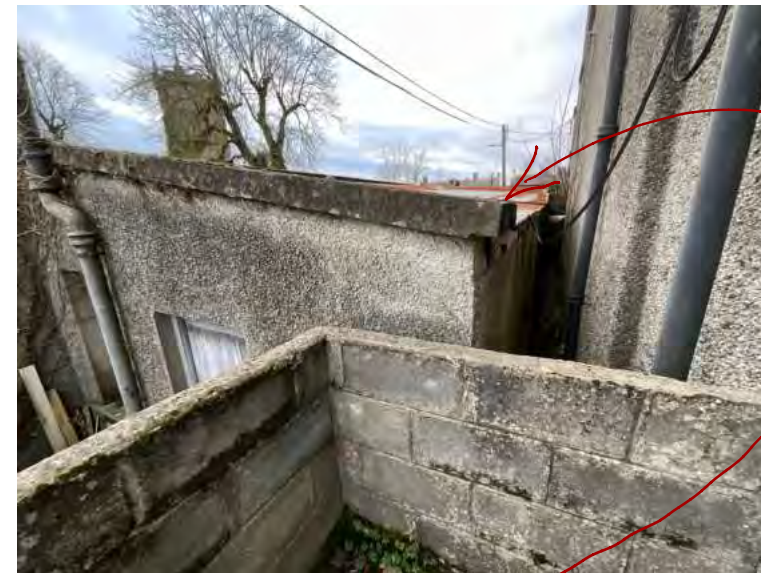
narrow hard to maintain
gap between fire station / cycle club
and court house

Shallow fall corrugated roof
to single storey fire station

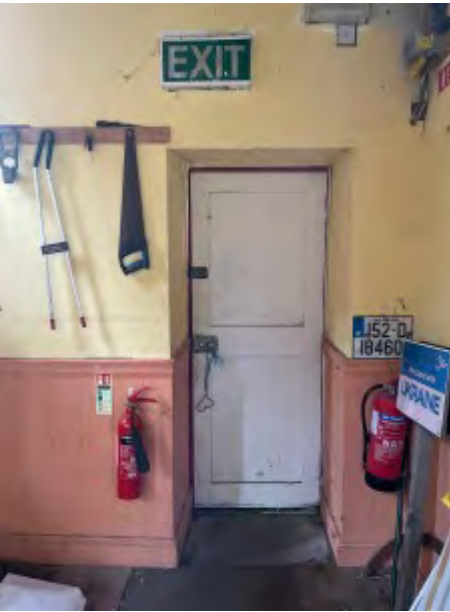
001 / 002

Door Clear Width 690MM.

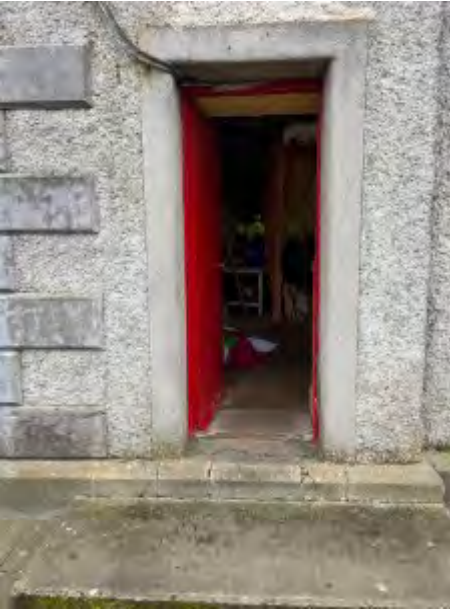
001 / 003

Two number of steps. Varies rises 150MM and 170MM. Width of the step 650MM.
(1) Not accessible entrance.

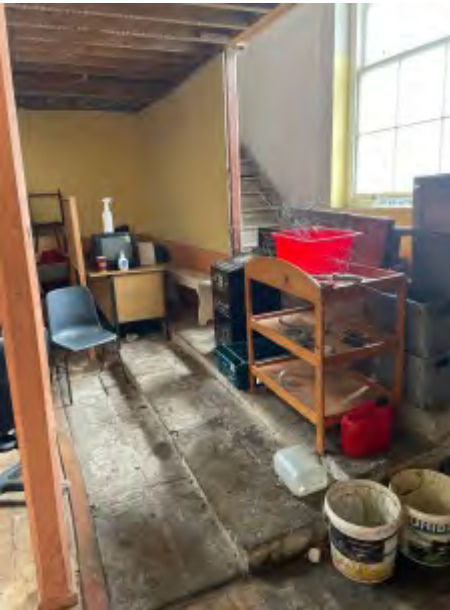
001 / 004

Internal steps to balcony over to Room (RM 0-13).
Various rises. 125MM and 156MM. Top step 145MM. Treads 540MM on top step 1135MM.
(1) Not accessible vertical as per TGD Part M

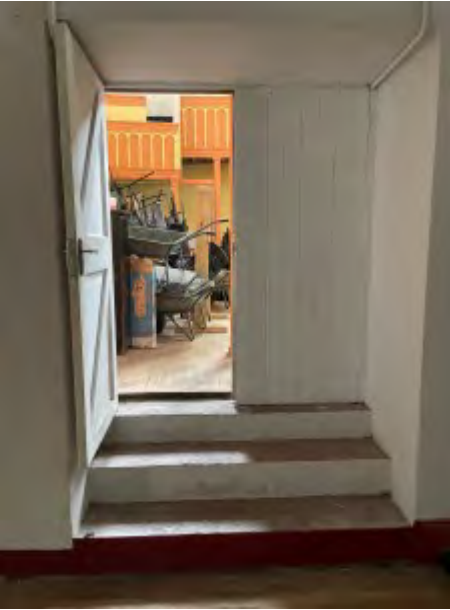
001 / 005

- Internal Door to Room (RM0-13)
- (1) width 1597MM
- (2) Single door leaf 741MM
- (3) Not accessible entrance to Room (RM 0-13)
- (4) Internal steps at door threshold of varying rise and thread dimensions

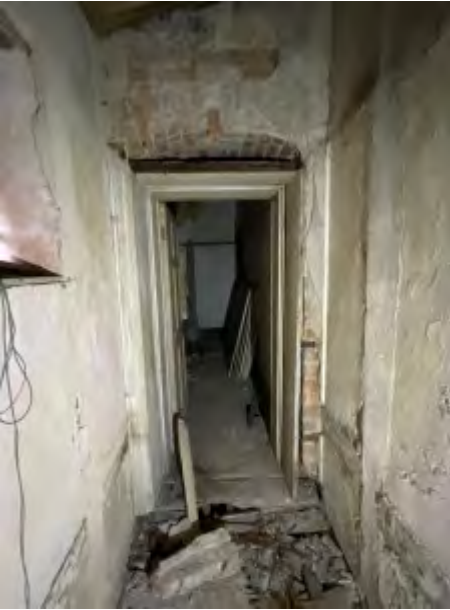
001 / 006

Internal Door Width to Room with 793MM. Step at threshold. Rise 80MM.

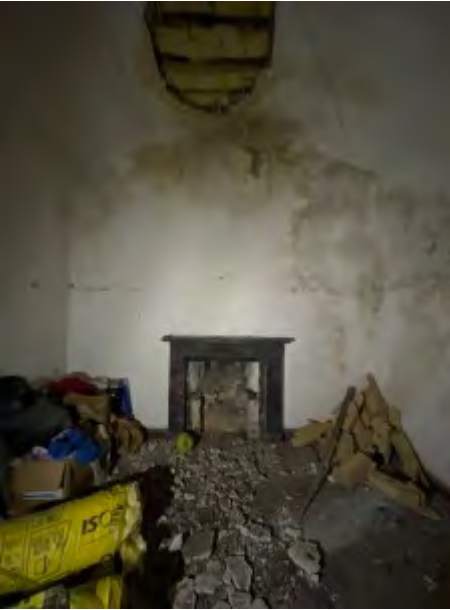
001 / 007

Floor to ceiling height at the centre of room
3942mm.
Floor to ceiling height at wall / ceiling junction
3453mm.

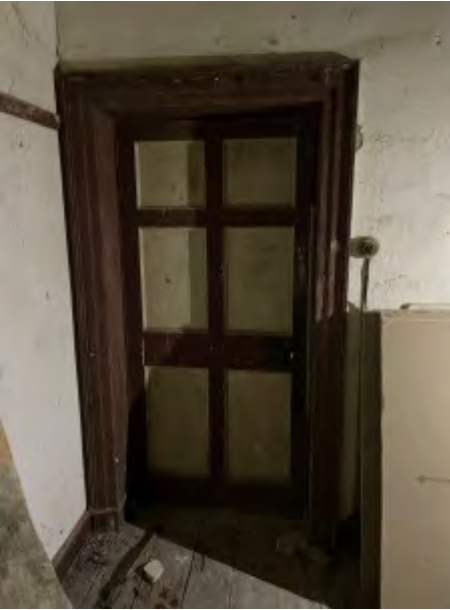
001 / 008

Door locked the time of inspection. Room No. M-02

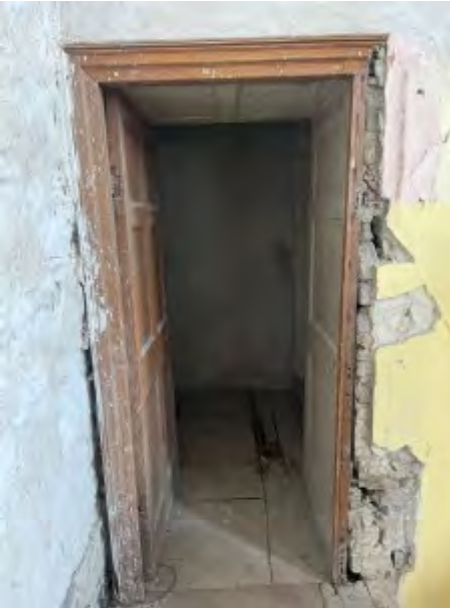
001 / 009

Door clear width 796MM.

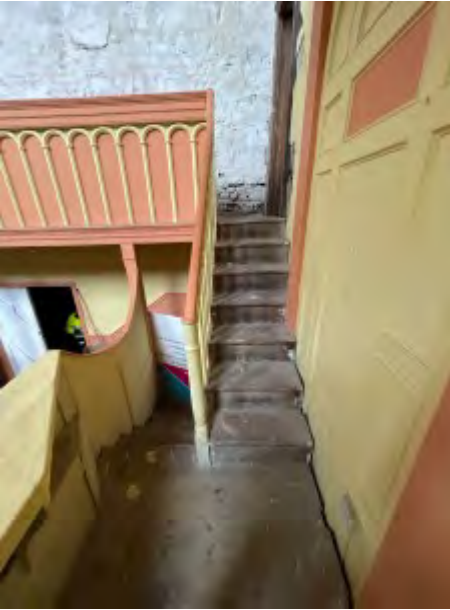
001 / 010

Seven steps.
Rise 260MM.
Going 265mm.
Clear width varies from 600MM - 700mm.
No Handrails
Not accessible as per Section 2 of TGD Part M

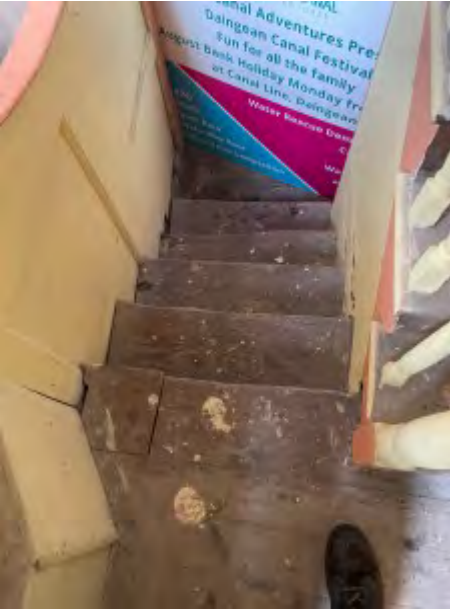
001 / 011

Five steps.
Rise 180MM.
Going to 60MM.
Clear width 731MM.
No Handrails
Not accessible as per Section 2 of TGD Part M

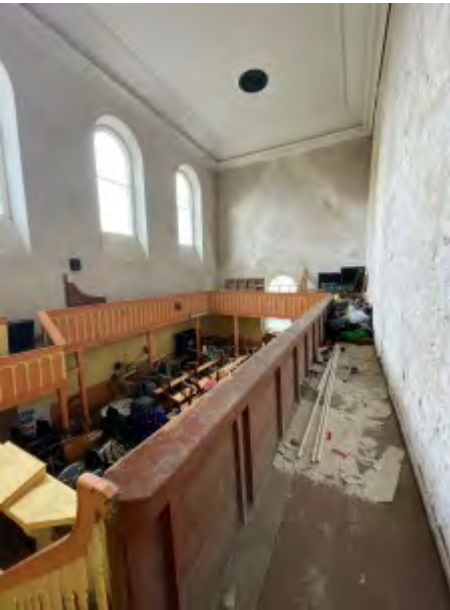
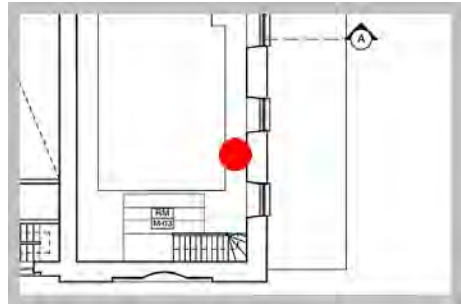
001 / 012

Gallery Clear width 1156mm

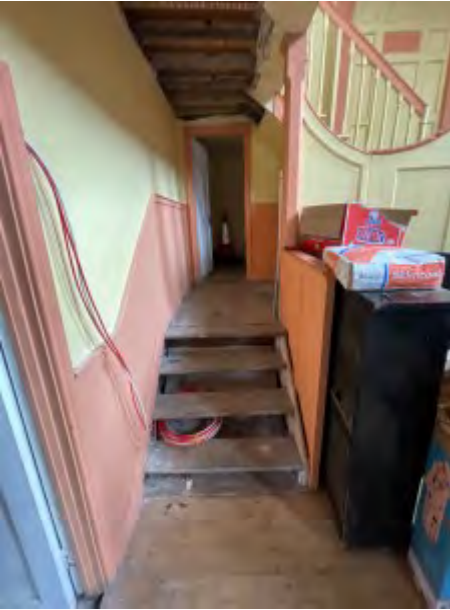
001 / 014

Four number rises.
Rise 190MM.
Going 274MM.
Clear width 1031MM.
No Handrails
Not accessible as per Section 2 of TGD Part M

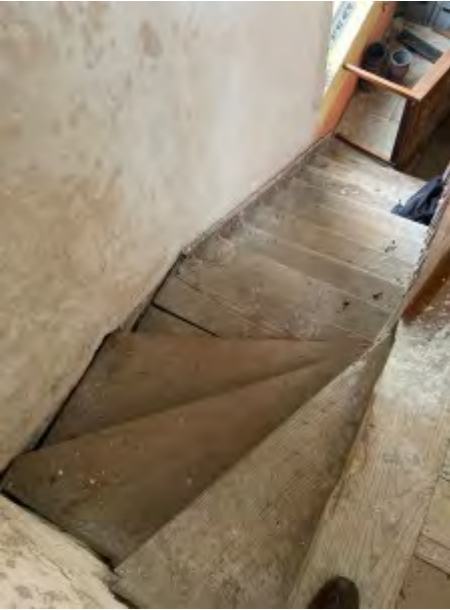
001 / 016

14 number rises.
Clear width 1054MM.
4 number winders at top of flight.
Rise 185mm
Going varies 283mm.
No Handrails
Not accessible as per Section 2 of TGD Part M

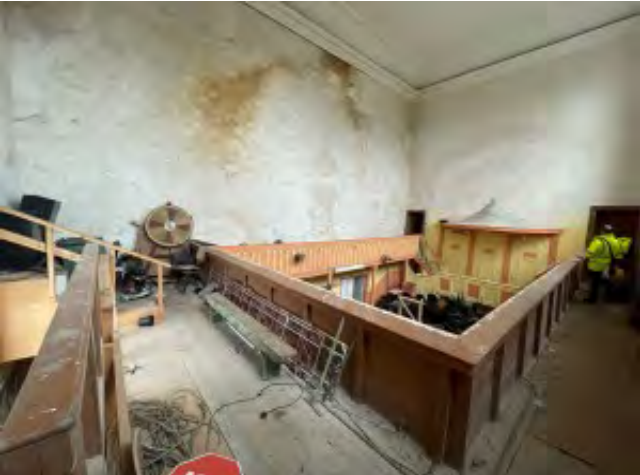
001 / 017

Width of balcony 1852MM.

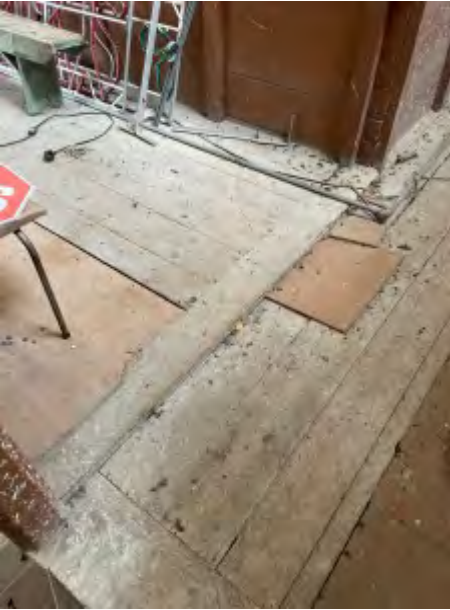
001 / 018

Step at balcony 50MM.
Floor to mezzanine floor not level
Not accessible as per Section 2 of TGD Part M

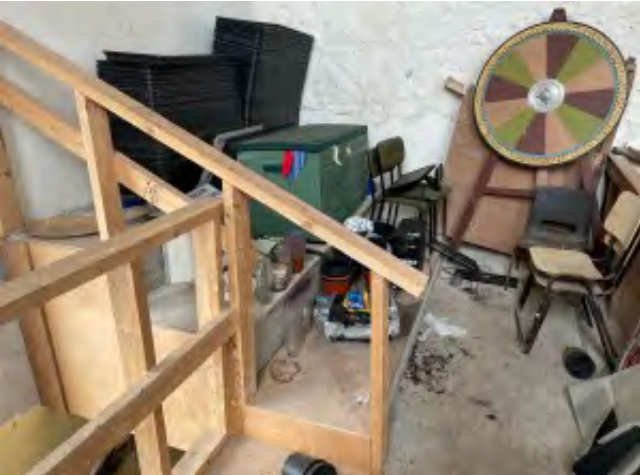
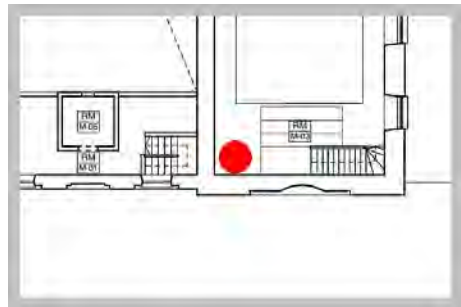
001 / 019

Three number tiers.
First tier 185 high.
Second & third tier 300mm high.
Width of tiers 629MM.
No Handrails
Not accessible as per Section 2 of TGD Part M

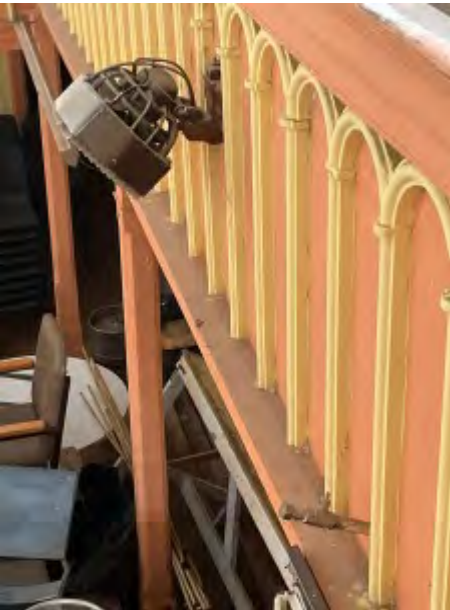
001 / 021

Electrical / Gas heaters present.
Gas supply pipe present.
Fire Safety risk item.
Space & Water Heating system for the building
should be checked to confirm it's installation
complies with relevant building codes.

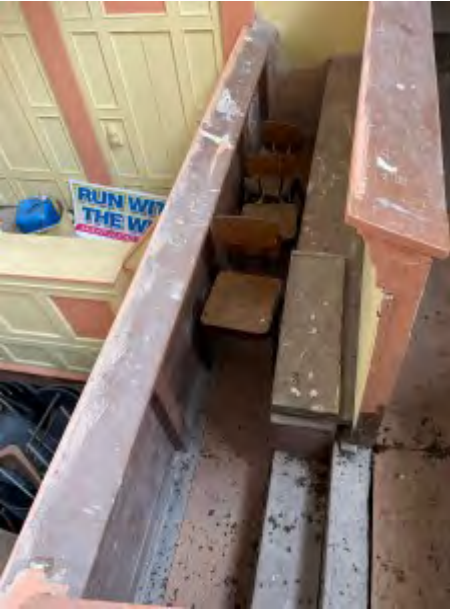
001 / 022

Balcony.
475mm level drop off balcony level.
Width of balcony 650mm
Access gate width 554mm
No Handrails
Not accessible as per Section 2 of TGD Part M
Guarding not in compliance with TGD Part K

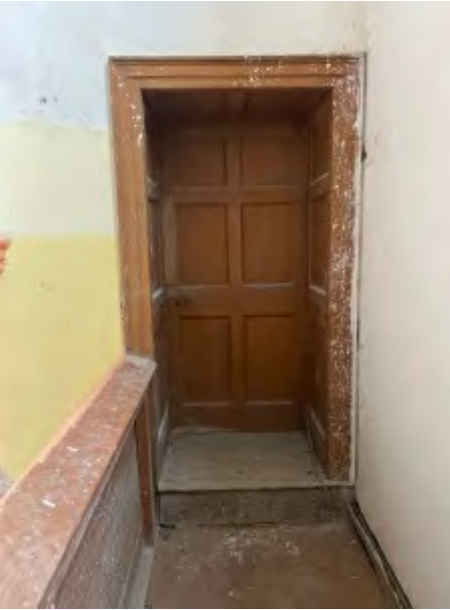
001 / 023

Step at door 252MM.

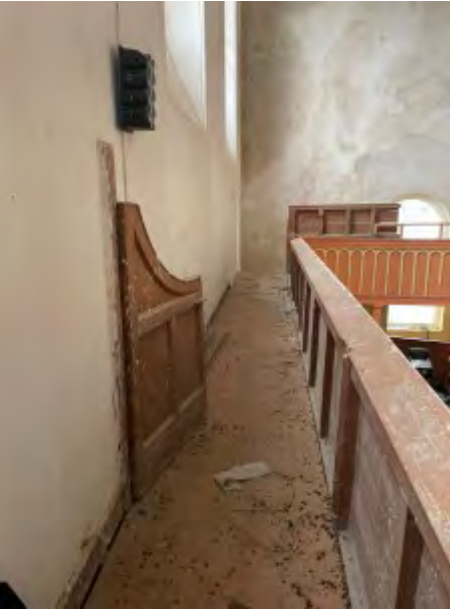
001 / 024

Gate at balcony.
Sliding Bolt present.
All doors / gates on escape routes should be free
from fastenings

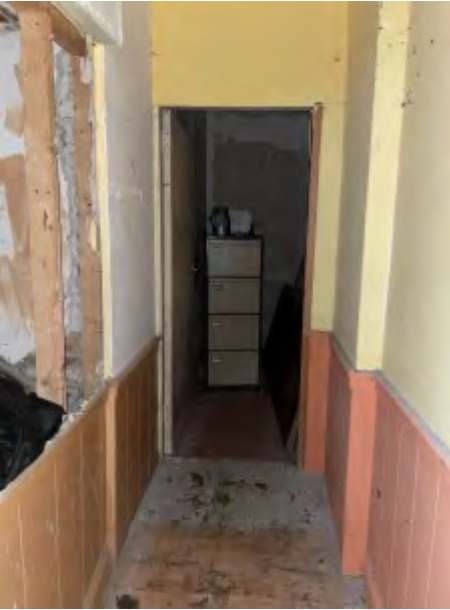
001 / 025

Door at top of ramp
Clear width of door 767MM.
Ramp raise 197MM.
Length of ramp 1500MM.
Clear width of ramp 1038MM.
No Handrails
Not accessible as per Section 2 of TGD Part M

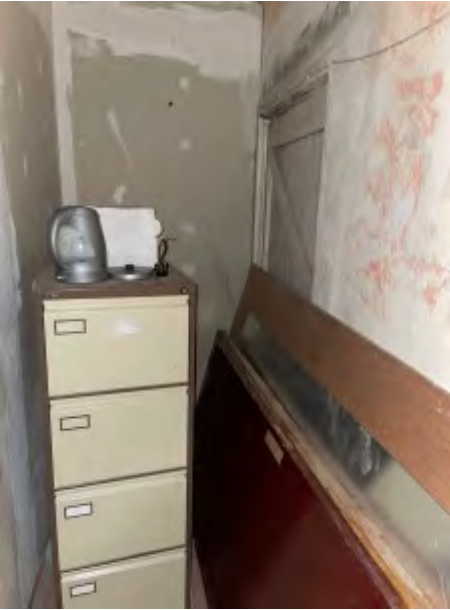
001 / 026

Access to door (external door) unavailable at time of inspection

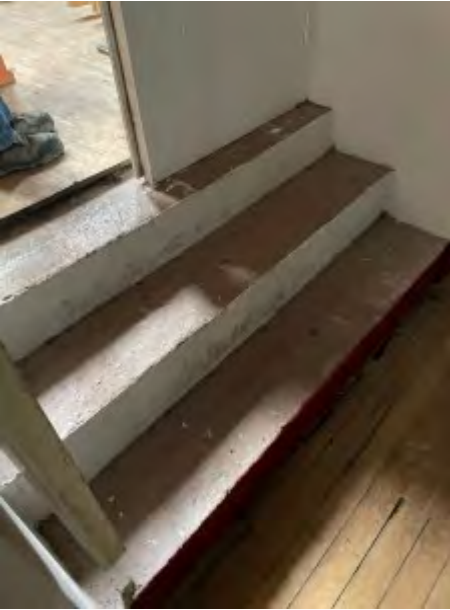
001 / 027

Internal Access to Room No: 0-13
Three number rises.
Rise 214MM.
Going 290MM.
Floor finish to courtroom 50MM rise.
No Handrails
Not accessible as per Section 2 of TGD Part M

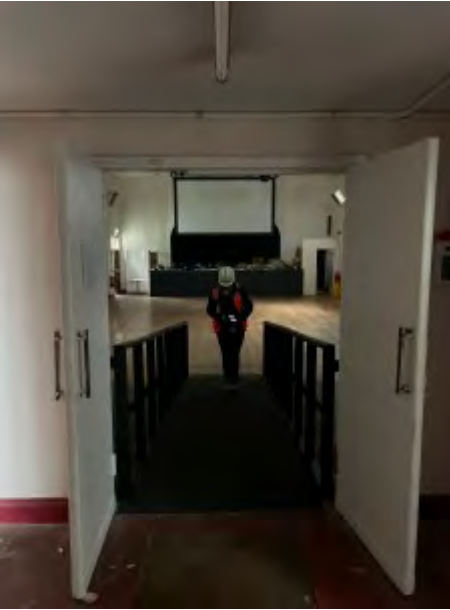
001 / 030

Door to Room 0-15
Clear width 1354MM.
Clear width of single leaf 677mm
Not accessible as per Section 2 of TGD Part M
Door appear not to be fire rated.

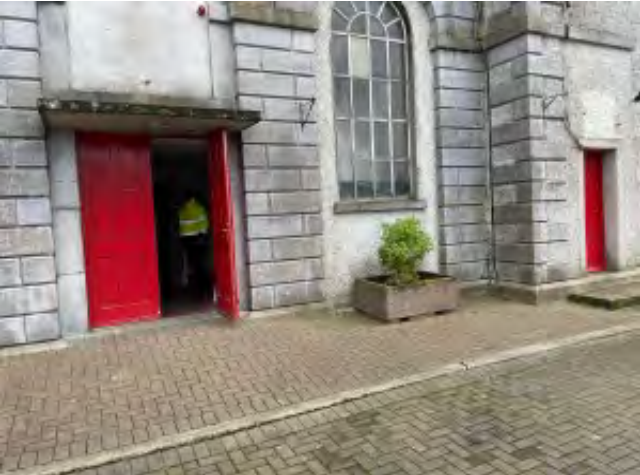
001 / 031

Entrance door clear width of a single leaf 672MM.
Clear with a double doors 1532MM.
Ramp at door.
Level landing not present.
No Handrails
Not accessible as per Section 2 of TGD Part M

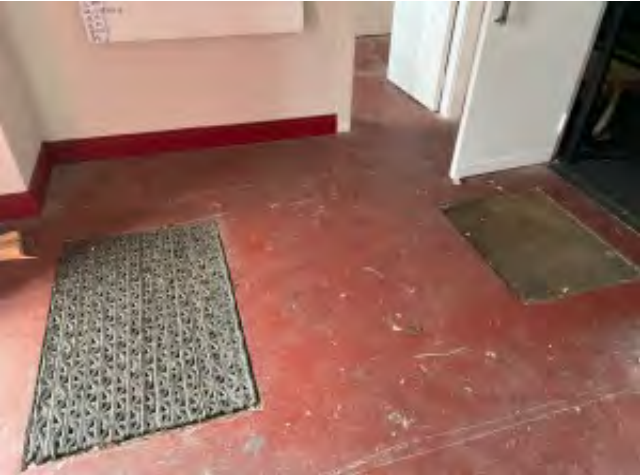
001 / 032

Two sunken Matt Wills present at entrance lobby.
Entrance lobby dimensions 3008mm deep by 2969mm wide.
The lobby doors swing into entrance lobby by 618mm.

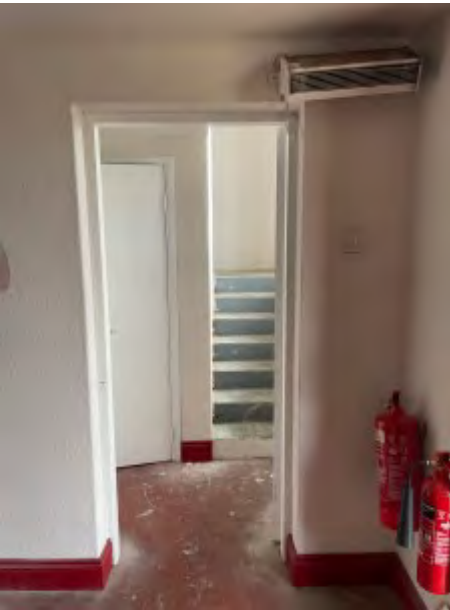
001 / 033

Door to internal Stairway
Clear width 784MM.
Door appear not to be fire rated.
Single stairway to Gallery at first floor level to have a max occupancy level of not more than 50 persons.

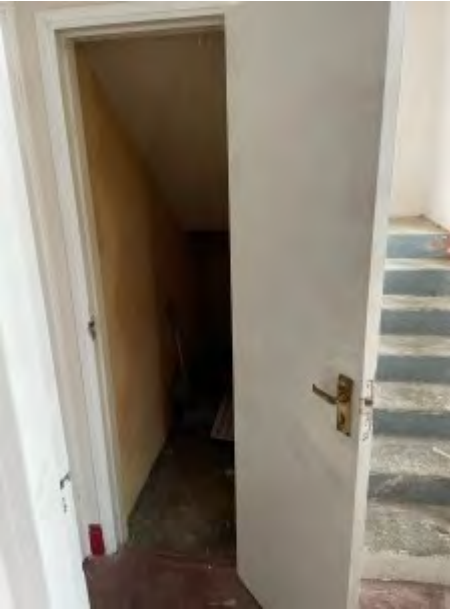
001 / 034

Door underneath stairway.
Clear width 542MM.
Storage within protected stairway not permissible.

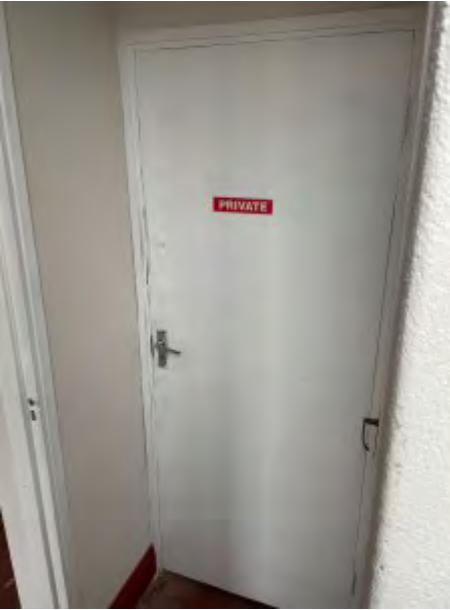
001 / 035

Door locked to ticket office at time of inspection.

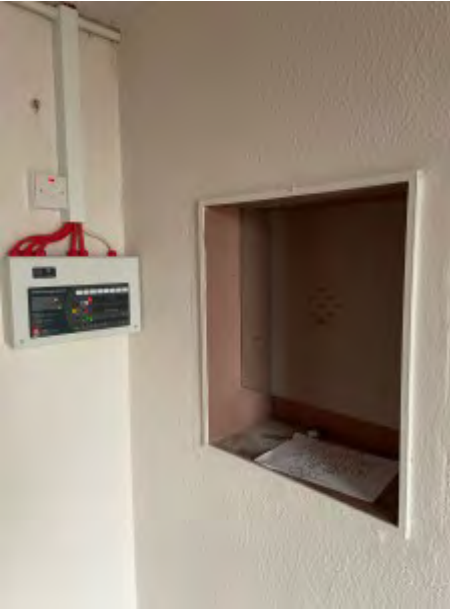
001 / 036

Hatch to ticket office.
Cill to floor 1108MM.
Not accessible as per Section 2 of TGD Part M

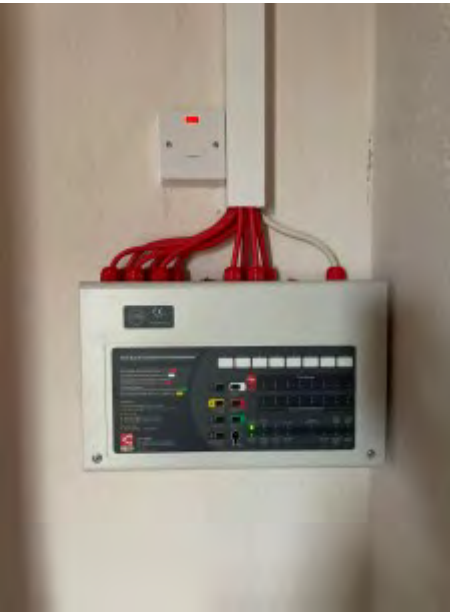
001 / 037

Fire detection alarm system.

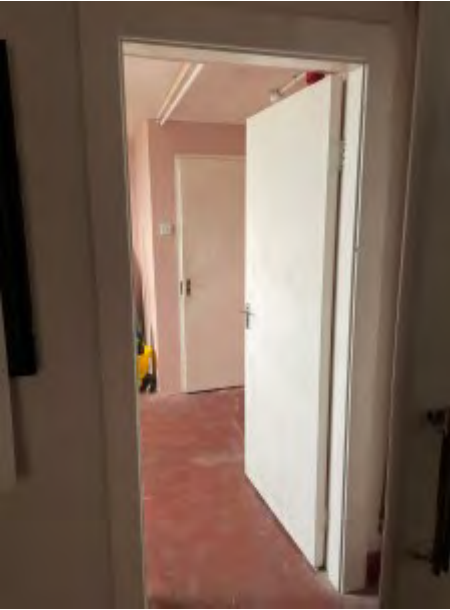
001 / 038

Door to Room 0-04.
Clear width 751MM.
Not fire rated.

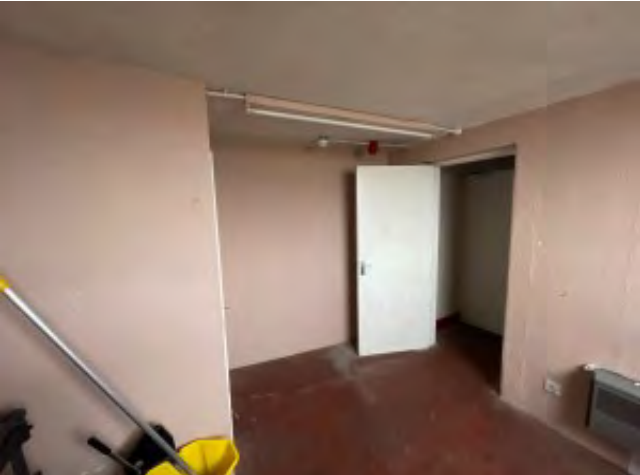
001 / 040

Room 0-04

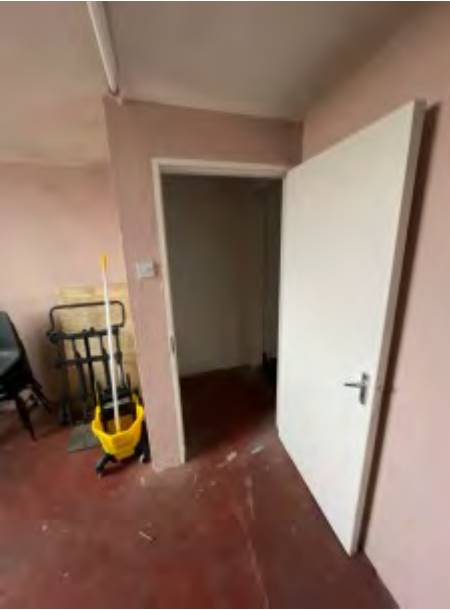
001 / 041

Door to Room 0-05 (Theatre)
Clear width 776mm.
Not fire rated door.

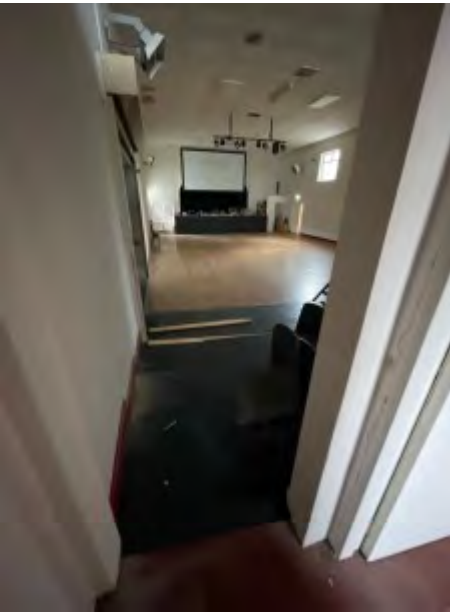
001 / 042

Ope to Room 0-05 (Theatre)
Ope clear width 892MM.
Step at threshold.

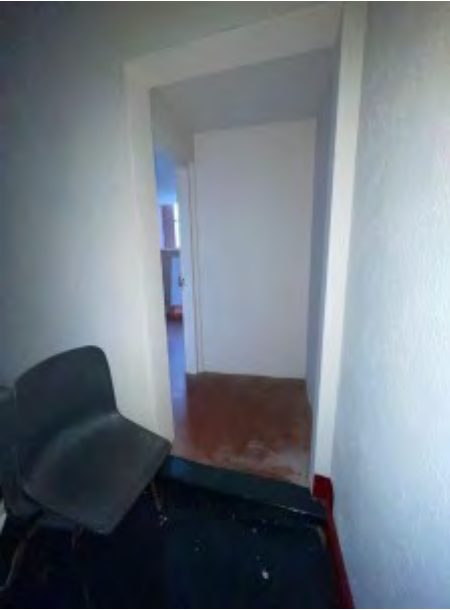
001 / 043

Door to tiered steps.
Steps are concrete with timber finish
Not accessible as per Section 2 of TGD Part M

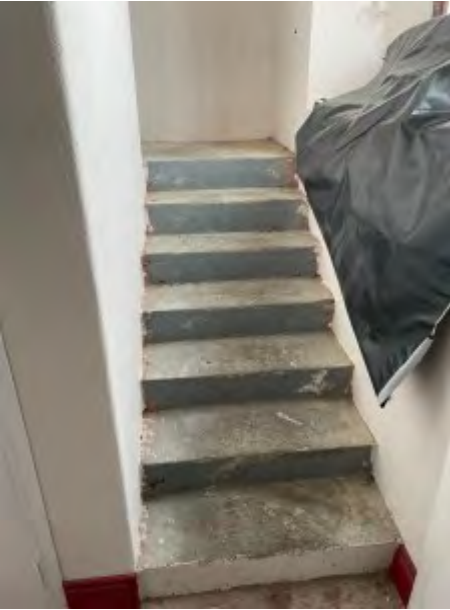
001 / 044

Stairway to Gallery (Room No. M-01)
1st flight:
Seven risers,
going 270MM,
Rise 160MM.
Clear width 827MM.
No Handrails
Not accessible as per Section 2 of TGD Part M
Steps of concrete construction.

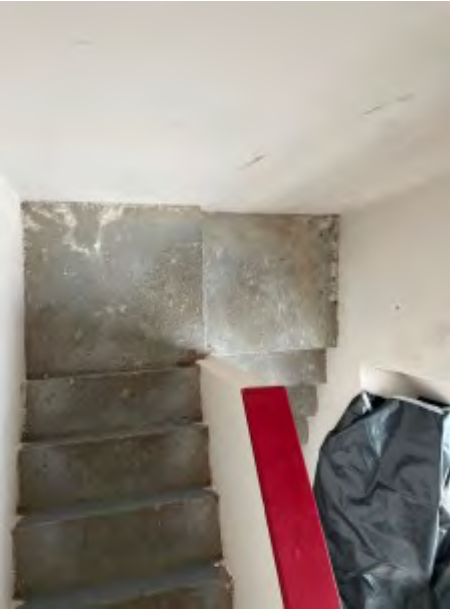
001 / 045

Stairway to Gallery (Room No. M-01)
One step at half landing.

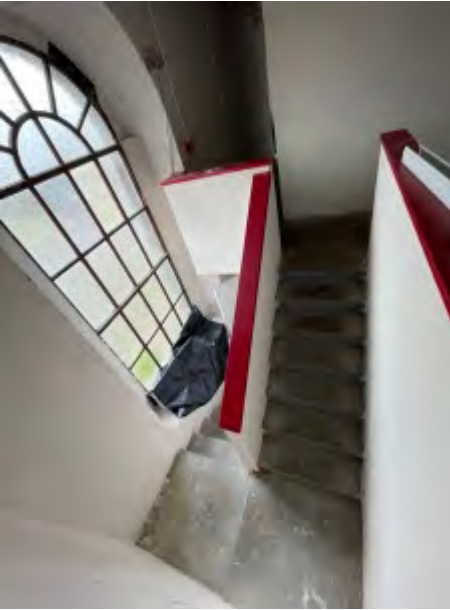
001 / 046

Stairway to Gallery (Room No. M-01)
2nd flight:
Seven rises
Going 270MM.
Rise 160MM.
Clear width 827MM.
Steps of concrete construction.
No Handrails
Not accessible as per Section 2 of TGD Part M

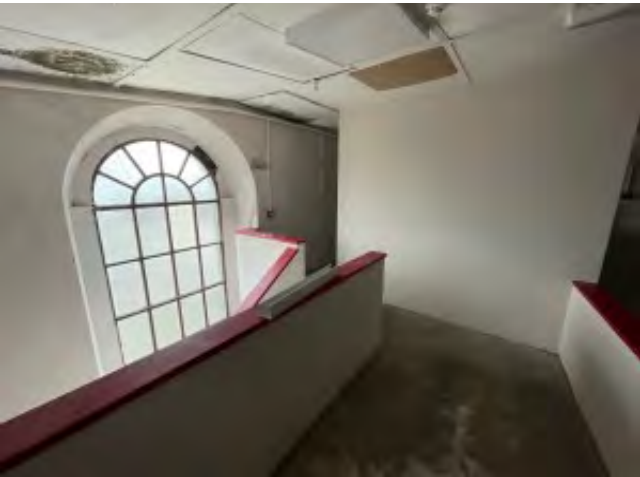
001 / 047

Room Number M-01

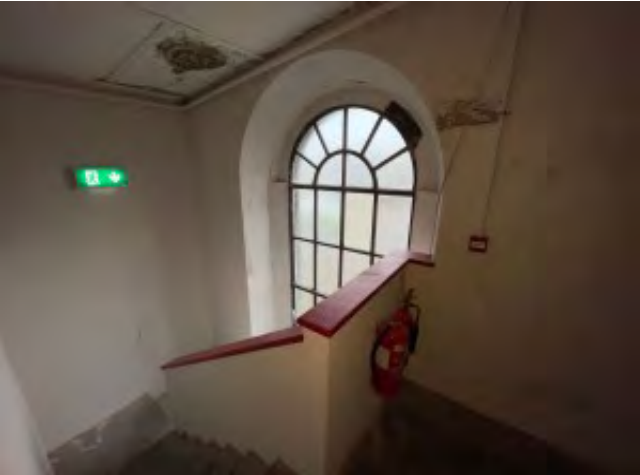
001 / 048

Room Number M-01
Break Glass Unit
Fire extinguishers present.
Directional Emergency Light present

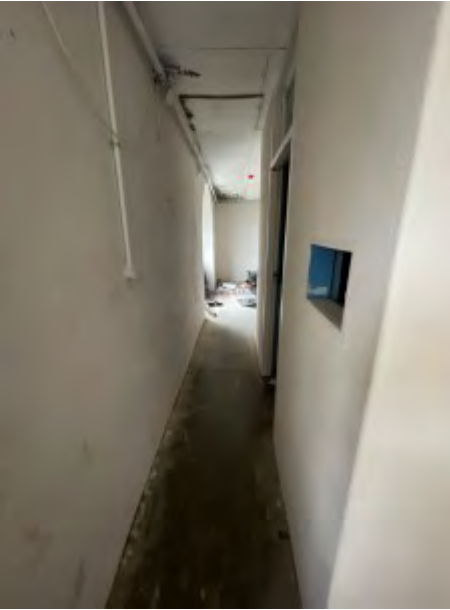
001 / 049

Room Number M-01
Clear width of passage way - 840MM.

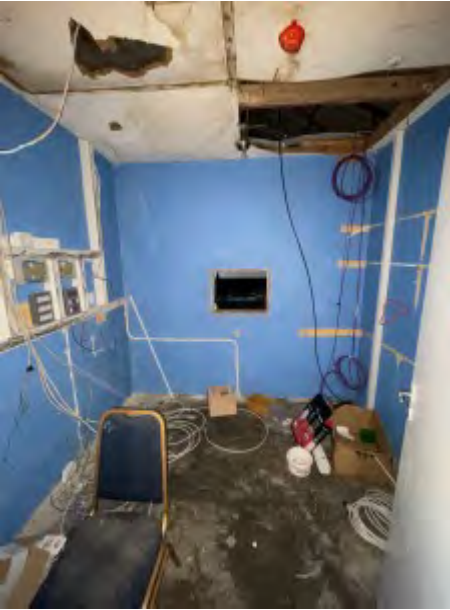
001 / 050

Room Number M-05 - Projector room.
Non Fire rated room (Ceiling)

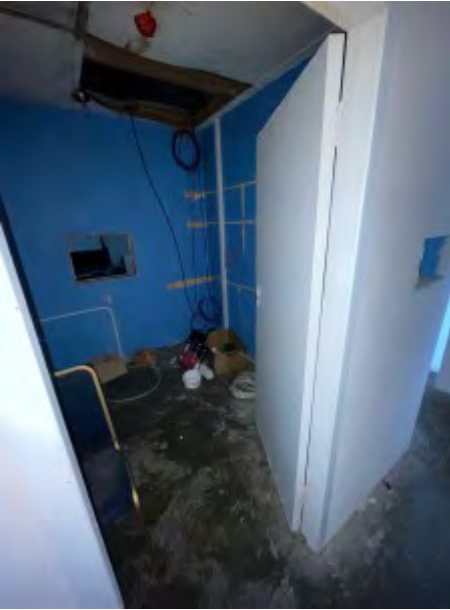
001 / 051

Room Number M-05 - Projector room.
Door width 767MM.
Non fire rated.

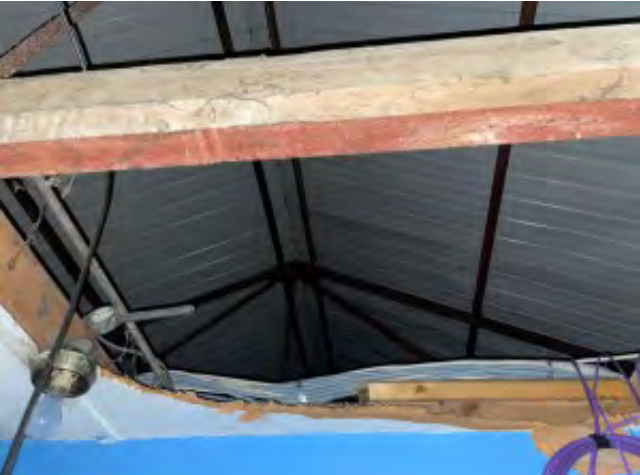
001 / 052

Room Number M-05 - Projector room.
Ceiling void. Not inspected at time of inspection
Non Fire rated room (Ceiling)

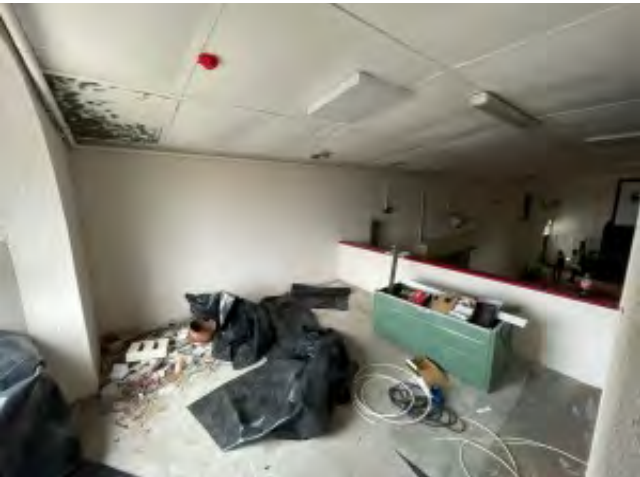
001 / 053

Gallery (Room No. M-01)
Balcony dimensions 3427 deep by 3620mm wide

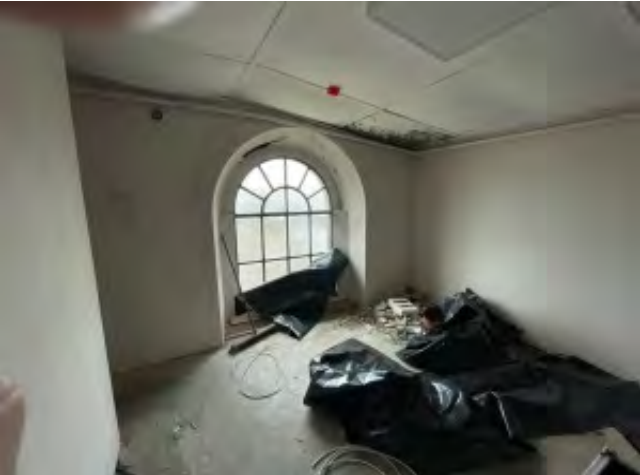
001 / 054

Gallery (Room No. M-01)
Timber glazed window non toughened glass present between floor level & 800mm from floor level.
No Guarding not compliance with TGD Part K

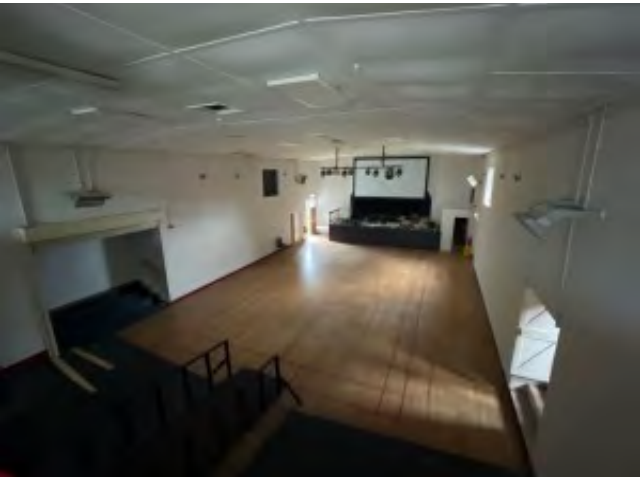
001 / 055

Hall heated by gas heaters (4 number).

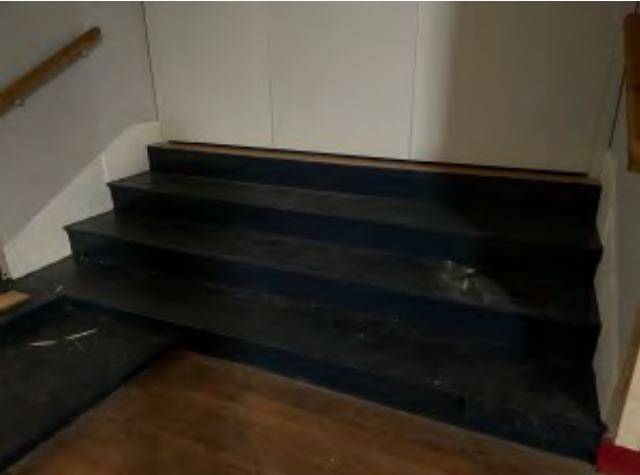
001 / 056

Access Door to Room No 0-19 from Theatre (Room No. 0-05)
Four number steps.
Rise 203MM.
Going 428MM.
Width 3166MM.
No Handrails
Not accessible as per Section 2 of TGD Part M
Steps not adequately illuminated or signed.

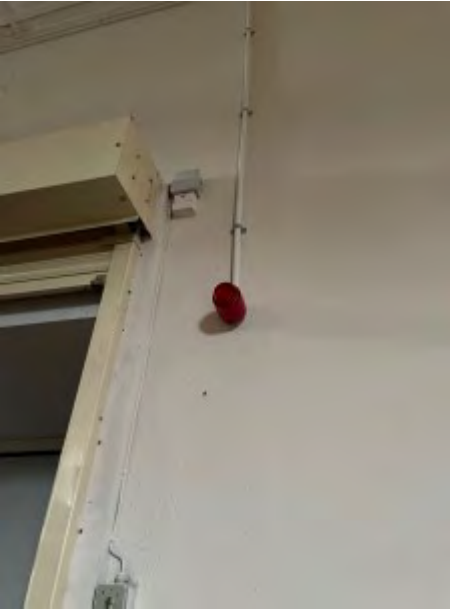
001 / 057

Fire detection alarm system alarm present to
Room 0-05 (Theatre)

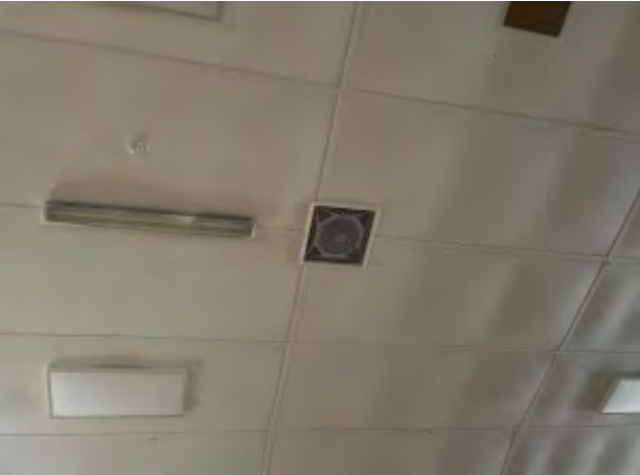
001 / 058

Room 0-05 (Theatre)
2 number smoke detectors present.

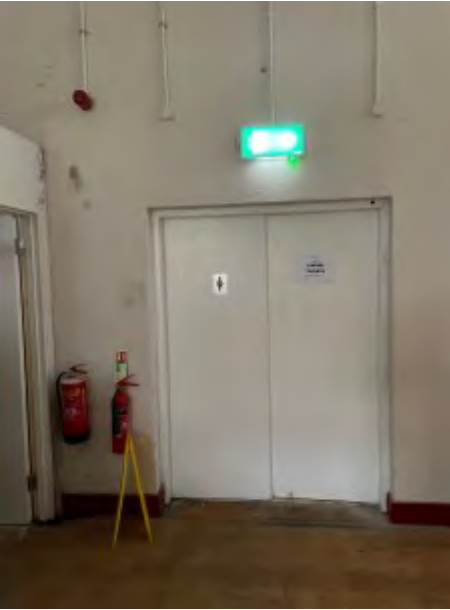
001 / 059

Room 0-05 (Theatre)
Exit Doors to south
Clear width 1395MM.

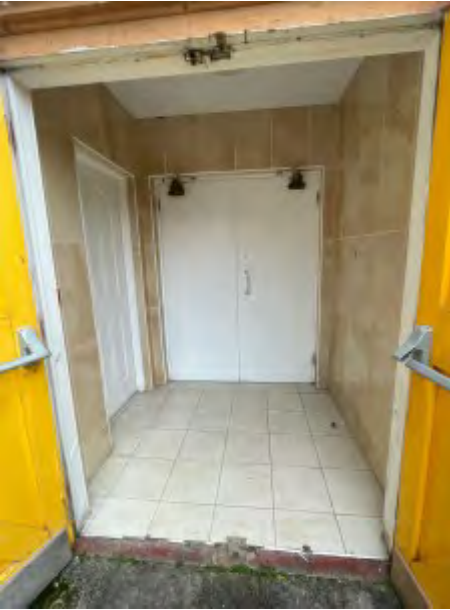
001 / 060

Room 0-08 (Lobby)
Lobby dimension 1460 deep by 1752 wide.
Inner doors open in the direction of escape into lobby.

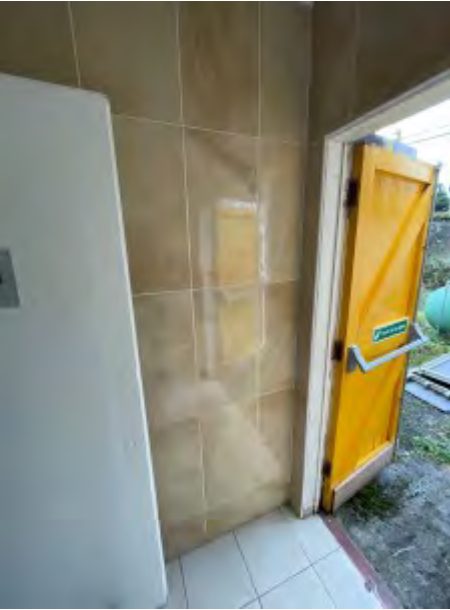
001 / 061

Room 0-08 (Lobby)
Distance between opened door leafs 807mm.

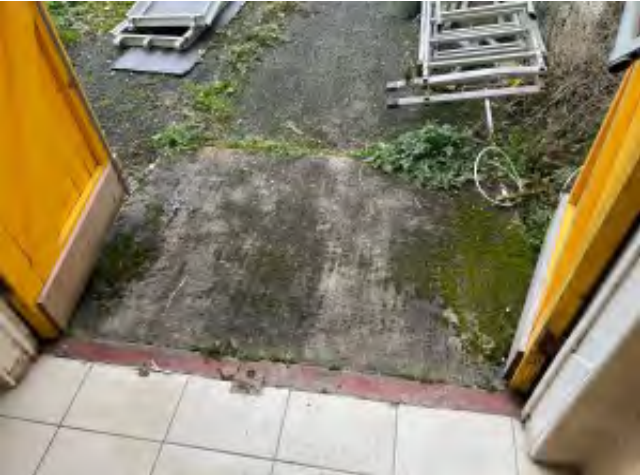
001 / 062

Ramp immediately outside exit doors.
Ramp height 200mm.
The ramp length 1259mm.
