Daingean Courthouse

Daingean, Co. Offaly

Conservation Masterplan

December 2024

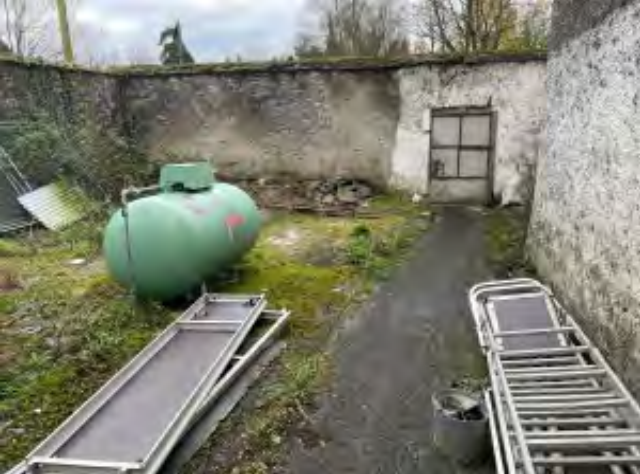
001 / 063

External southern enclosed yard
Calor gas propane tank present adjacent to means
of escape

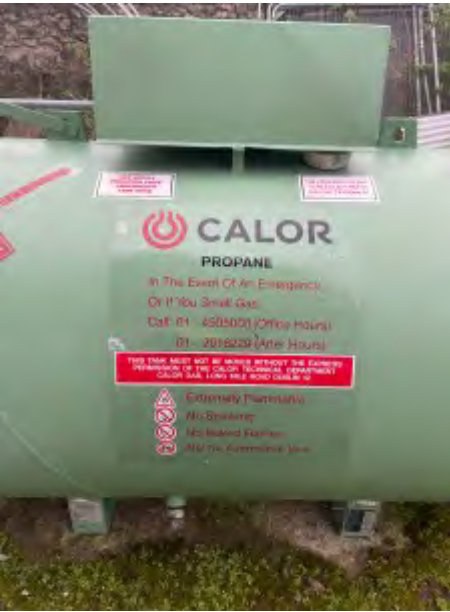
001 / 064

External southern enclosed yard

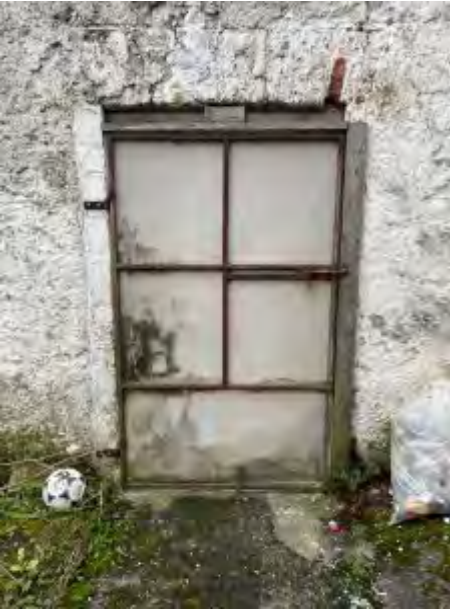
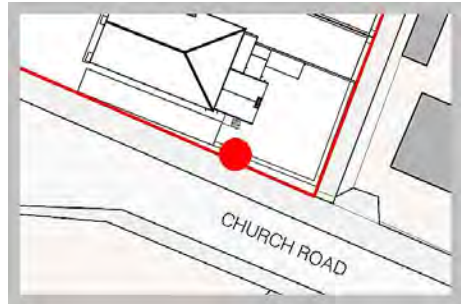
001 / 065

Boundry exit clear with 1200MM.

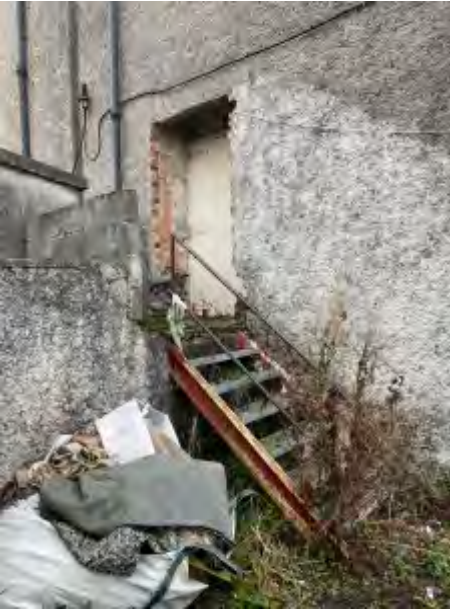
001 / 066

External Landing & Escape Stairs (Metal steps)
from Room 0-13 (Courtroom).
Seven rises.
Rise 190MM.
Going 230MM.
Handrail to one side.
And clear width 800MM.
Not accessible as per Section 2 of TGD Part M
Not in compliance with TGD Part K

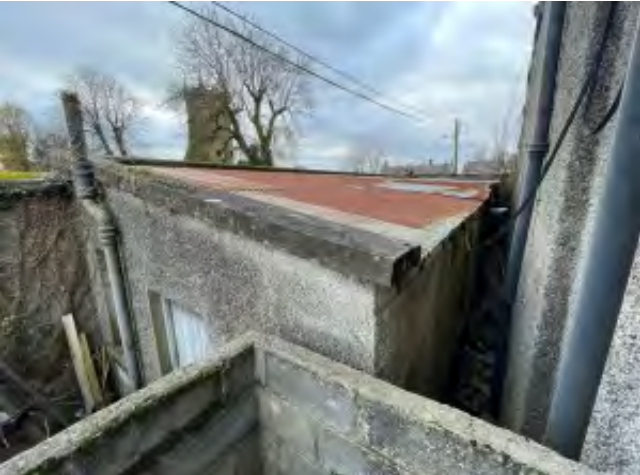
001 / 067

Fire station. No access present at time of inspection

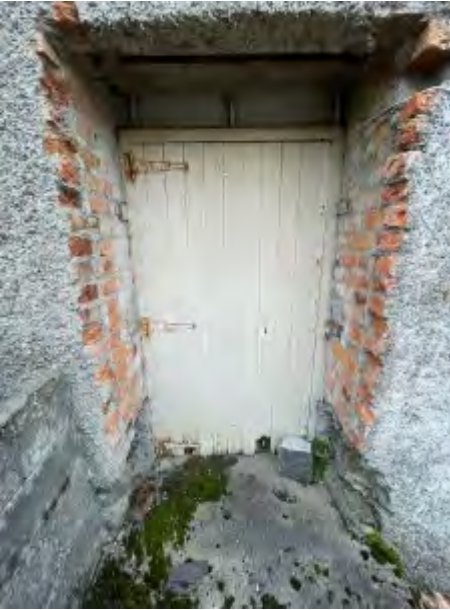
001 / 068

Final Exit from Room 0-13 (Courtroom).
Locked at time of inspection.
Possibly clear width 1000MM.
Structural ope 1200MM.

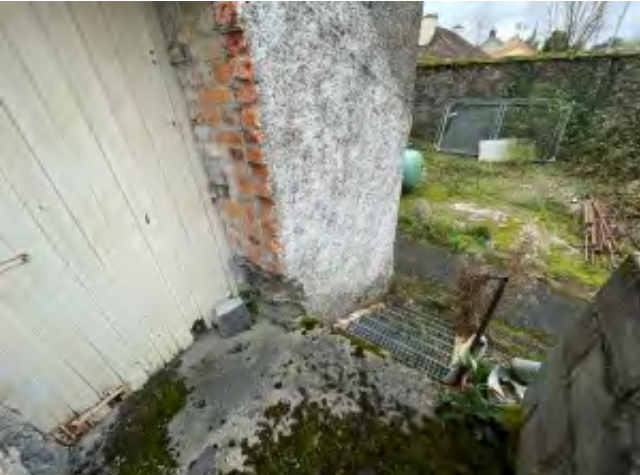
001 / 069

External Landing & Escape Stairs (Metal steps)
from Room 0-13 (Courtroom).

Current Status
Requires Attention

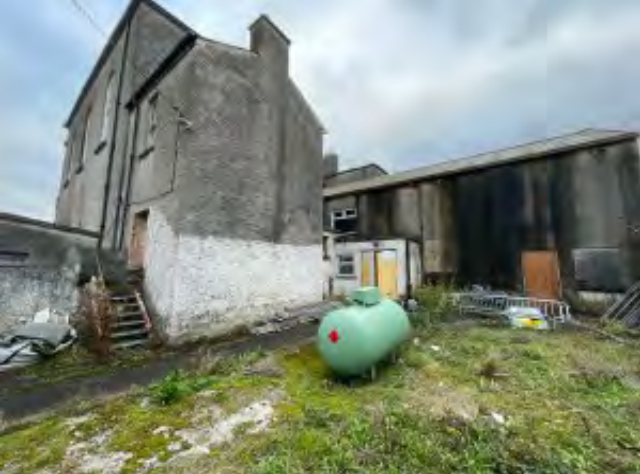
001 / 070

Comment
Southern enclosed yard.

Current Status
Requires Attention

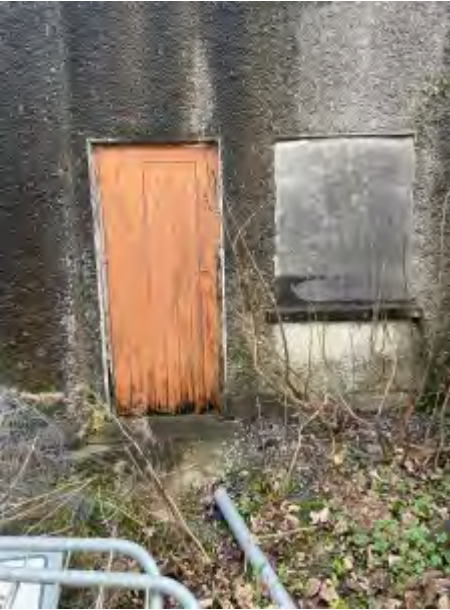
001 / 071

External Door access to Room No. 0-07 (Stage)
Access not available at time of inspection.

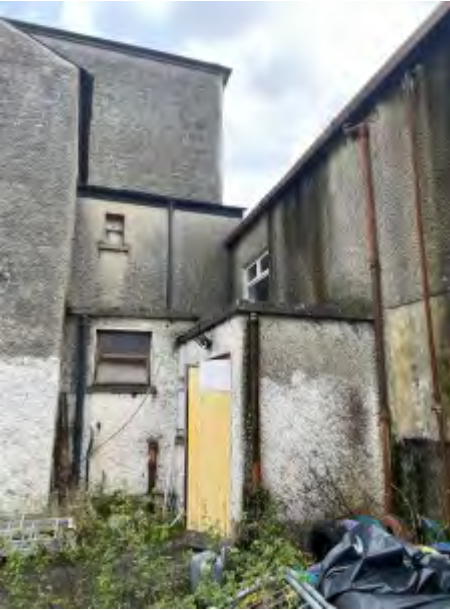
001 / 072

Southern enclosed yard.

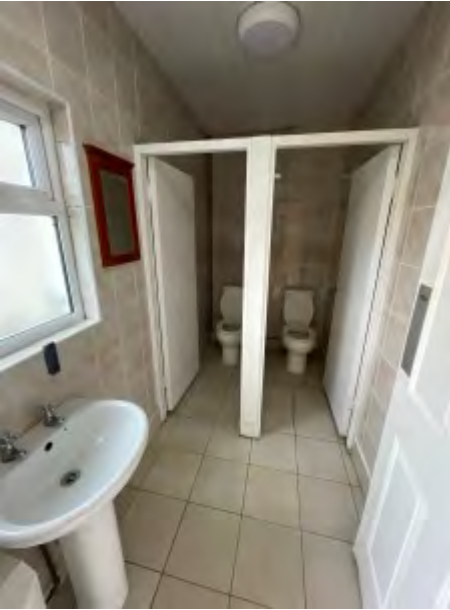
001 / 073

Toilets (Room 0-19)
Not accessible as per Section 2 of TGD Part M

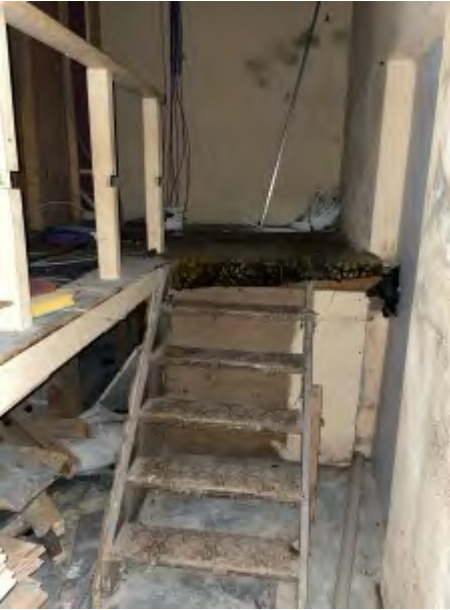
001 / 074

Stage Access (Room No. 0-07)
Access restricted a timer for inspection.

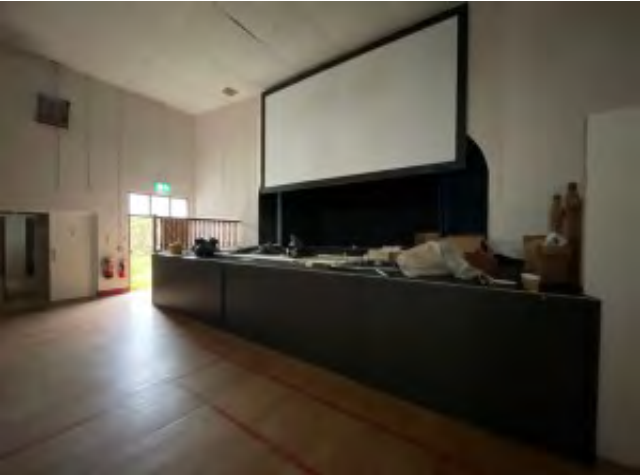
001 / 075

Stage (Room No. 0-06)
Access to stage restrict a time of inspection.

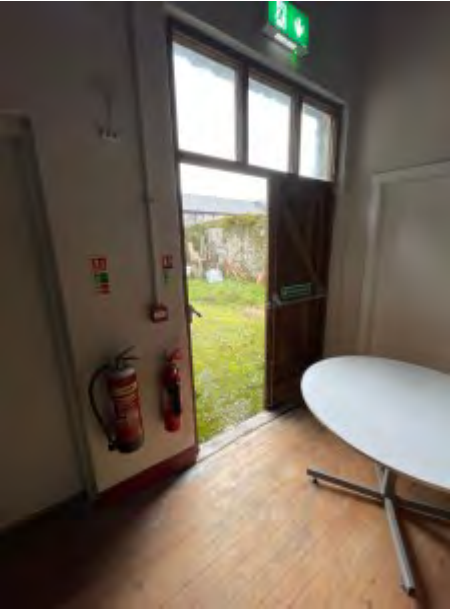
001 / 076

Final Exit door from Room 0-05
Clear width 1437MM.
Step threshold 70MM.
Not in compliance with TGD Part B & M

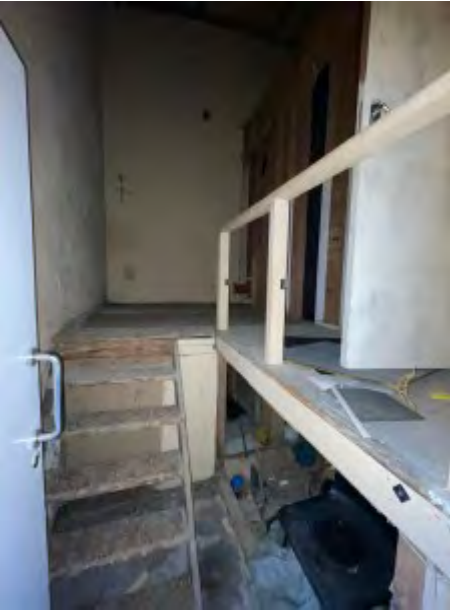
001 / 077

Stage Access (Room No. 0-07)
Stage door clear width 779MM.

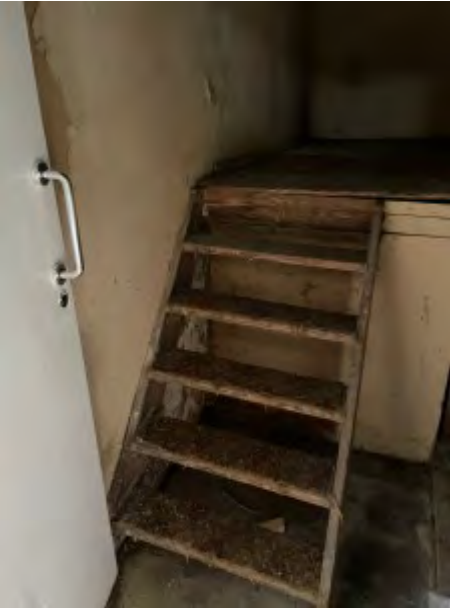
001 / 078

Stage Access (Room No. 0-07)
Door swings on to stair to stage level.
Not in compliance with TGD Part B & M

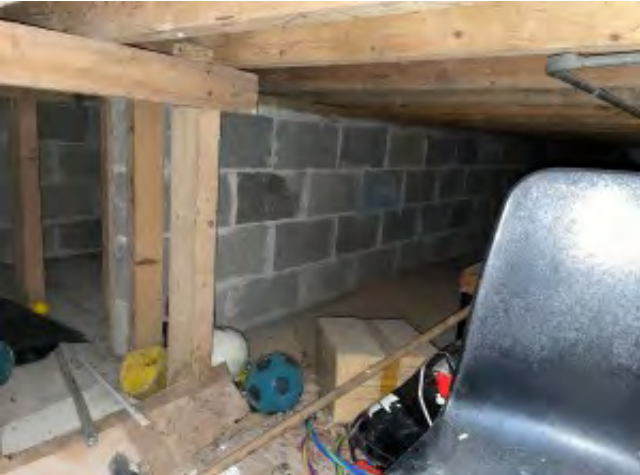
001 / 079

Stage floor timber floor construction on supporting block walls.
Not fire rated

Current Status
Requires Attention

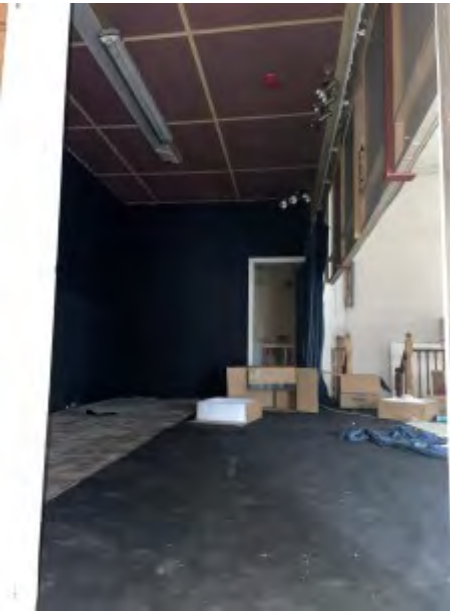
001 / 080

Stage not access at time of inspection

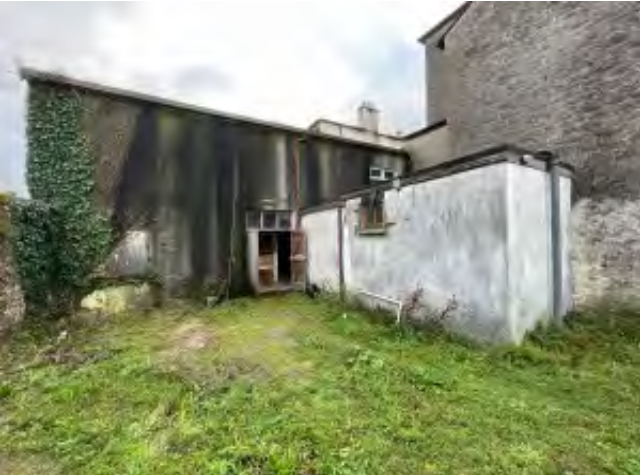
001 / 081

Northern Enclosed Yard

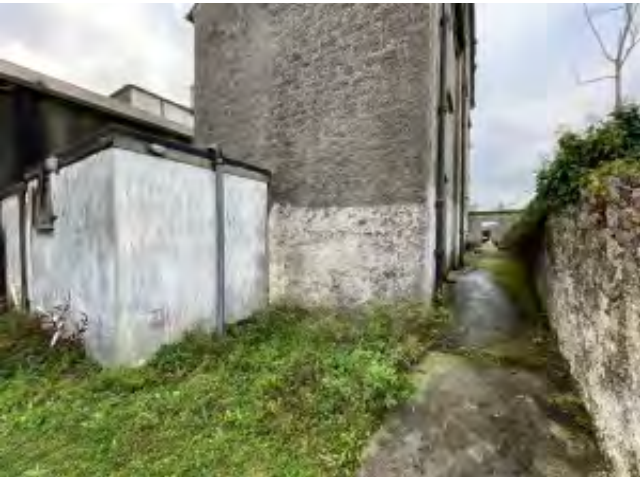
001 / 082

Northern Enclosed Yard
Exit passage way
Clear width varies from 1415mm to 2631mm.

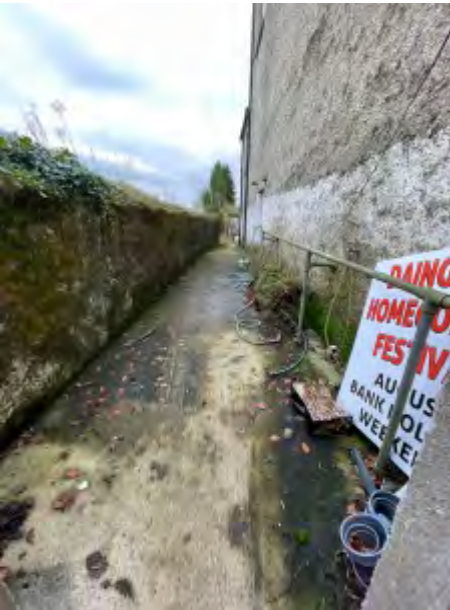
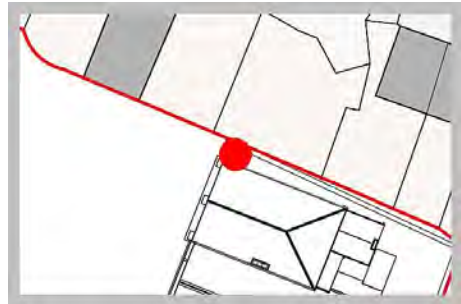
001 / 083

Northern Enclosed Yard
Exit passage way
Clear with 2631MM.

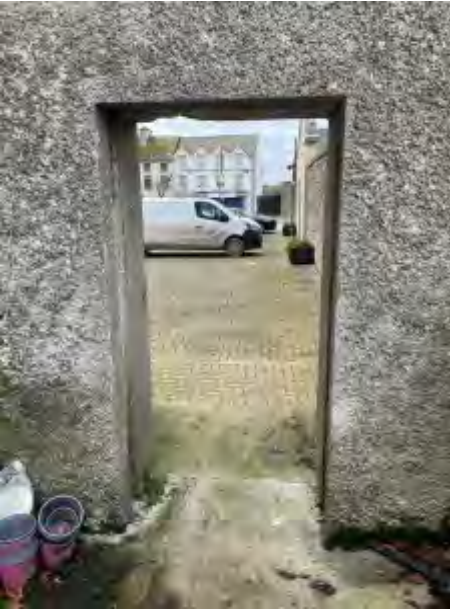
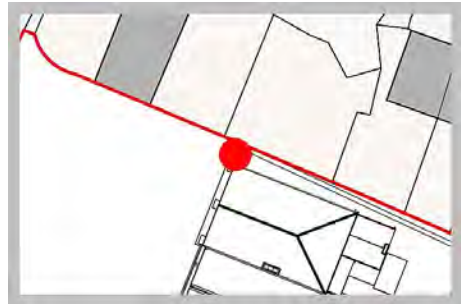
001 / 084

Northern Enclosed Yard
Final Exit from passage way
Clear with 1005MM.

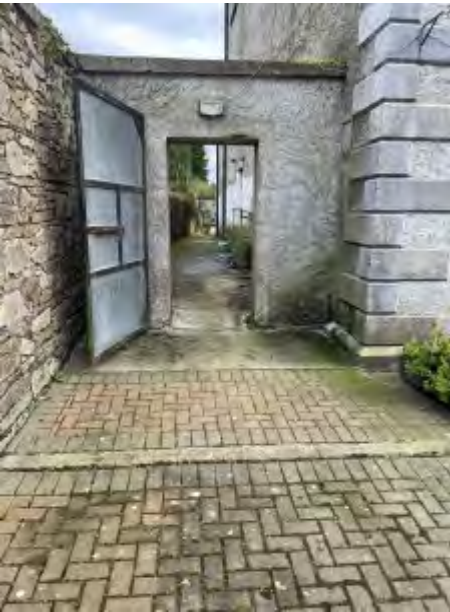
001 / 085

Ramp at exit door rise 100MM.
landing width 1100MM.
Not in compliance with TGD Part B & M

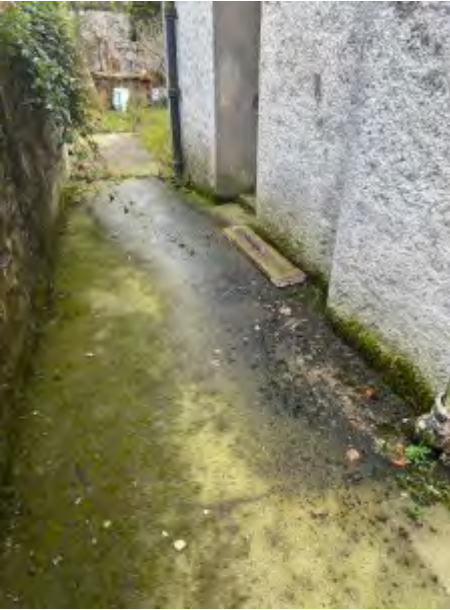
001 / 086

Northern Enclosed Yard
Passage way
Ramp present.
Not in compliance with TGD Part M

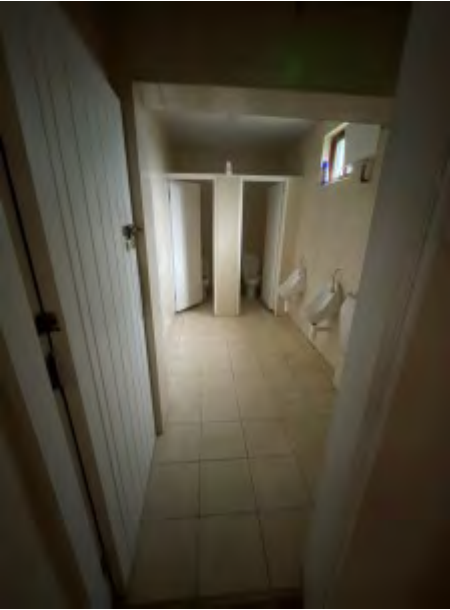
001 / 087

Toilet. (Room No. 0-15)
Step at inner door threshold 60MM.
Door width 760MM.
Sanitary provision is not in compliance with TGD
Part M

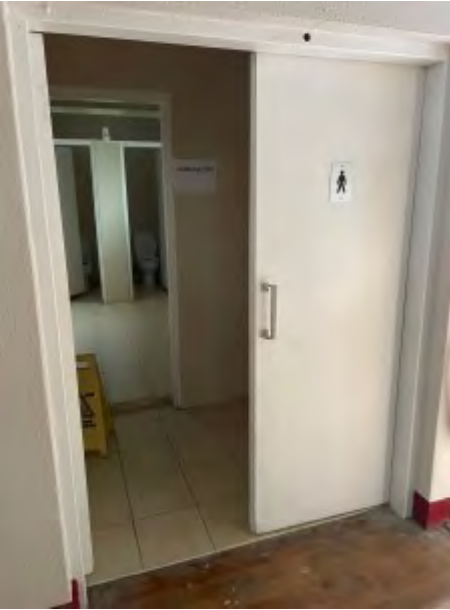
001 / 088

Double doors to male toilets.
Not in compliance with TGD Part M

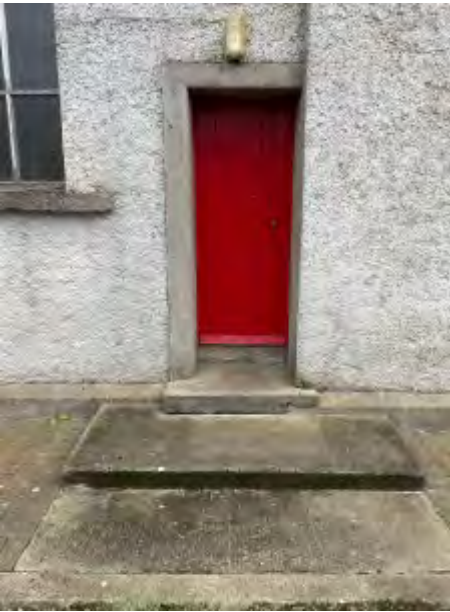
001 / 089

Door clear width 646MM.
Clear door height 1832MM.
Not in compliance with TGD Part B & M

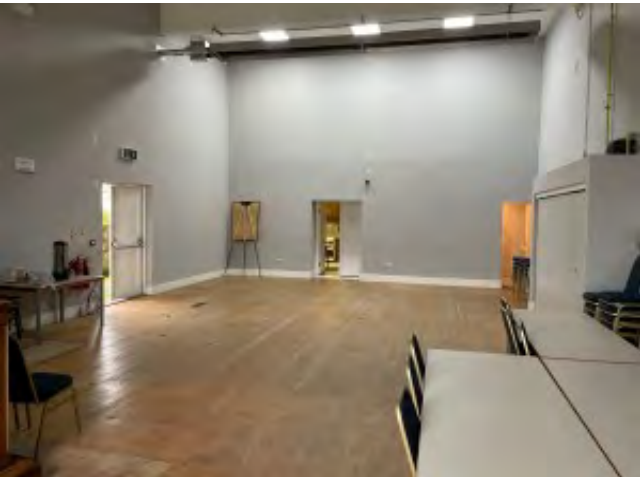
001 / 090

Side Hall (Room No. 0-19)
Timber suspended floor.

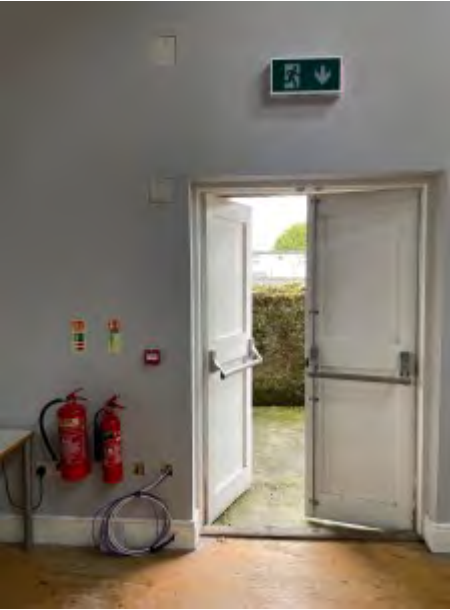
001 / 091

Final Exit from Side Hall (Room No. 0-19)
Door clear width 1274MM.

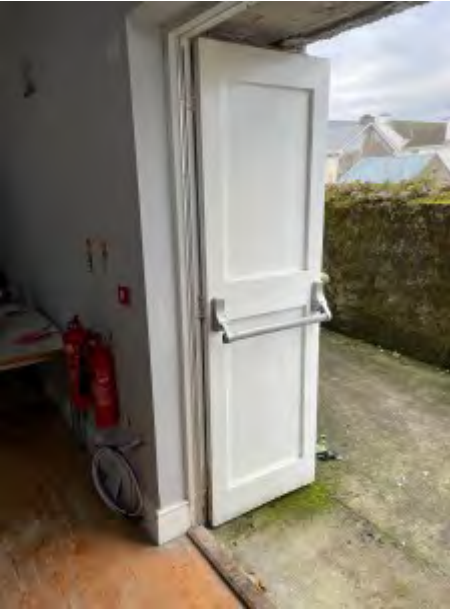
001 / 092

Final Exit from Side Hall (Room No. 0-19)
Saddle at door threshold. 40mm rise.

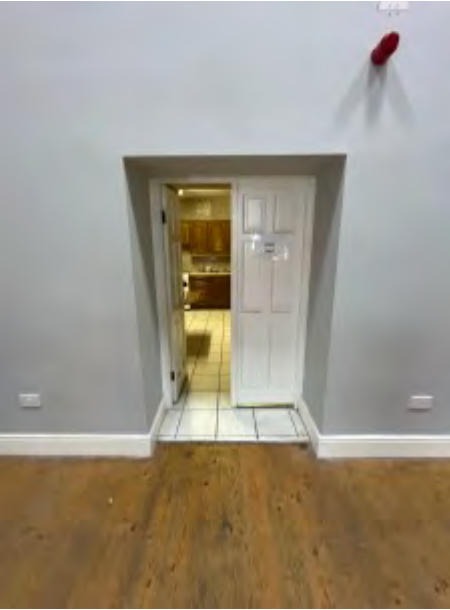
001 / 093

Doors to Room No. 0-17
Door single leaf clear with 562mm.
Structure ope width 1307mm.
Doors not fire rated.
Not in compliance with TGD Part M & B

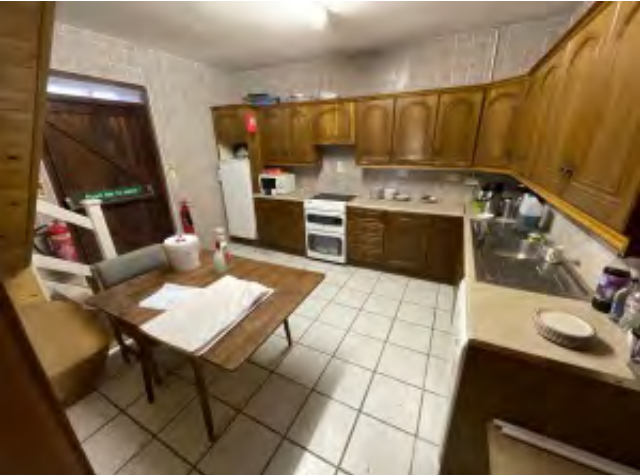
001 / 094

Kitchen (Room 0-17)
Cooker present

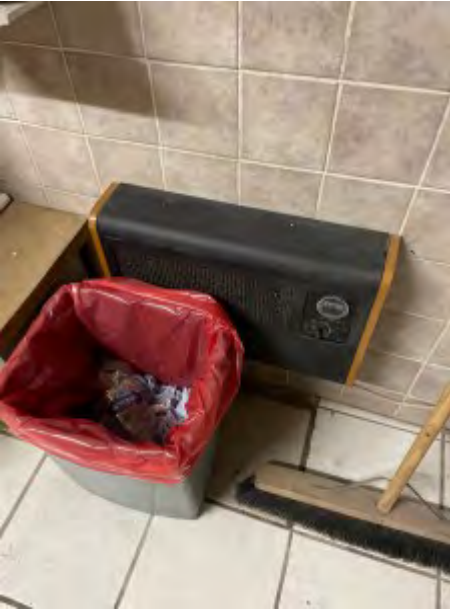
001 / 095

Kitchen (Room 0-17)
Electrical heating.

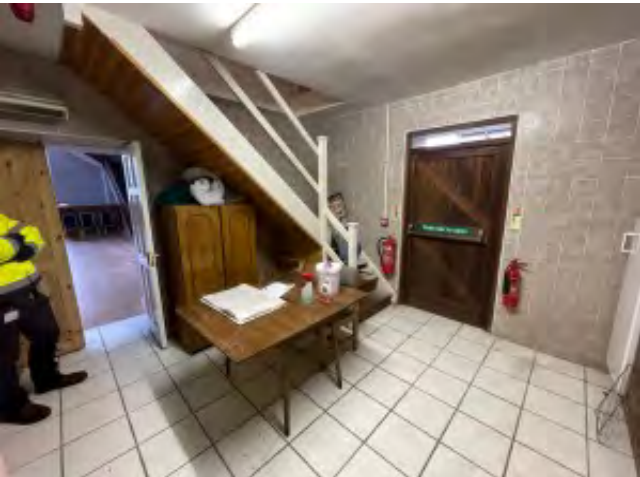
001 / 096

Kitchen (Room 0-17)
Internal stairway exiting into area of risk.
Not in compliance with TGD Part M & B

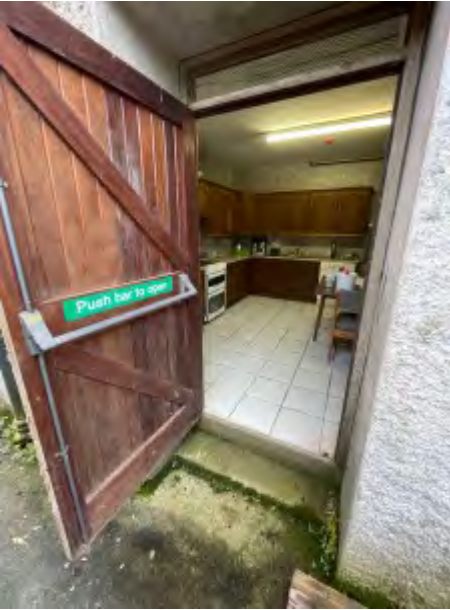
001 / 097

Kitchen (Room 0-17)
Fire exit door clear width 973MM.
2 steps at threshold.
Step at threshold 167mm.
Minor step threshold 50MM.
Not in compliance with TGD Part M & B

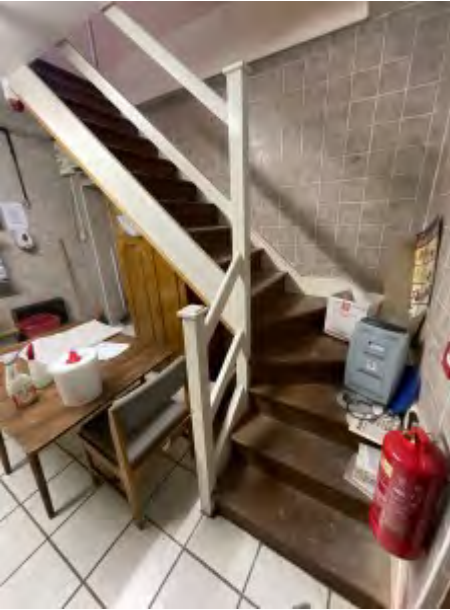
001 / 098

Kitchen (Room 0-17)
Internal stairway exiting into area of risk.
15 risers@193MM rise.
Going 250MM.
Clear width 900mm
Winders at bottom of the flight
Not in compliance with TGD Part M & B

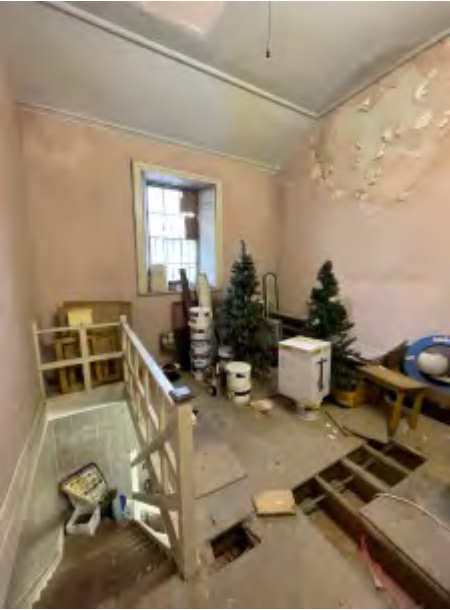
001 / 099

Room (No. M-04)

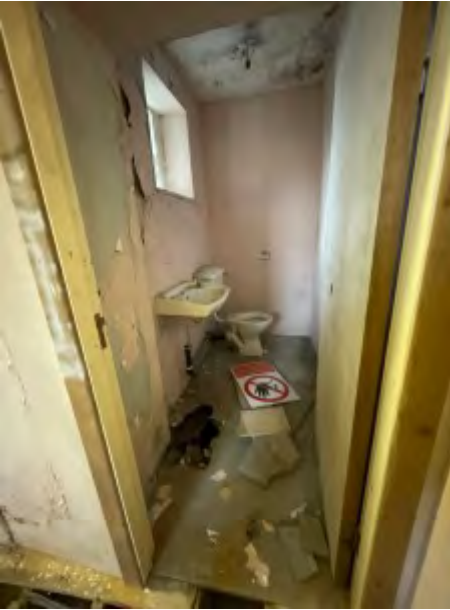
001 / 100

Door clear width 703MM.

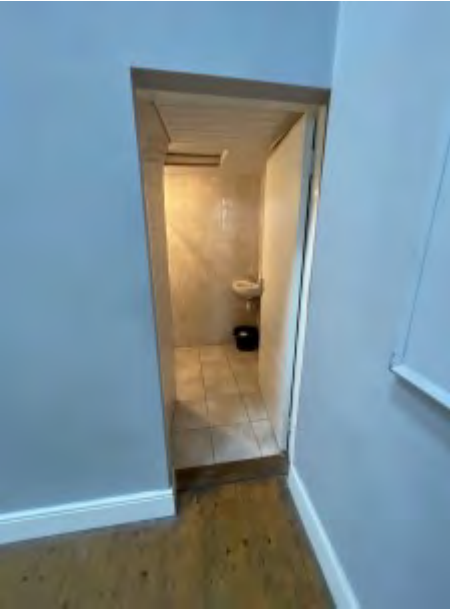
001 / 101

Clear width of door 755MM.

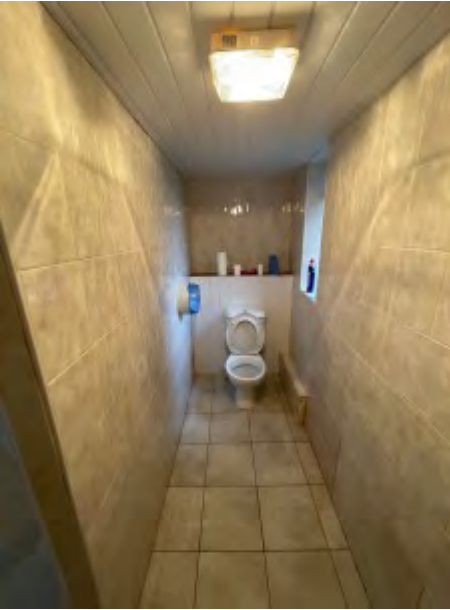
001 / 102

Toilet dimensions width 1024MM.
Width does not include door alcove.
Length 3102MM.
Floor to ceiling 2066MM.

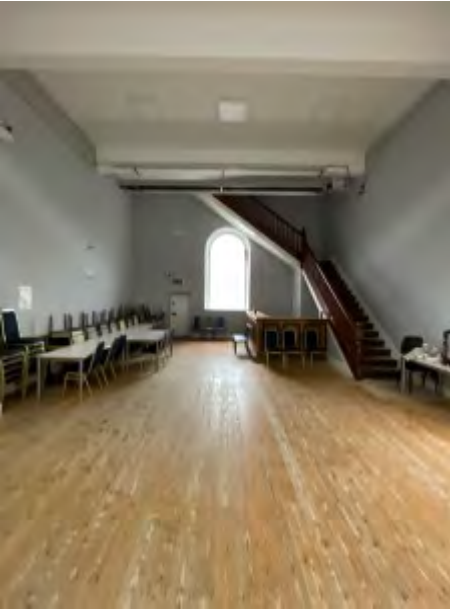
001 / 103

Side Hall (Room No. 0-19)
Space heating by ceiling radiators

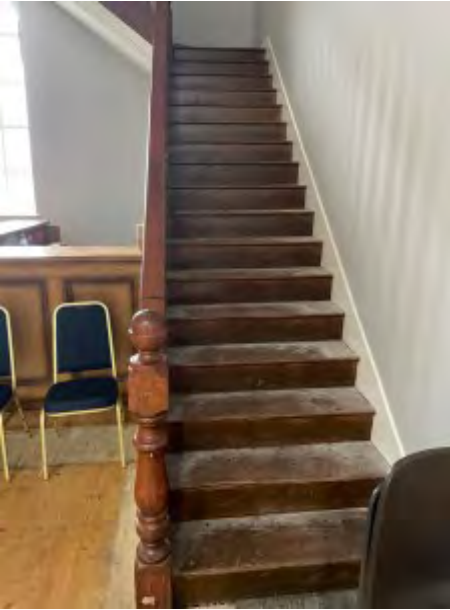
001 / 105

Timber stairs to access Room No. M-08
2 flights of 17 rises
Going 280MM.
Rise 180MM.
Clear width between handrail and wall 1032.
Not in compliance with TGD Part M & B & K

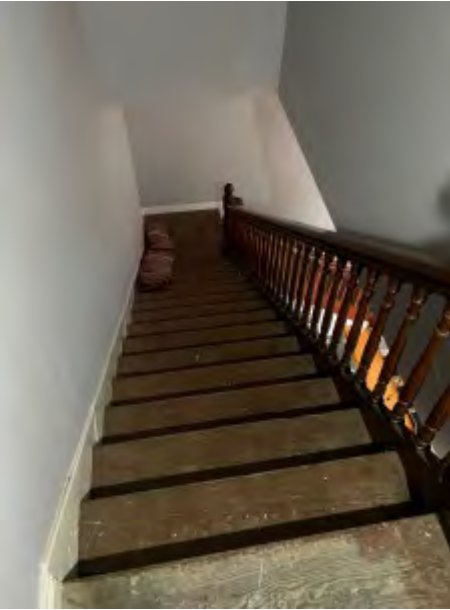
001 / 106

Timber stairs to access Room No. M-08

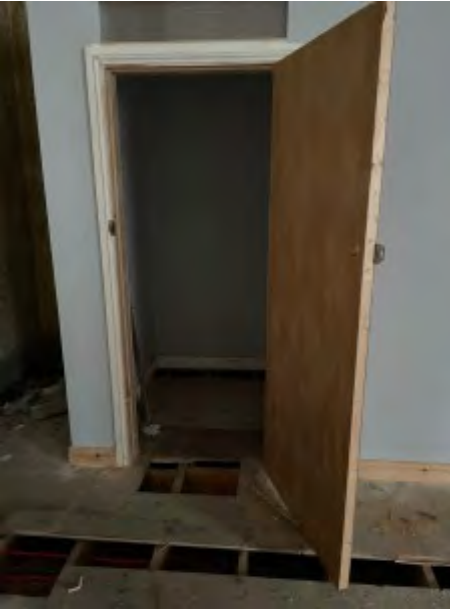
001 / 107

Side Hall (Room No. 0-19)
Door to Storage underneath stairway enclosure
clear width 769MM.

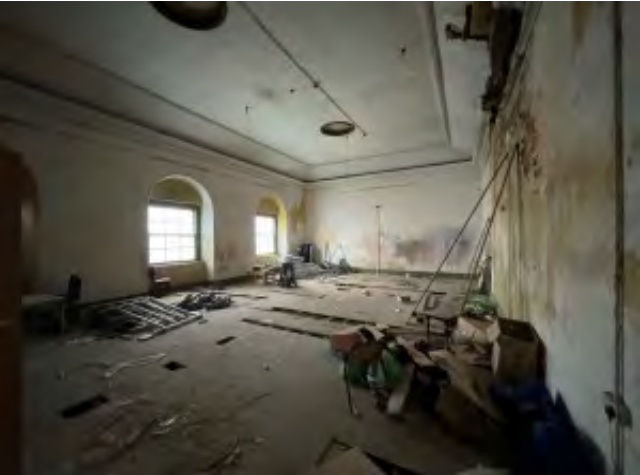
001 / 108

Comment
First Floor Level (Room No. M-08)

Current Status
Requires Attention

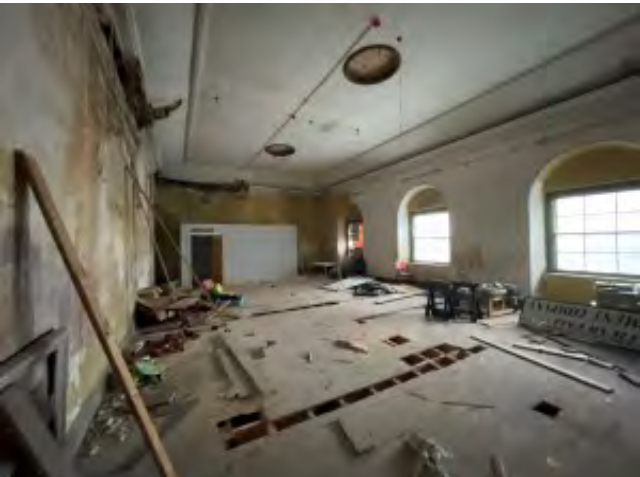
001 / 109

Comment
First Floor Level (Room No. M-08)
Floor to ceiling height 5036MM.

Current Status
Requires Attention

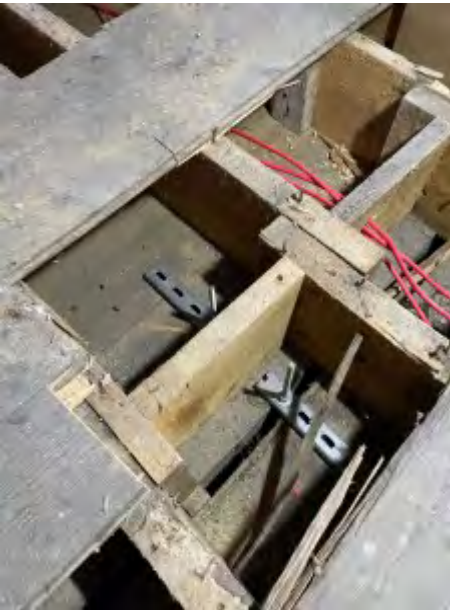
001 / 110

First Floor Level (Room No. M-08)
Joists running from north to south i.e. front to back.
Joists 40mm THK, 220mm deep with 380mm centre to centre.
Timber floor finish tongue and groove planks 30 MM thick

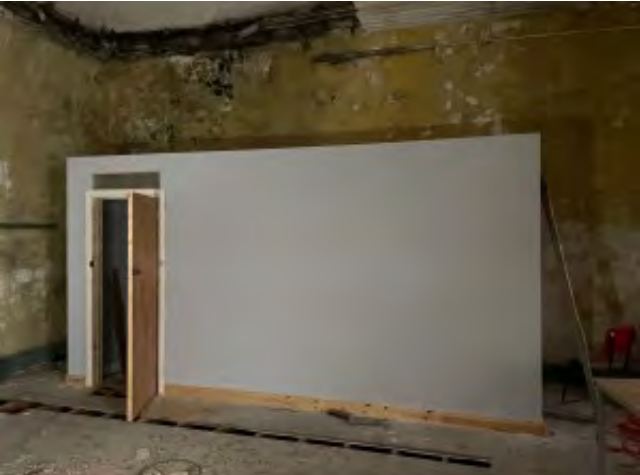
001 / 111

First Floor Level (Room No. M-08)
Stairway enclosure not fire rated.
Not in compliance with TGD Part M & B & K

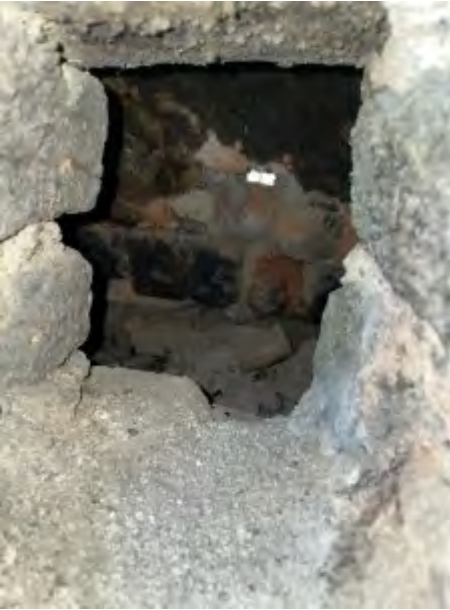
001 / 112

First Floor Level (Room No. M-08)
Dividing wall through present?

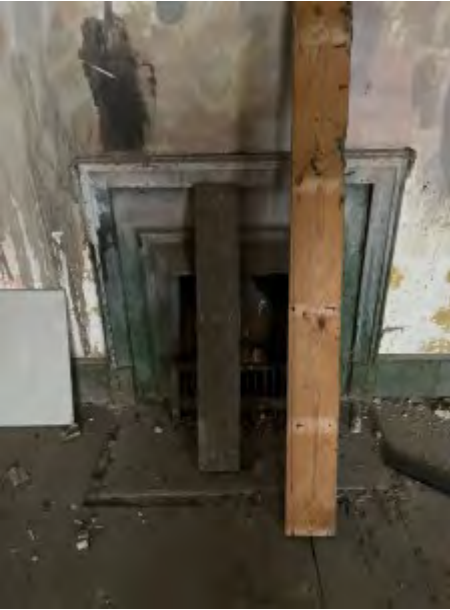
001 / 113

First Floor Level (Room No. M-08)
Open fireplace present.

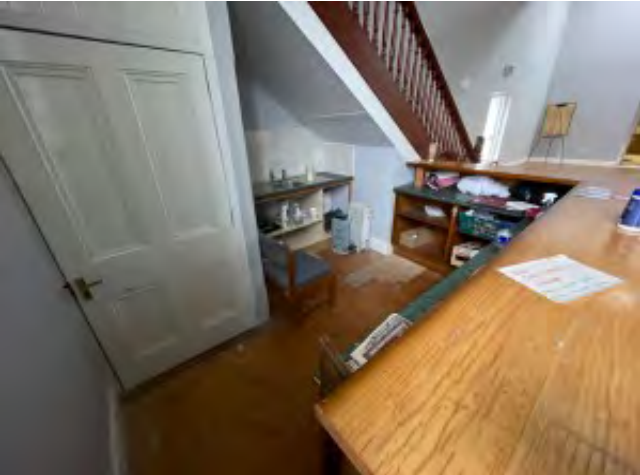
001 / 114

Comment
Side Hall (Room No. 0-19)
Stairway not in compliance with TGD Part M & B & K

Current Status
Requires Attention

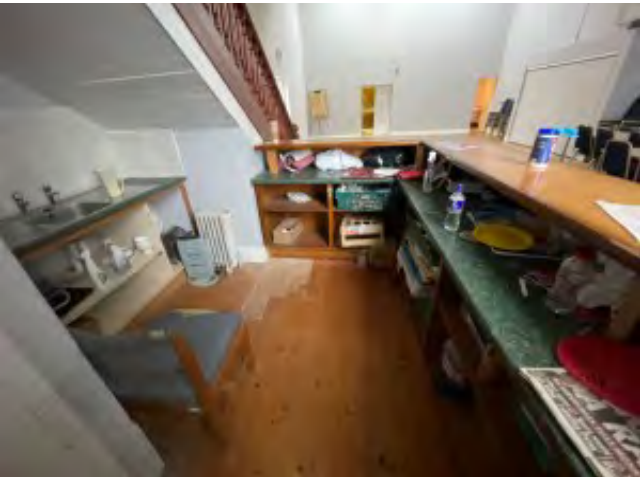
001 / 115

Comment
Side Hall (Room No. 0-19)
Stairway not in compliance with TGD Part M & B & K

Current Status
Requires Attention

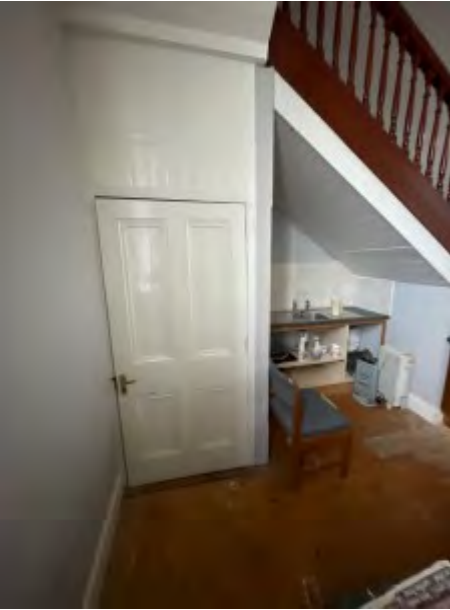
001 / 116

Door locked at time of inspection.
