Birr Courthouse

HSF Grant Scheme 2021: Final Report

October 2021

This report was produced for Offaly County Council by Howley Hayes Cooney Architecture in October 2021 to determine the extent of repairs carried out at the Birr Courthouse for the Historic Structures Fund 2021. The overall project at this building is also part funded by the Heritage Council.

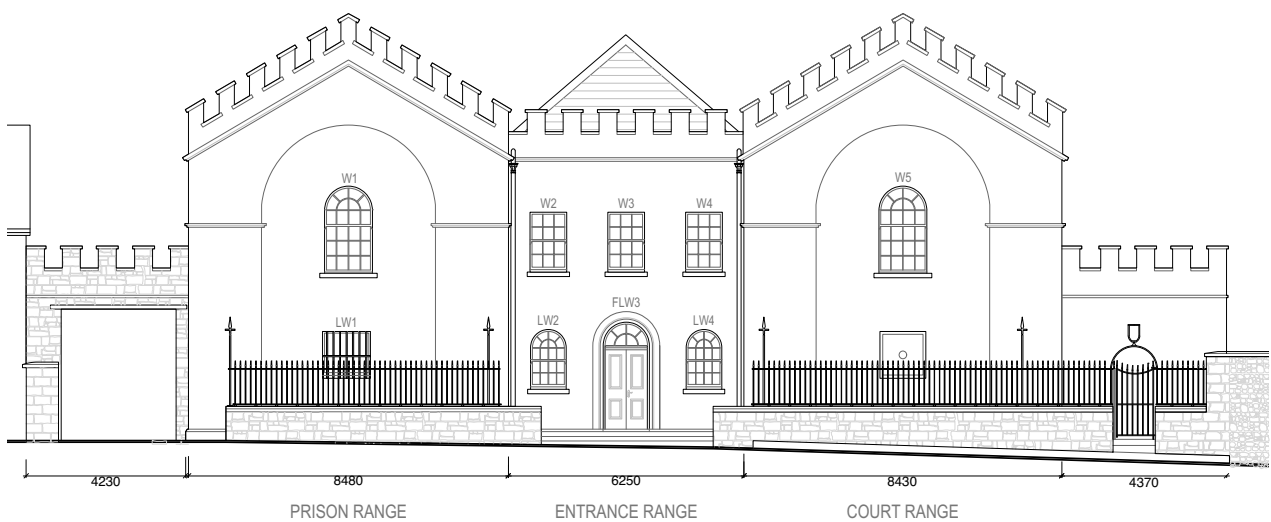
- Natural slates with some displacement around chimneys.
- Fibre cement slates, laid in approx. 1970s.
- Chimney: inspect and repair chimney stack.
- Lead valley gutters laid after 1970s.
- General areas of significant interior damage due to water ingress.

Existing roof plan showing extent of fibre cement slates on structure in light blue, area of suspected water ingress highlighted with red dashed line
Elevation of structure can be divided in three bays, Prison Range, Entrance Range, Court Range

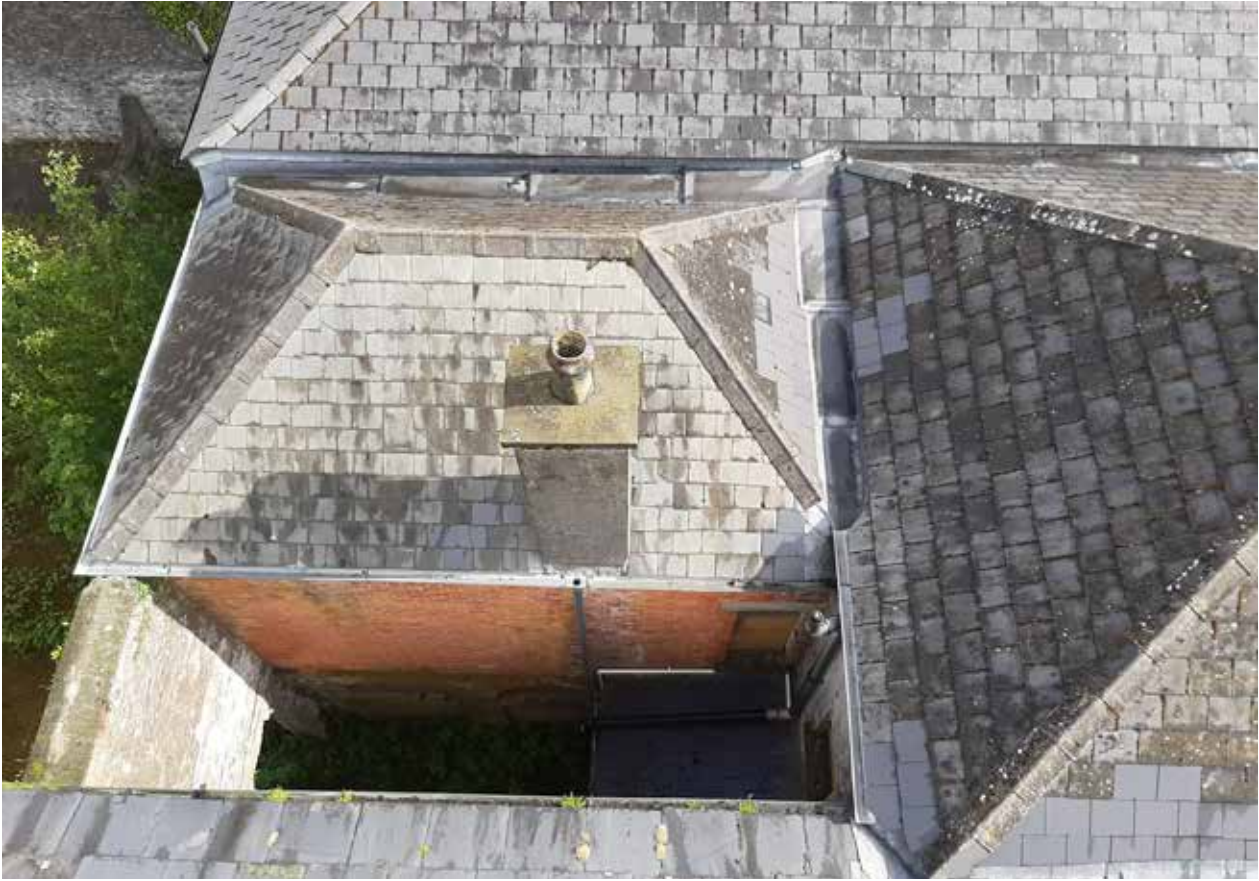
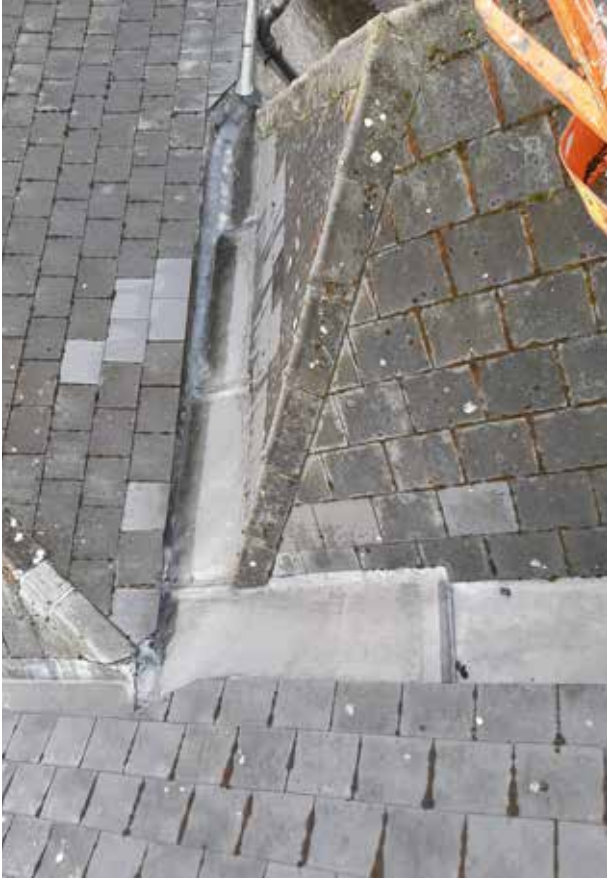
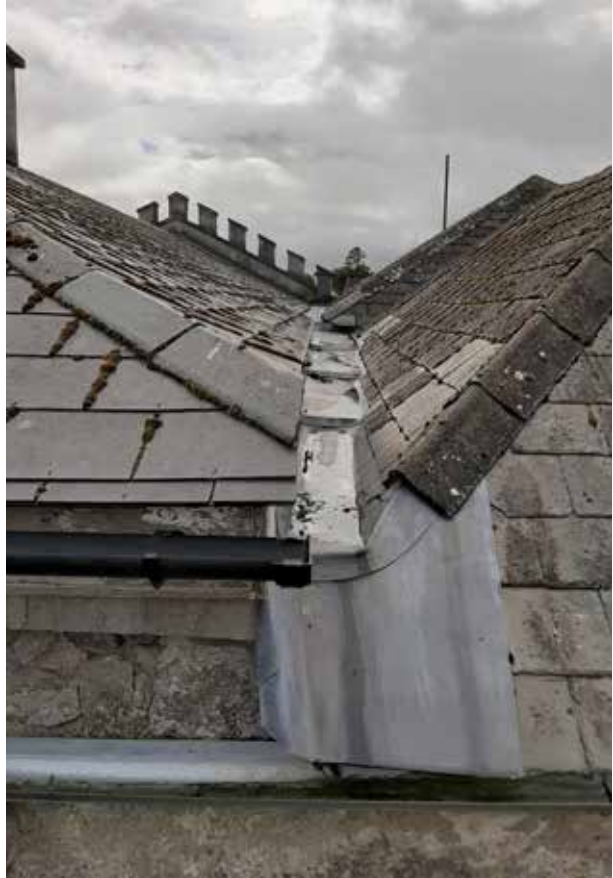
Lead Valley / Gutters 3&4 - Before works were carried out.

The existing valley gutters were a 20th century failing addition and are not considered to be of historic value. They were not installed correctly, laid to shallow falls with shallow steps. They were removed and the timber boarding beneath was fully inspected and replaced where necessary with 18mm marine ply. New code 6 leadwork valleys were installed throughout detailed in full accordance with the Lead Development Association guidelines by experienced an experienced heritage contractor. The eaves level fibre cement slates running along the valley will were removed and replaced during this process. The lead & copper works were carried out in full accordance with all guidelines.

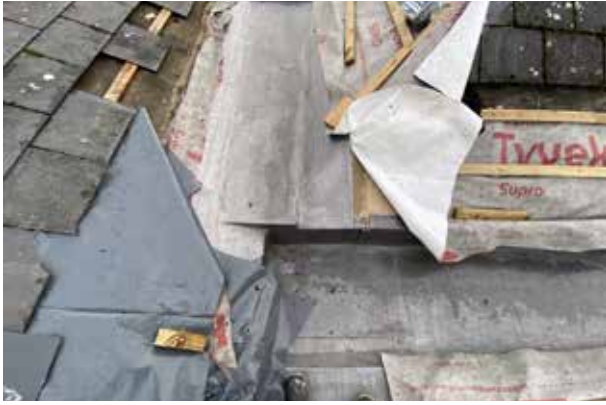
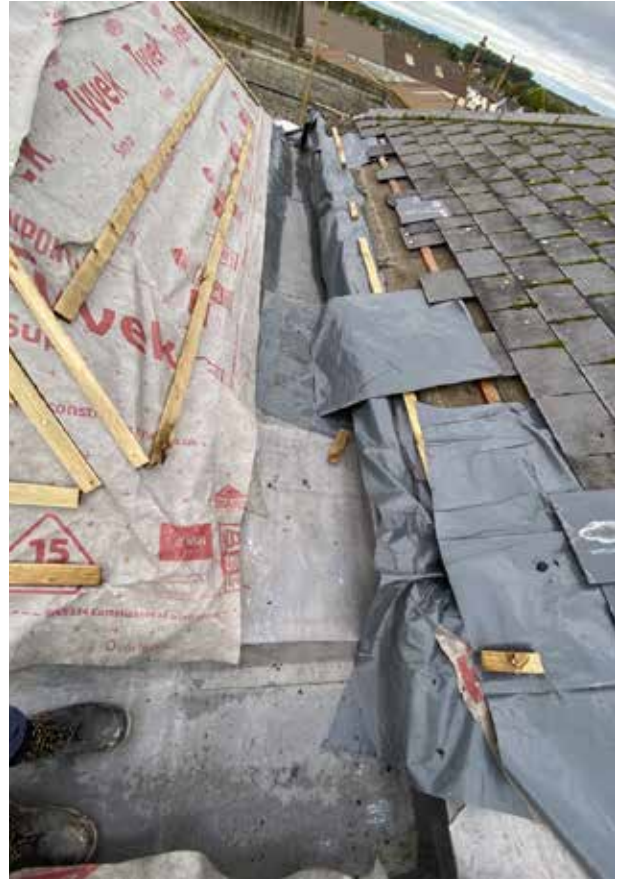
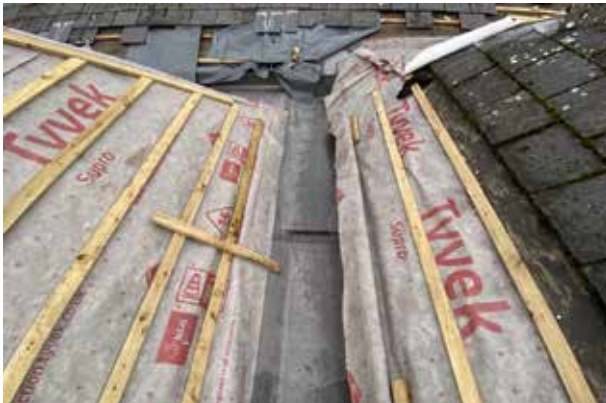
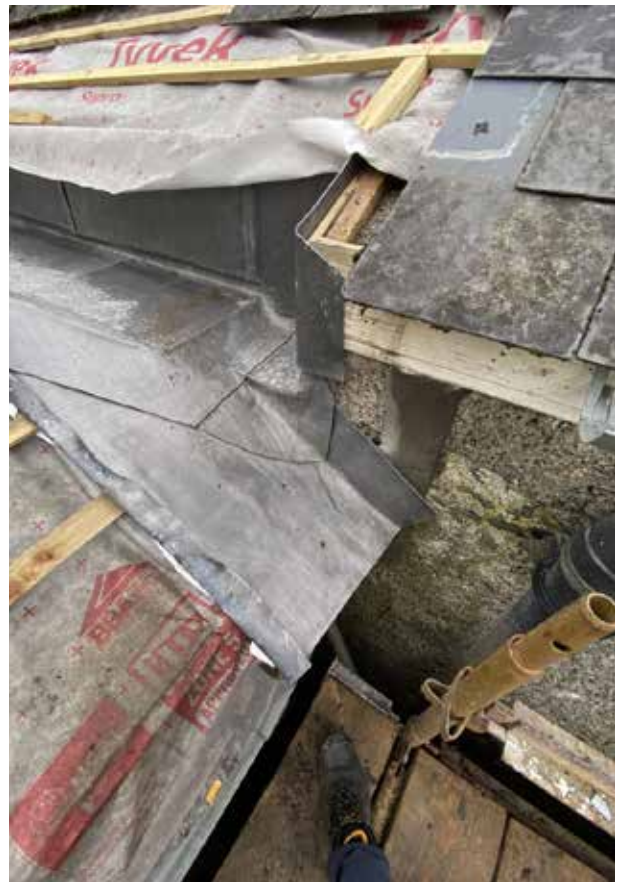
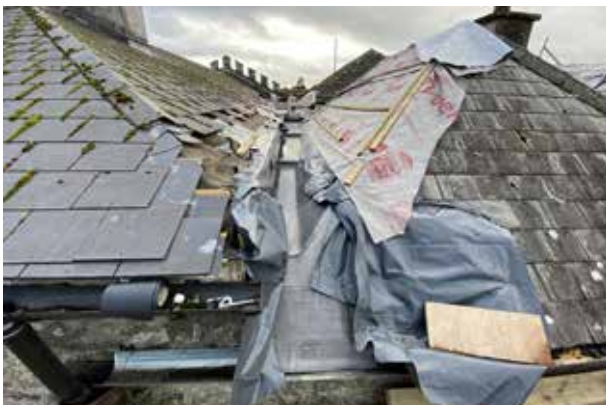
Lead Valley / Gutters 3&4 - Before works were carried out.

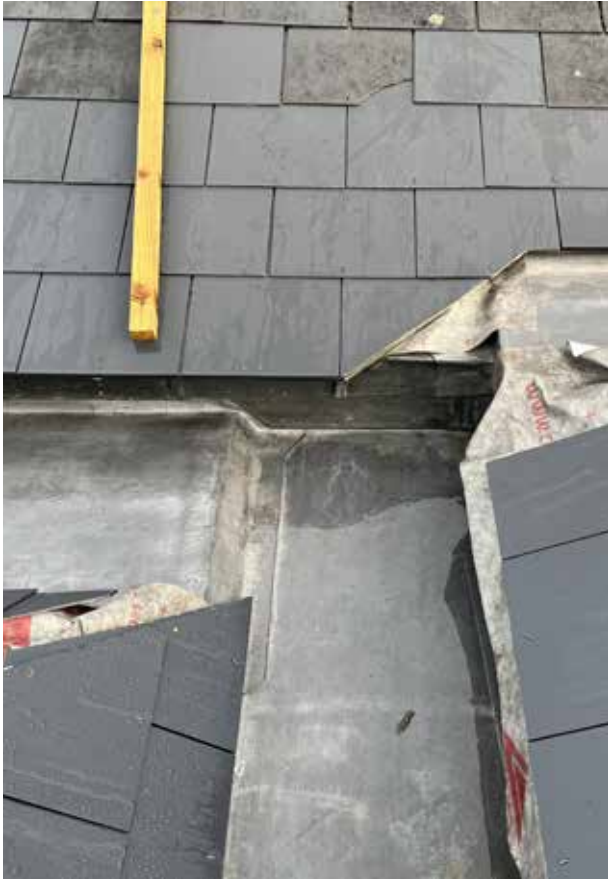
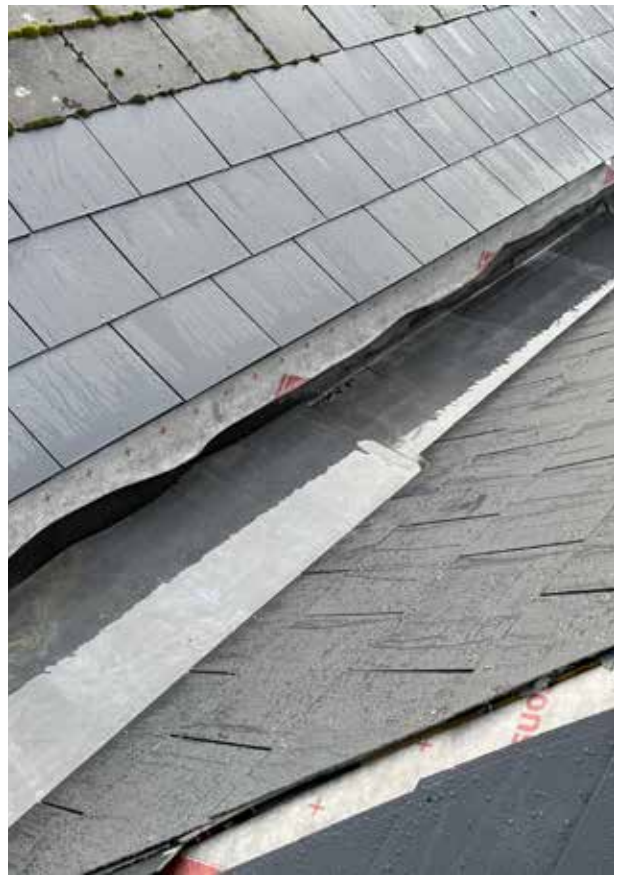
Lead Valley / Gutters 3&4 - Upon completion of the works.
